# VEHICLE INSPECTION REPORT

**DG66UBT**

## Man TGS 26.360

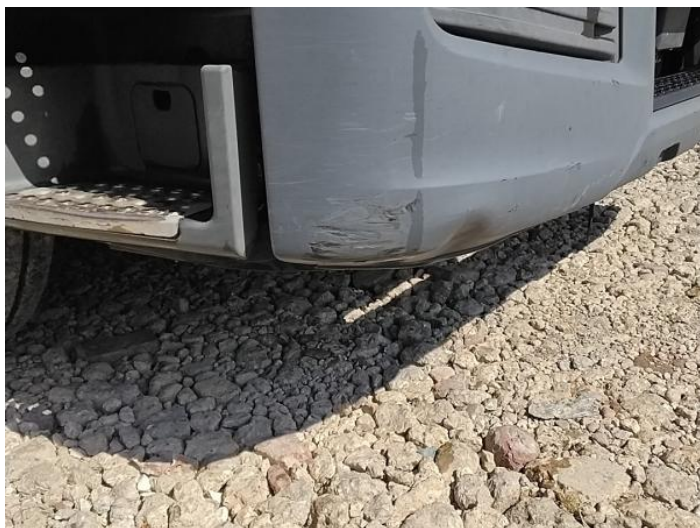
1: Bumper Front Moulding  
Scuffed (Unpainted)  
Over 100mm

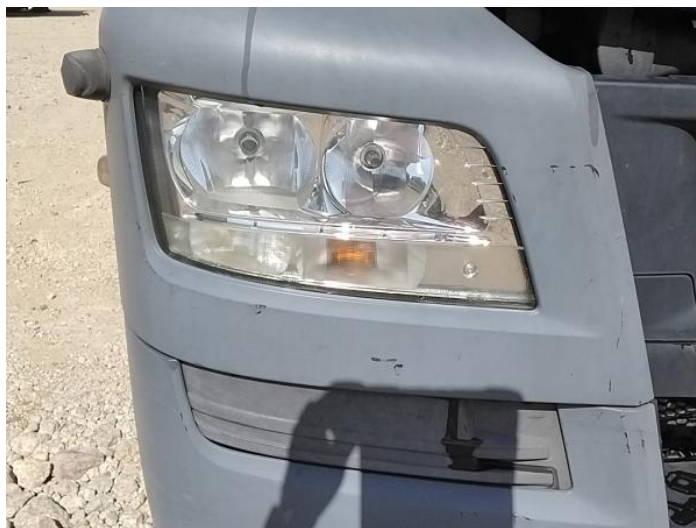
2: Fog Lamp Surround os  
Scuffed (Unpainted)  
UpTo 100mm

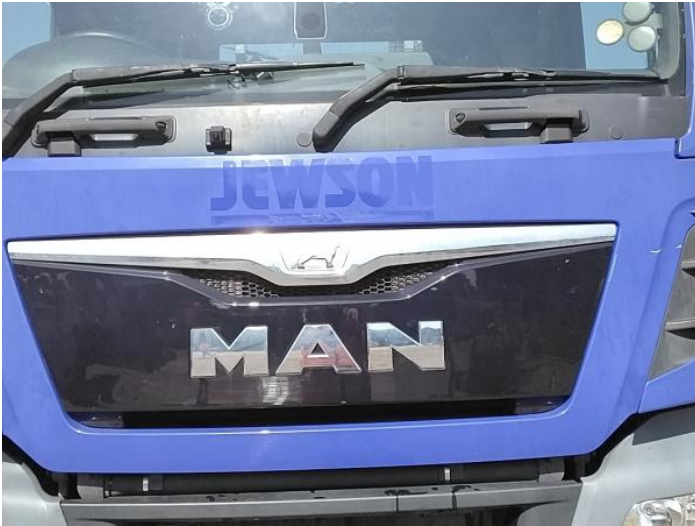
3: Bonnet  
Scratched  
Over 25mm Thru Paint

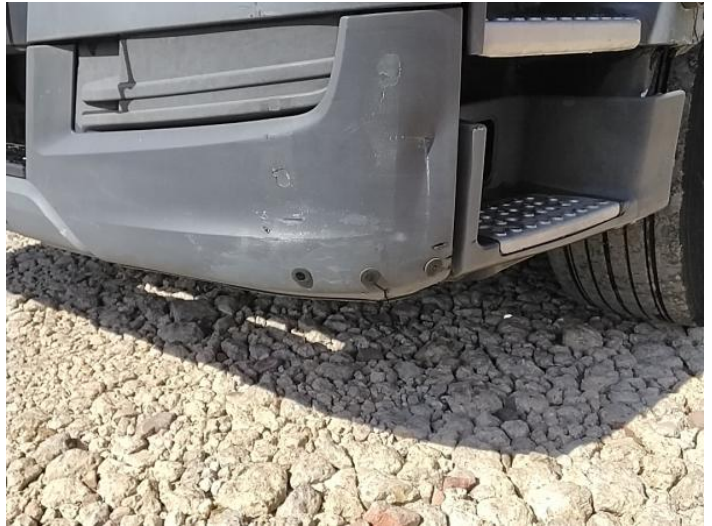
4: Bumper Front Moulding  
Scuffed (Unpainted)  
UpTo 100mm

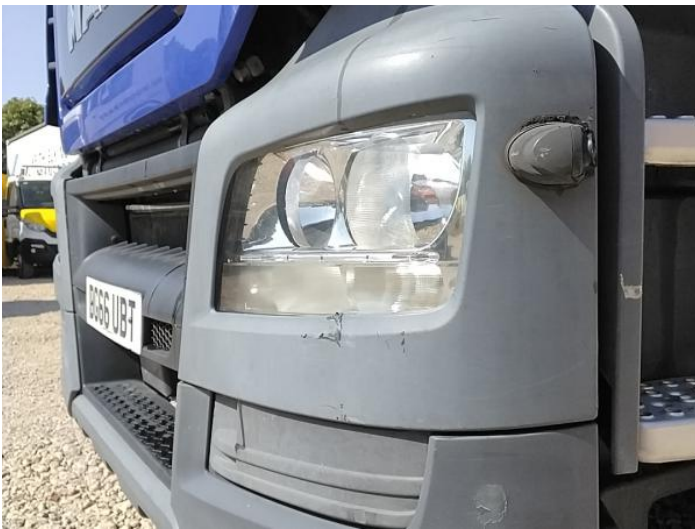
5: Fog Lamp Surrounds  
Scuffed (Unpainted)  
UpTo 100mm

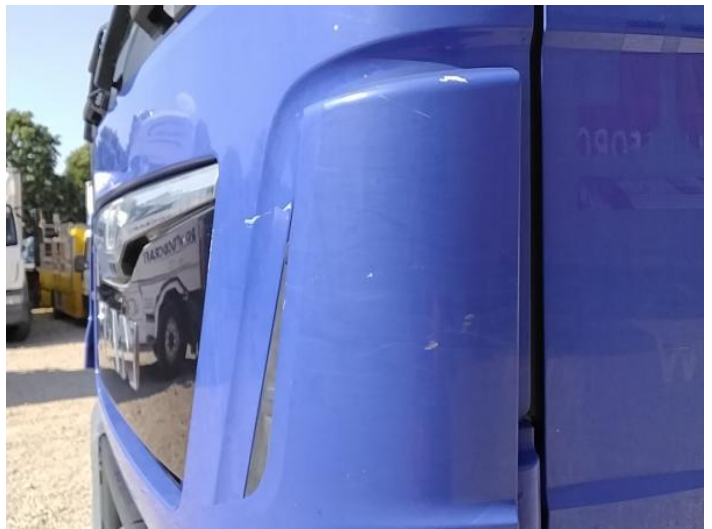
6: Wing nsf  
Scratched  
UpTo 25mm Thru Paint

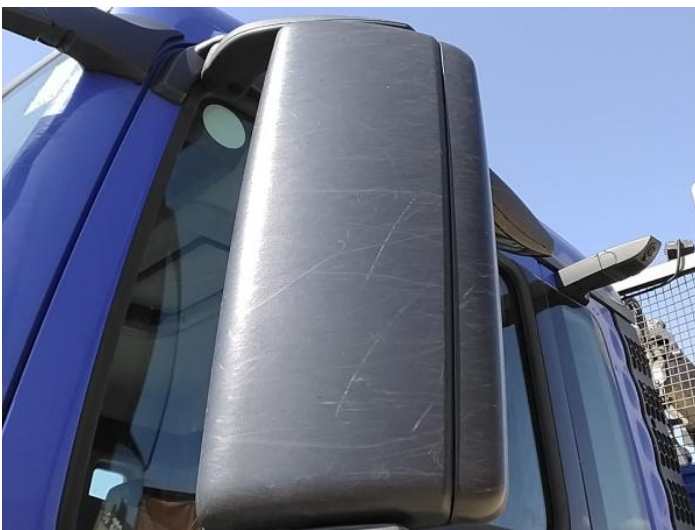
7: Door Mirror Assy nsf  
Scuffed (Unpainted)  
UpTo 100mm

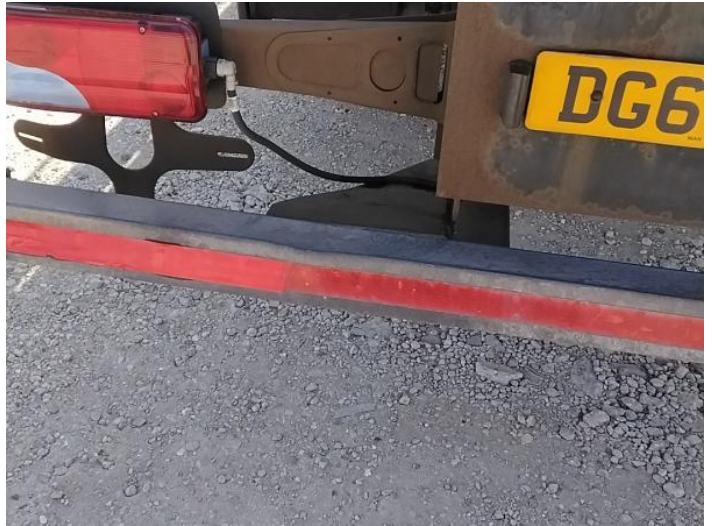
10: Bumper Rear  
Dented  
Between 10mm + 30mm

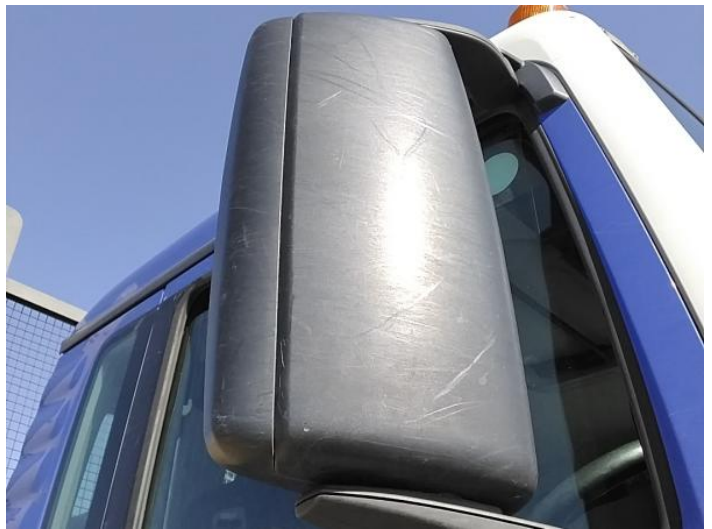
12: Door Mirror Assy osf  
Scuffed (Unpainted)  
UpTo 100mm

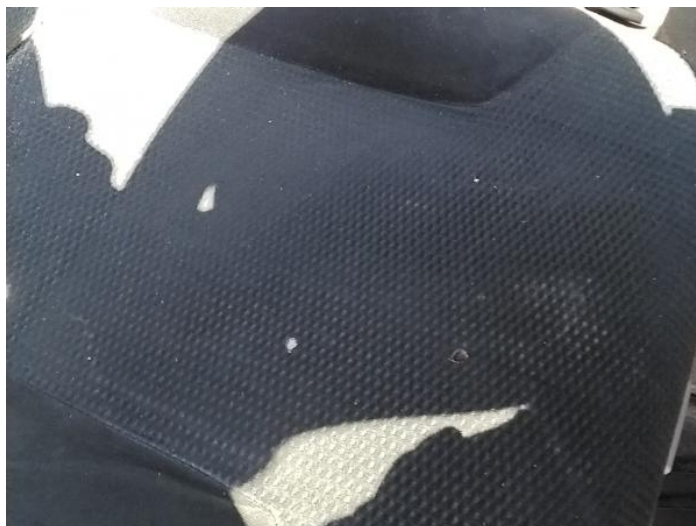
16: Seat Base Cover osf  
Burn  
Over 3mm
