VEHICLE INSPECTION REPORT

HX16FXK

Mercedes-Benz Antos 1824

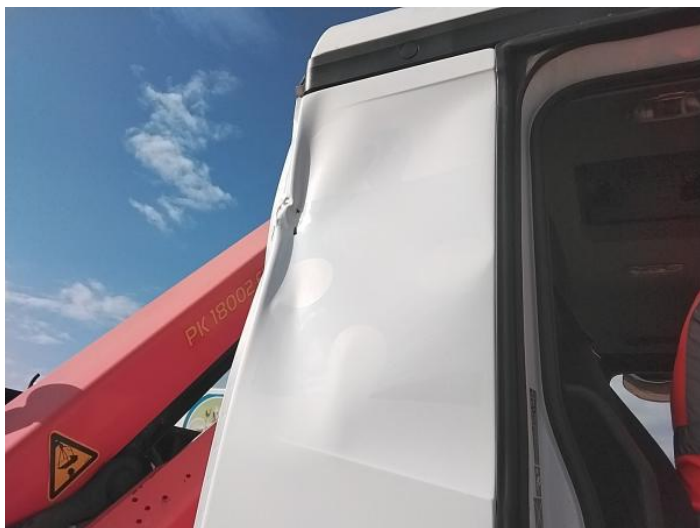
1: Qtr Panel osr
Dented
Over 30% Of Panel

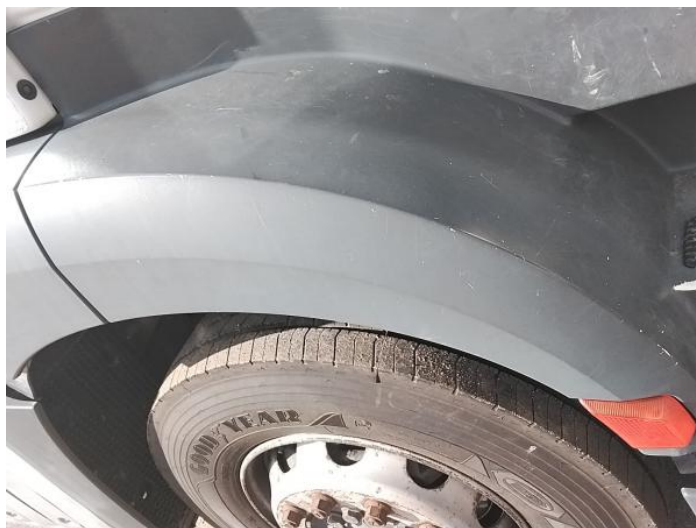
2: Wing osf
Chipped
Multiple Chips

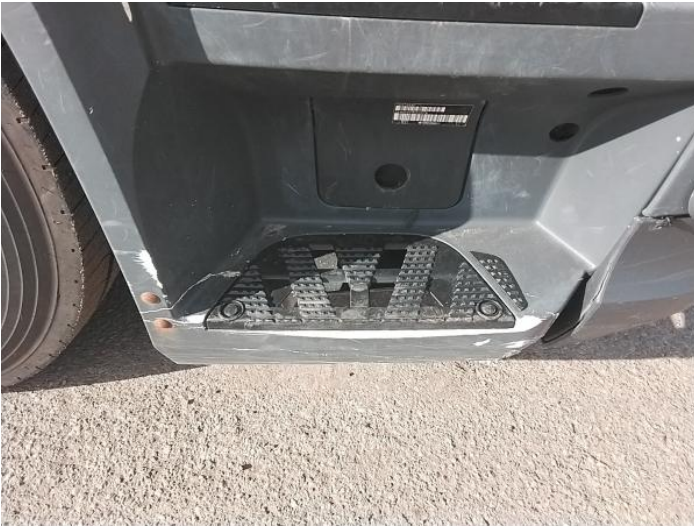
3: Bumper Front Moulding
Broken
Replace

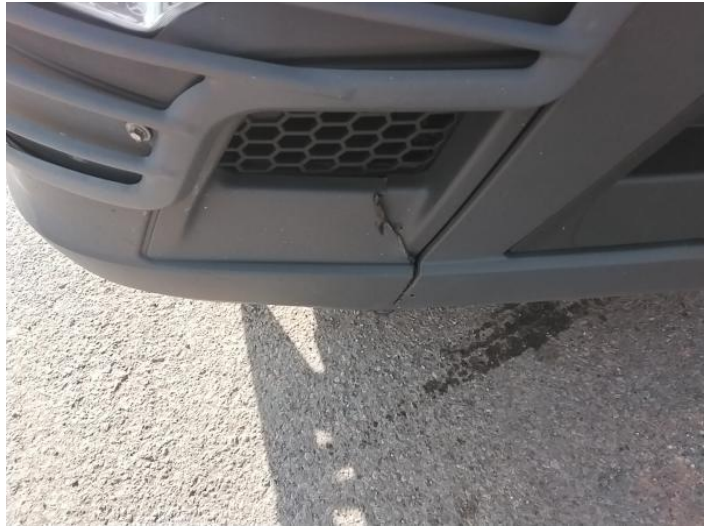
4: Bumper Front
Cracked
Over 25mm

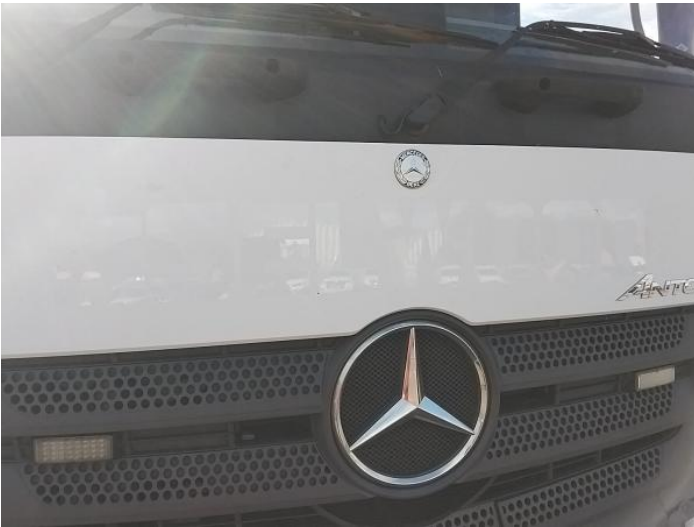
5: Bonnet
Chipped
Multiple Chips

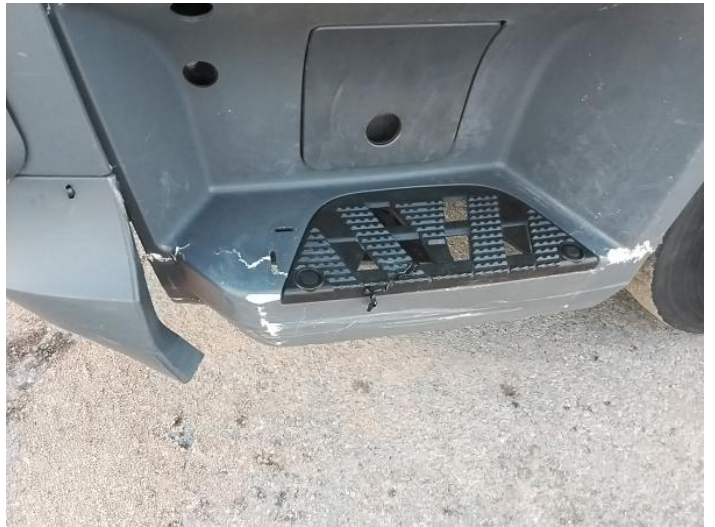
6: Bumper Front Moulding
Broken
Replace

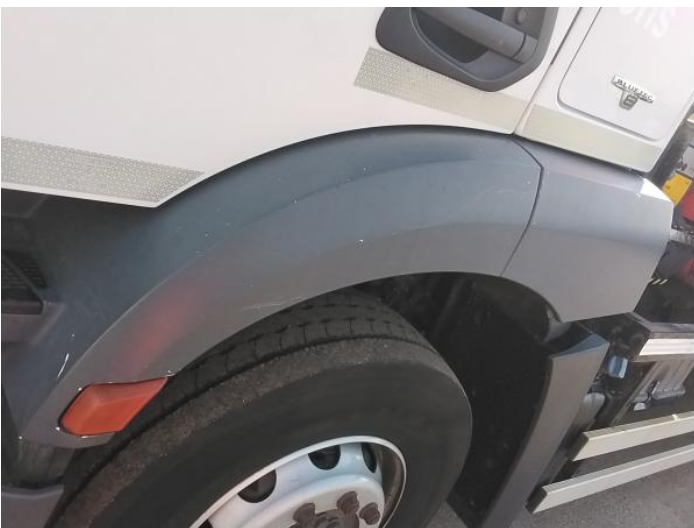
7: Wing nsf
Chipped
Multiple Chips

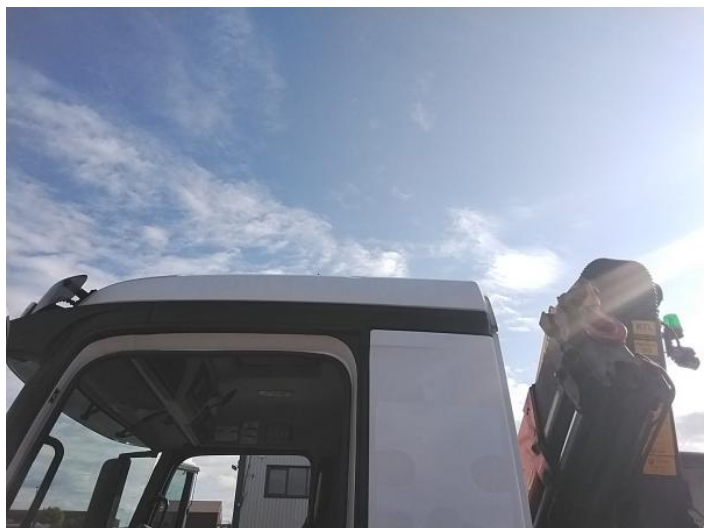
8: Roof
Dented
Over 30mm

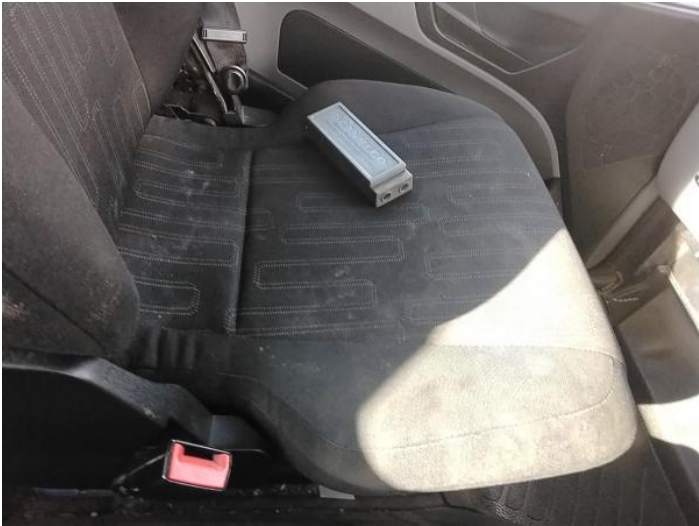
9: Seat Base Cover nsf
Soiled
Heavy

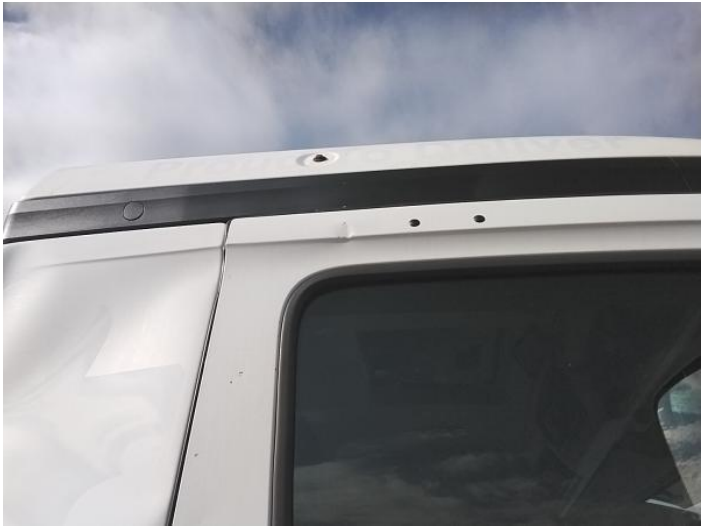
10: Door osf
Dented
With Paint Damage

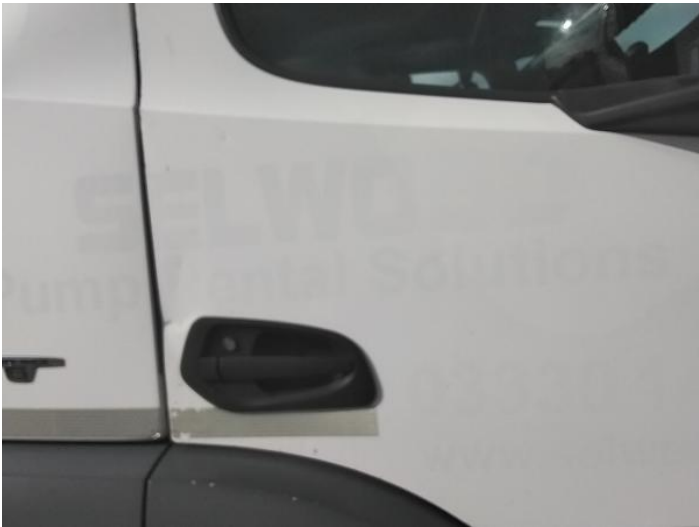
11: Door osf
Chipped
Multiple Chips

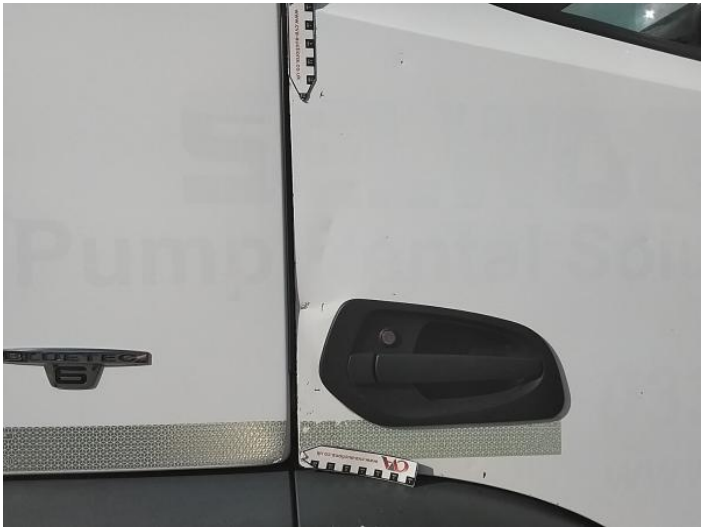
12: Door osf
Dented
With Paint Damage
