## VEHICLE INSPECTION REPORT

**BV67GSU**

### Volkswagen Crafter CR35 2.0 TDI BMT 109PS

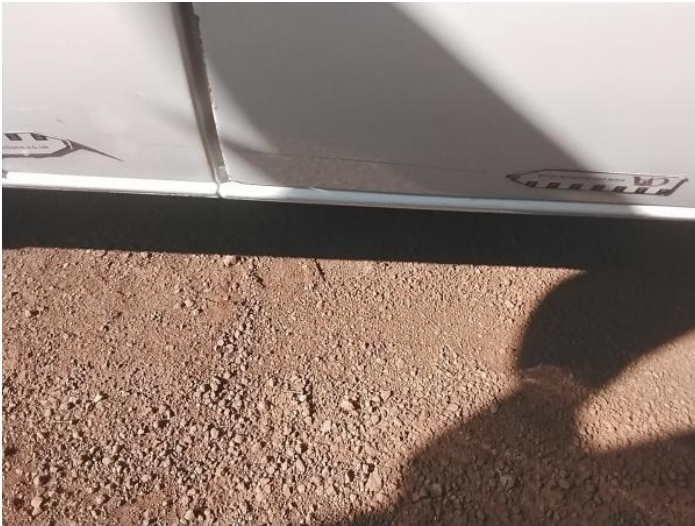
9: Qtr Panel nsr  
Scratched  
Over 25mm Not Thru Paint

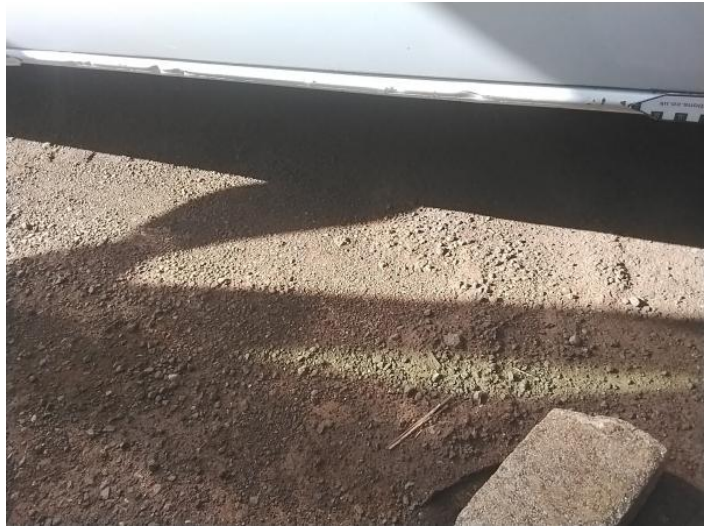
10: Sill ns  
Dented  
With Paint Damage

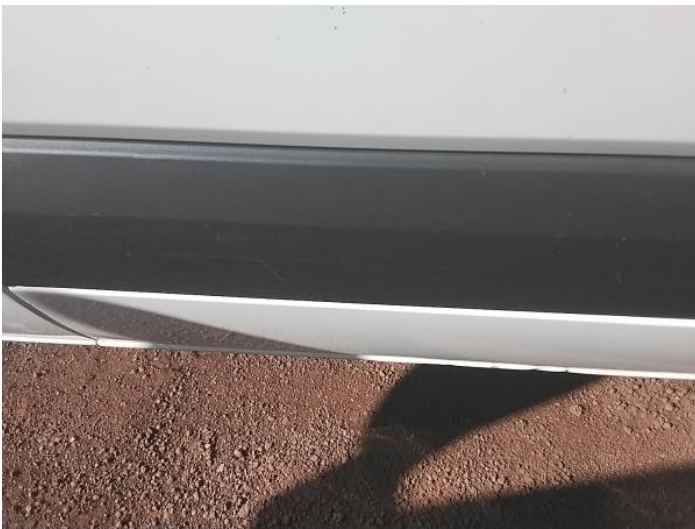
11: Qtr Panel Moulding ns  
Scuffed (Unpainted)  
Over 100mm

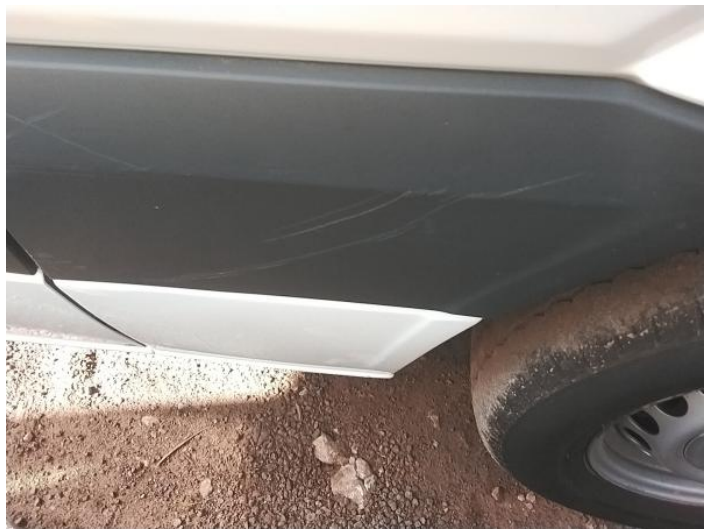
12: Qtr Panel Moulding ns  
Scuffed (Unpainted)  
Over 100mm

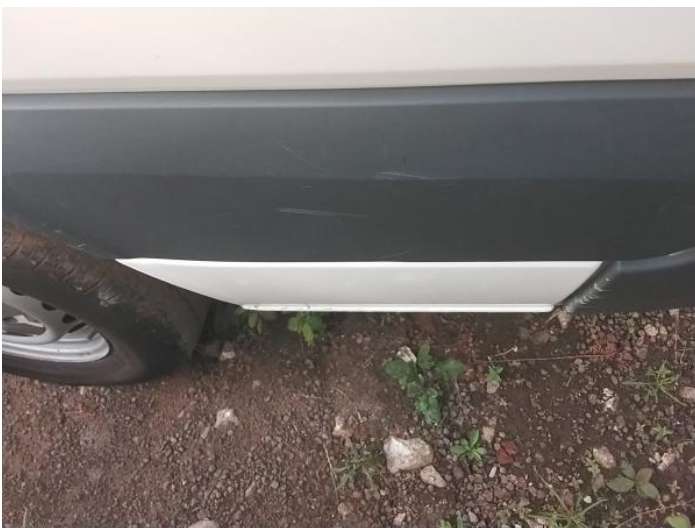
13: Qtr Panel Moulding ns  
Scuffed (Unpainted)  
Over 100mm

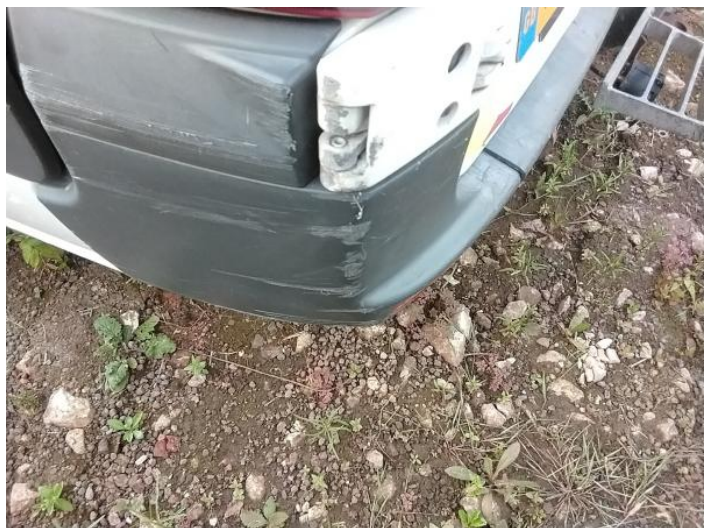
14: Bumper Rear Moulding  
Scuffed (Unpainted)  
Over 100mm

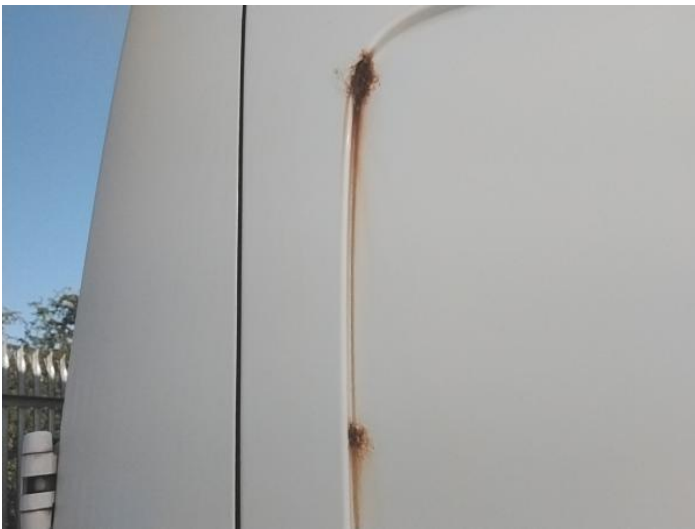
17: Qtr Panel osr  
Rusted  
Over 5mm

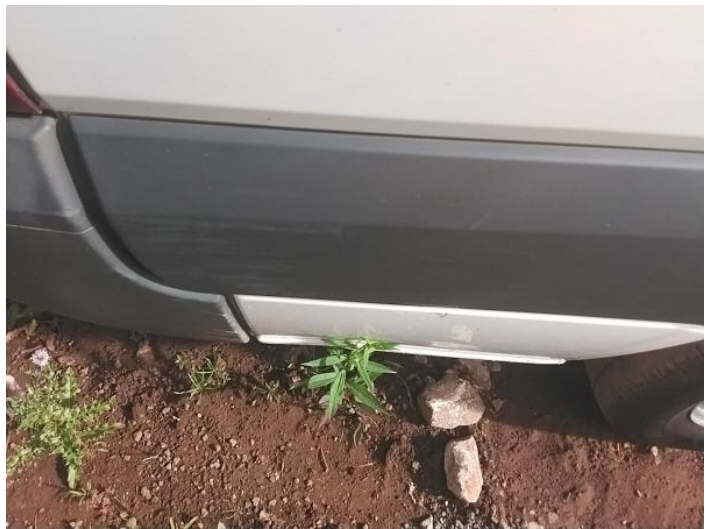
18: Qtr Panel Moulding os  
Scuffed (Unpainted)  
Over 100mm

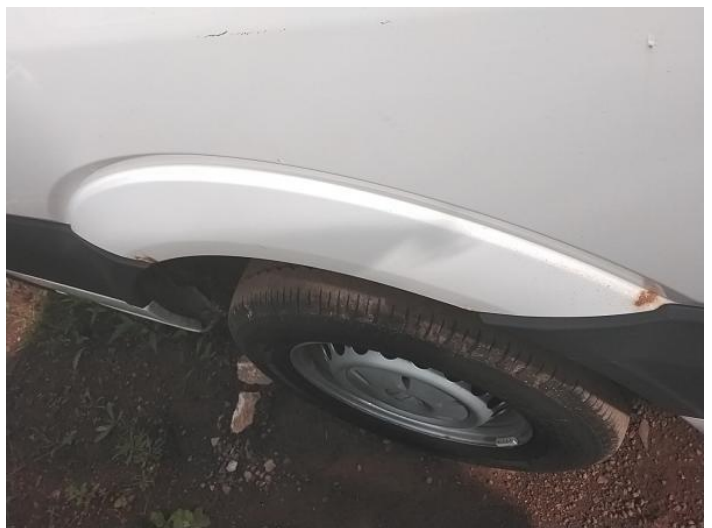
20: Qtr Panel osr  
Dented  
Over 30mm
