VEHICLE INSPECTION REPORT

DX19XHM

Daf LF 180

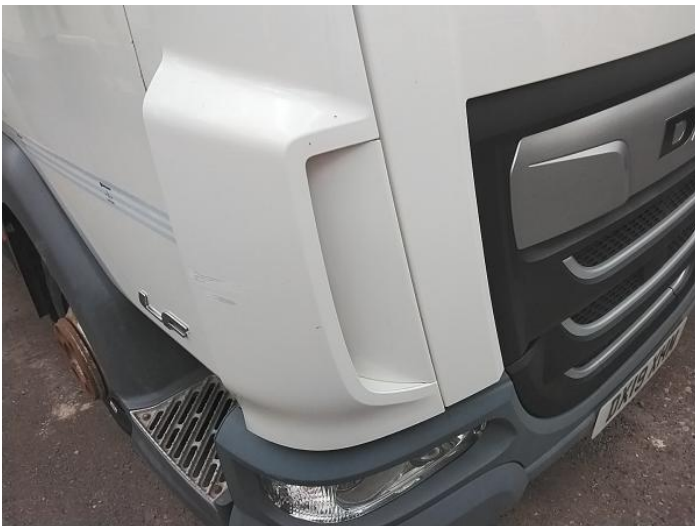
1: Panel Front
Scratched
Over 25mm Thru Paint

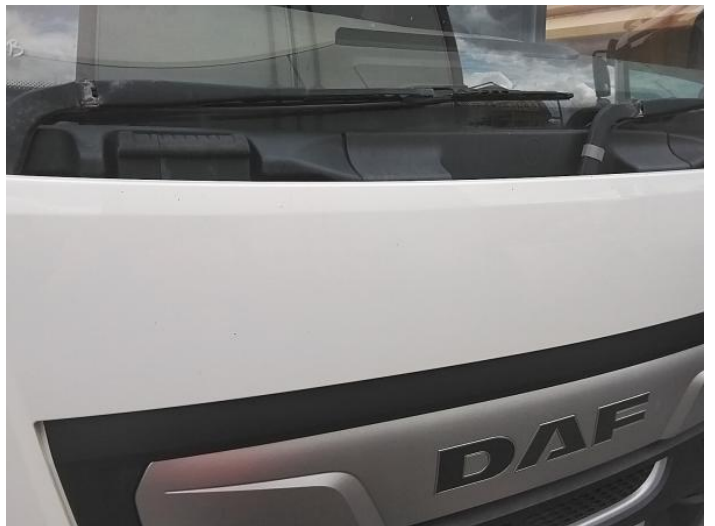
2: Bonnet
Chipped
Multiple Chips

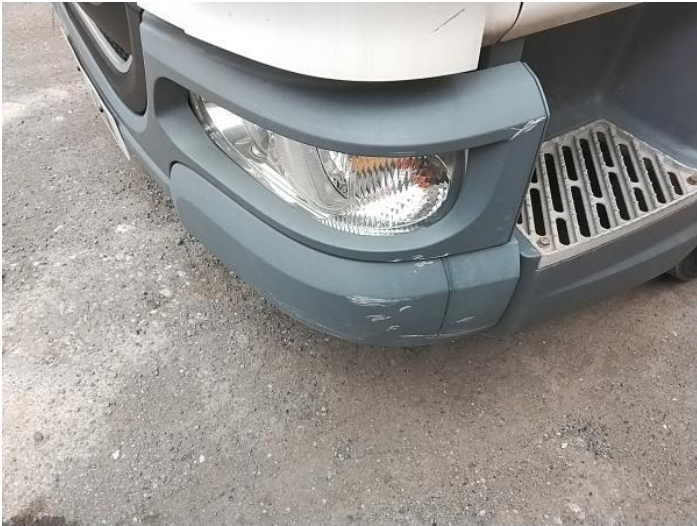
3: Bumper Front
Scratched
Over 100mm Thru Paint

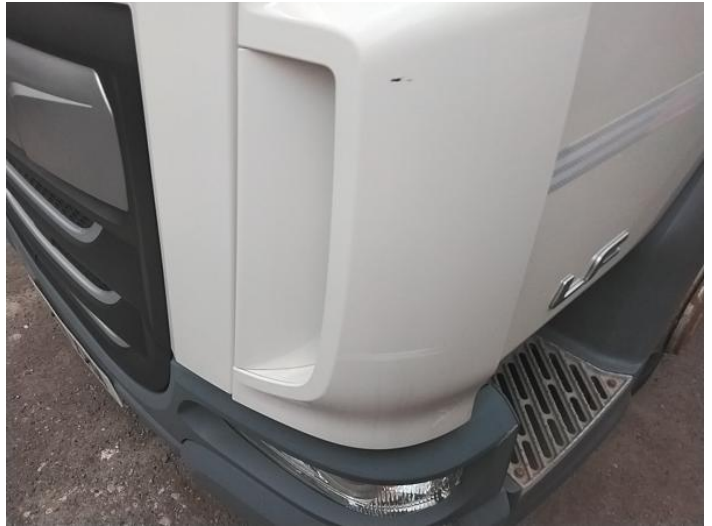
4: Panel Front
Scratched
Over 25mm Thru Paint

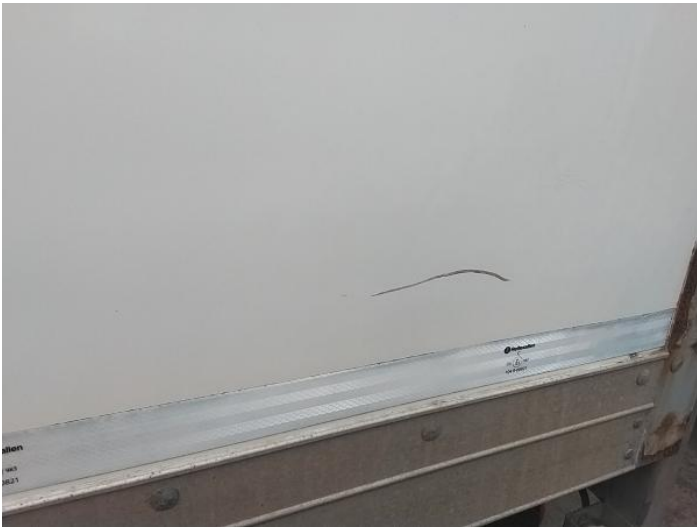
5: Qtr Panel nsr
Dented
With Paint Damage

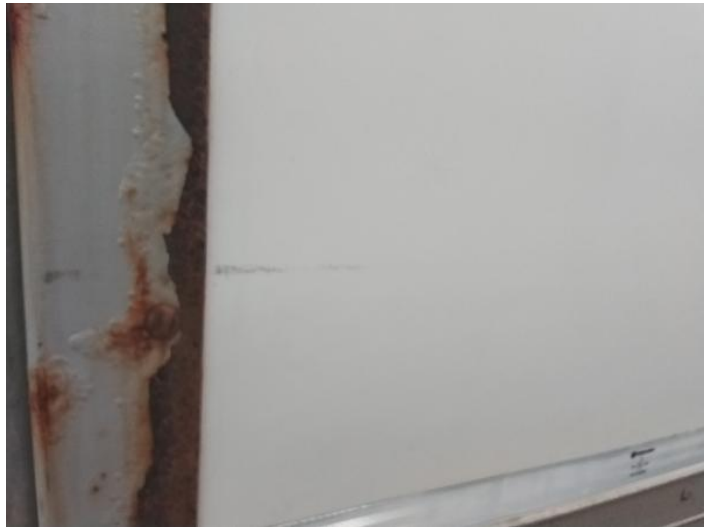
6: Qtr Panel osr
Scratched
Over 25mm Thru Paint

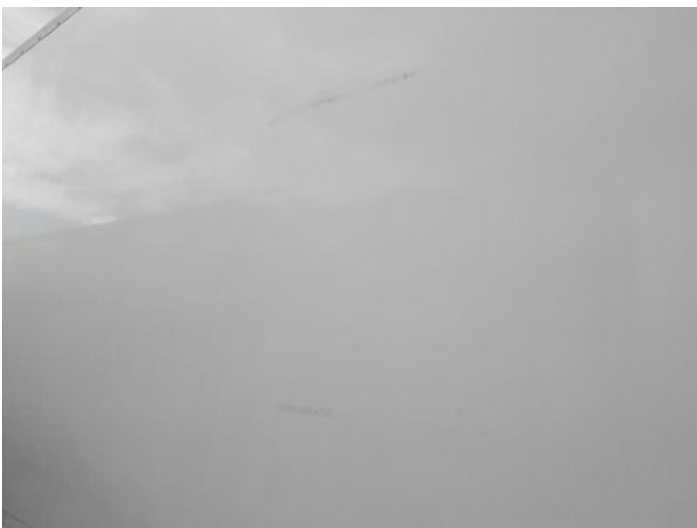
7: Qtr Panel osr
Scratched
Over 25mm Thru Paint

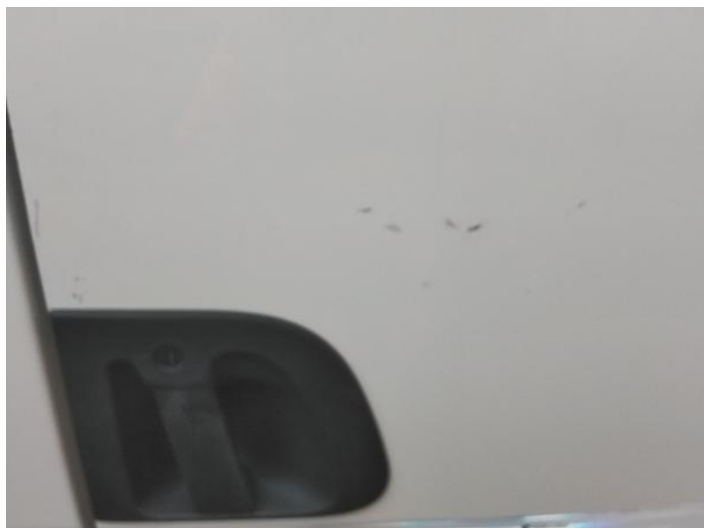
8: Door osf
Scratched
Over 25mm Thru Paint

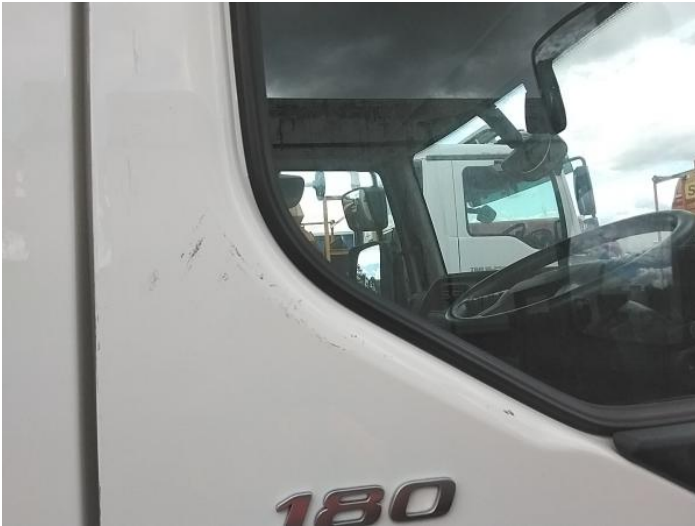
9: Door osf
Scratched
Over 25mm Thru Paint

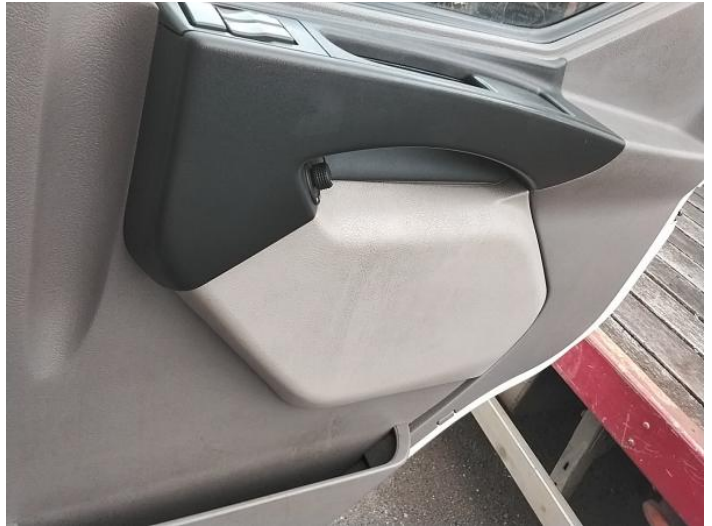
10: Door Pad osf
Soiled
Heavy

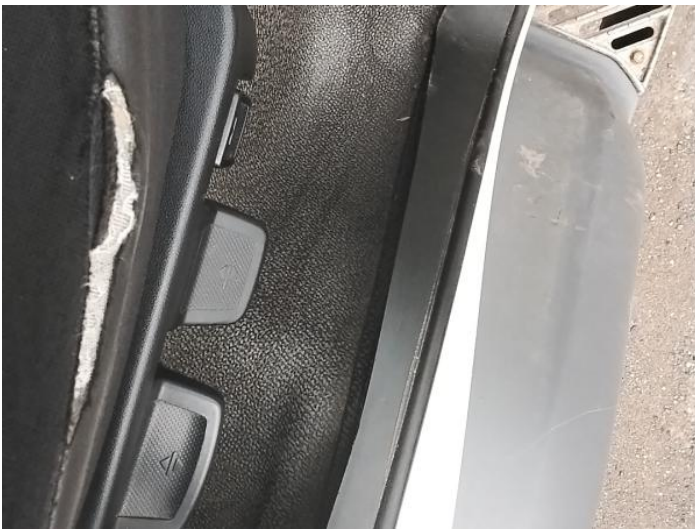
11: Seat Base Cover osf
Torn
Over 3mm

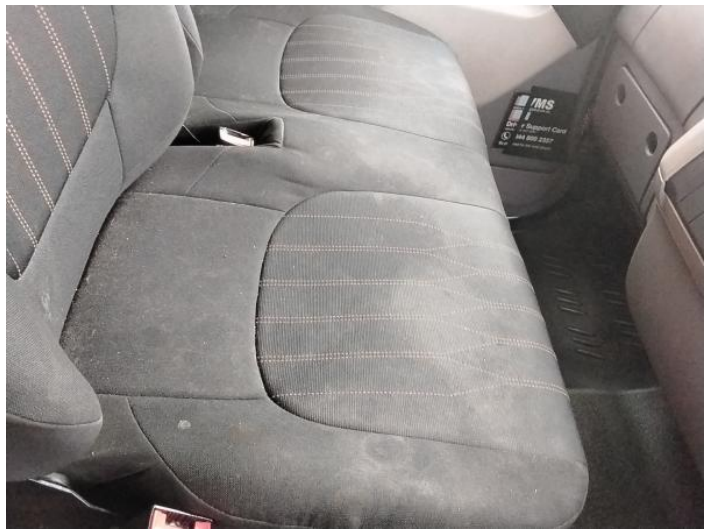
12: Seat Base Cover nsf
Soiled
Heavy

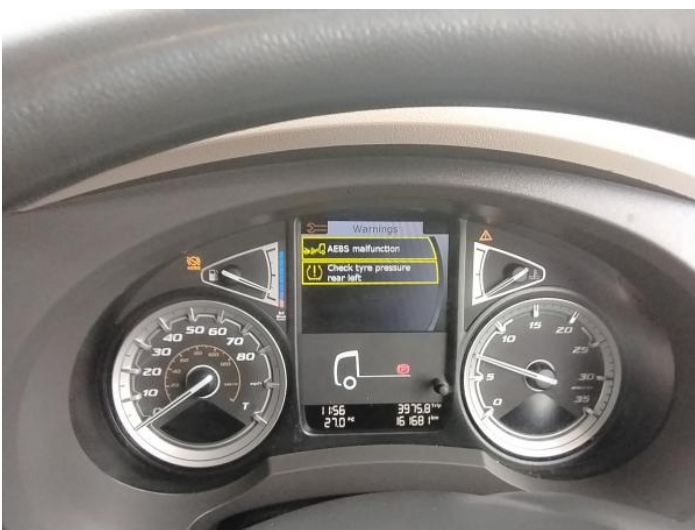
WARNING LIGHT ON DASH

13: Dash Warning Lights
Displayed
No Action
