# VEHICLE INSPECTION REPORT

**YC19LZN**

## Volvo FM 410

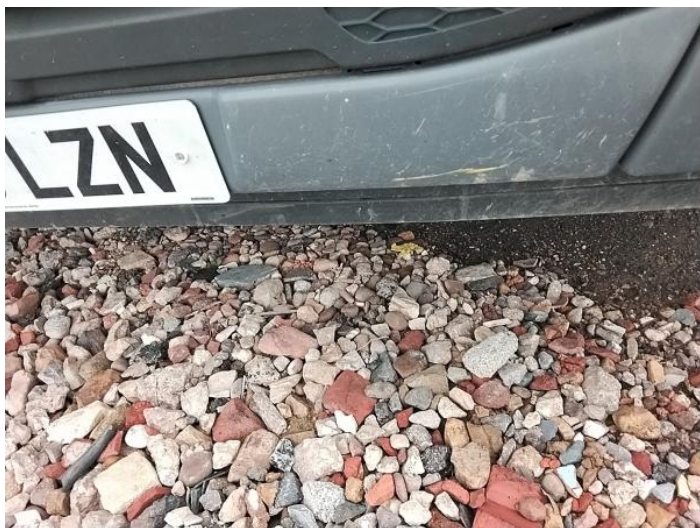
1: Bumper Front  
Dented  
With Paint Damage

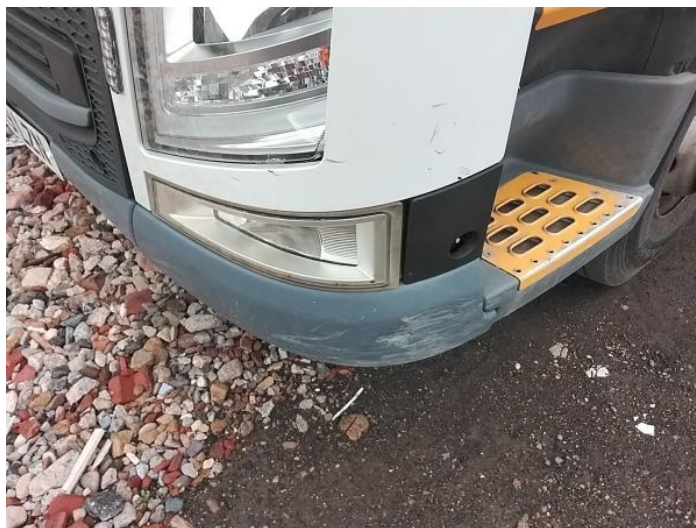
2: Bumper Front  
Dented  
With Paint Damage

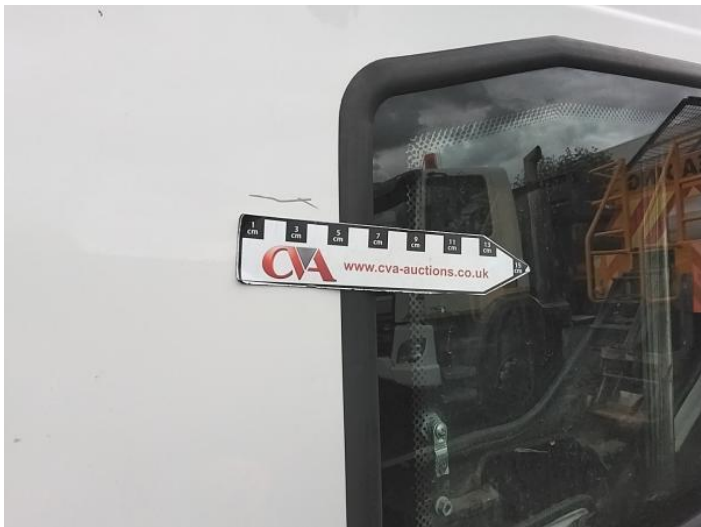
3: Door nsf  
 Scratched  
 Over 25mm Thru Paint

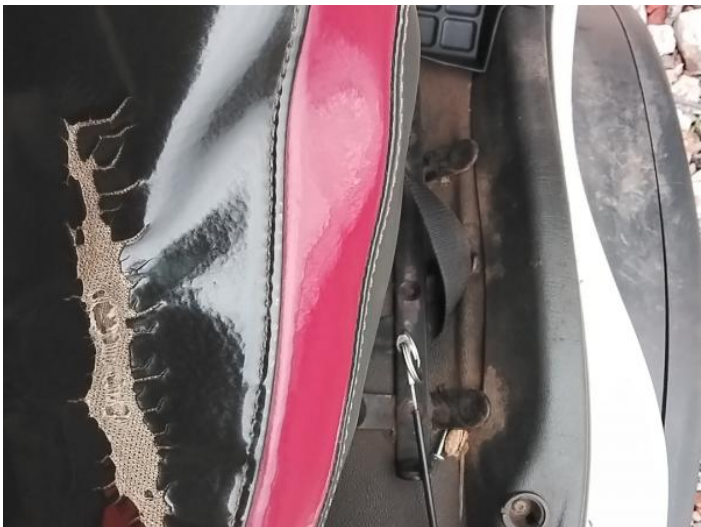
4: Seat Base Cover osf  
 Torn  
 Over 3mm
