VEHICLE INSPECTION REPORT

WU68NXY

Volvo FH 460

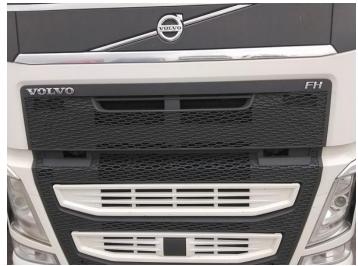
1: Bonnet Chipped Multiple Chips

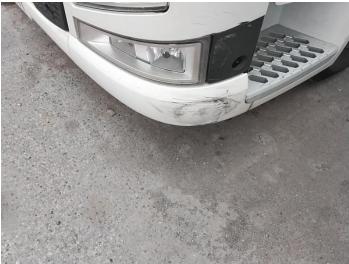
2: Bumper Front Scratched Over 100mm Thru Paint

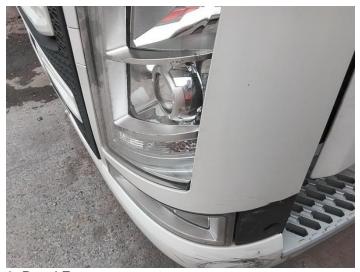
3: Panel Front Scratched Over 25mm Thru Paint

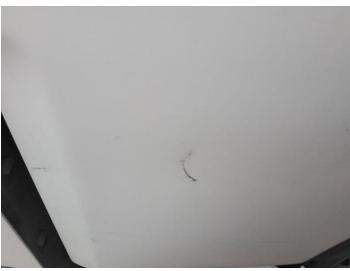
4: Door nsf Dented With Paint Damage

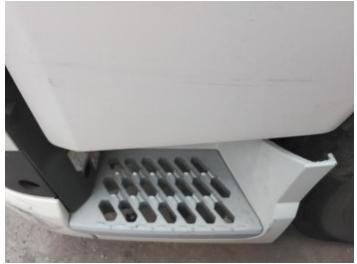
5: Door nsf Scratched UpTo 25mm Not Thru Paint

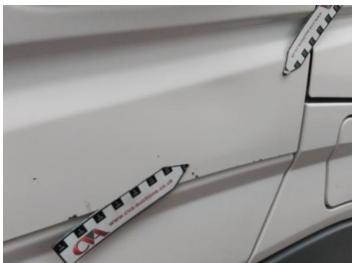
6: Door nsf Dented Over 30mm

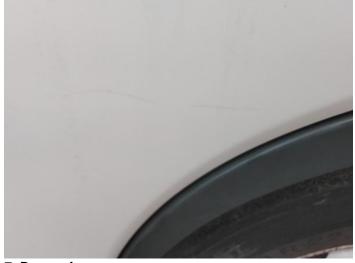
7: Door nsf Scratched Over 25mm Not Thru Paint

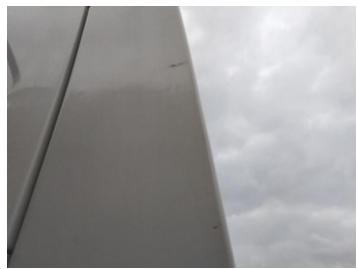
9: Qtr Panel Trim ns Scuffed Over 25mm

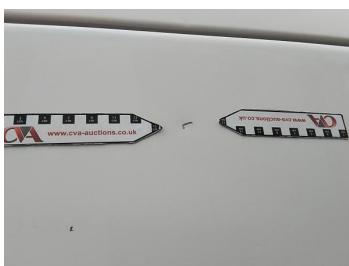
10: Qtr Panel osr Dented With Paint Damage

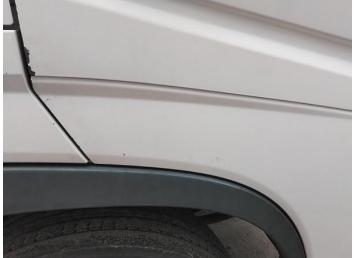
11: Door osf Chipped Multiple Chips

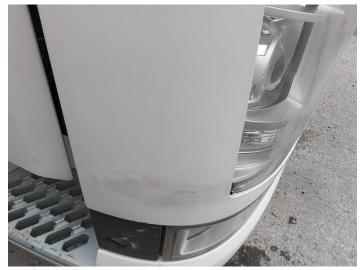
13: Panel Front Poor Previous Repair Poor Colour

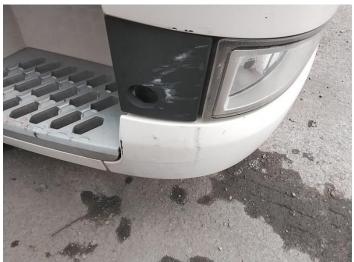
14: Bumper Front Scratched Over 100mm Thru Paint

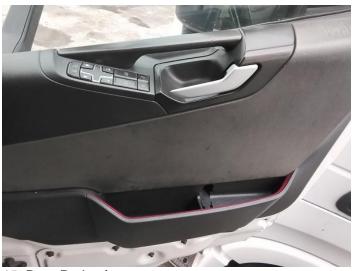
15: Door Pad osf Soiled Heavy
