VEHICLE INSPECTION REPORT

DK17LUY

Man TGS 26.360

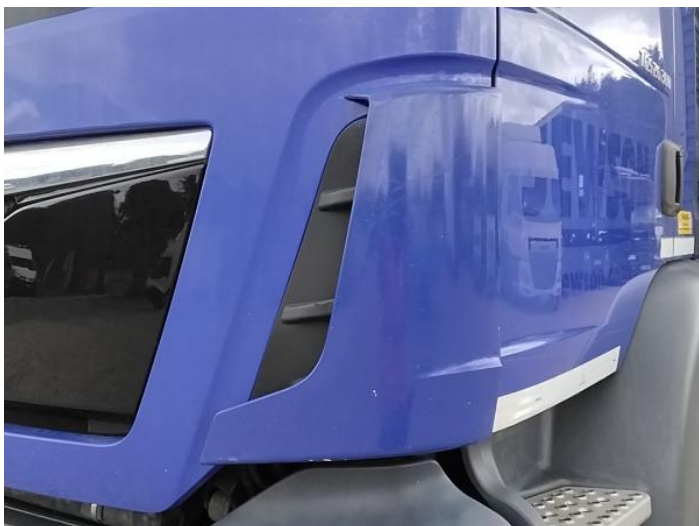
9: Wing nsf
Chipped
Multiple Chips

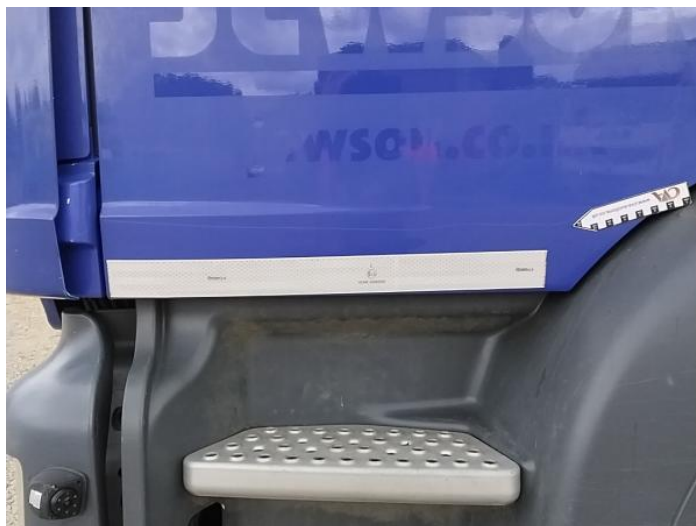
10: Door nsf
Scratched
Over 25mm Not Thru Paint
