VEHICLE INSPECTION REPORT

PN61PKZ

Daf CF 75.310

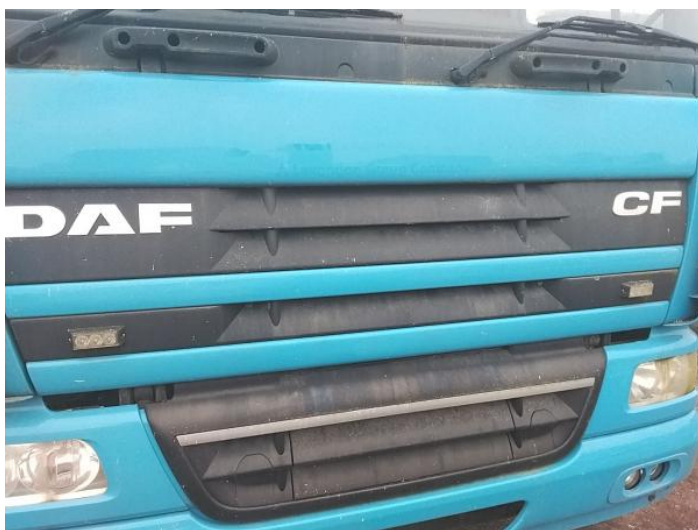
1: Bonnet
Chipped
Multiple Chips

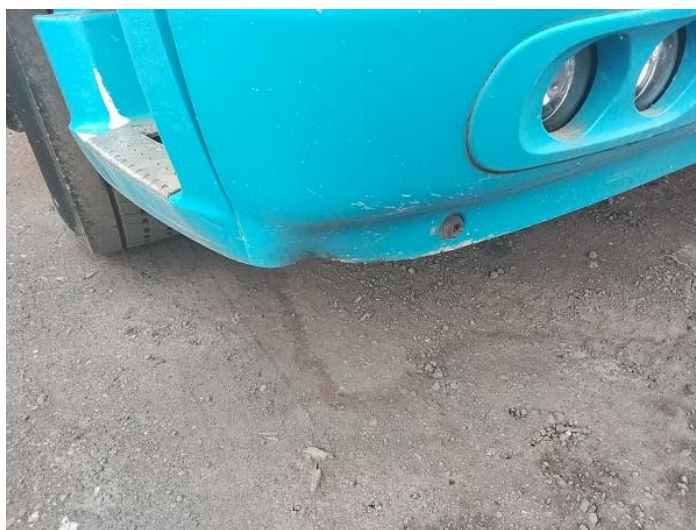
2: Bumper Front
Dented
With Paint Damage

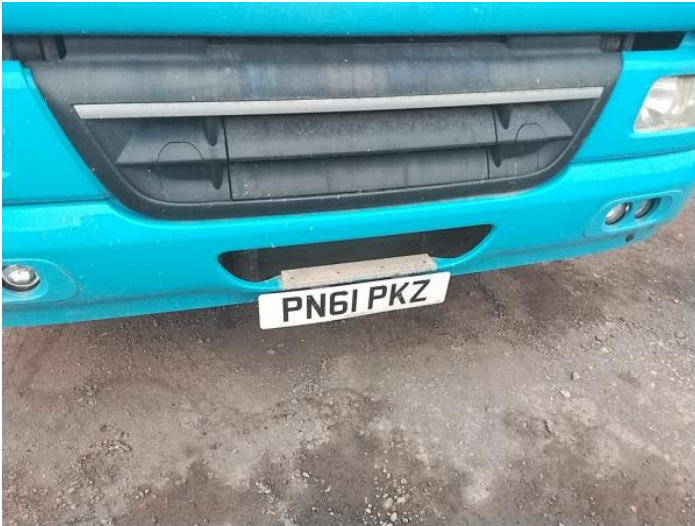
3: Bumper Front
Chipped
Multiple Chips

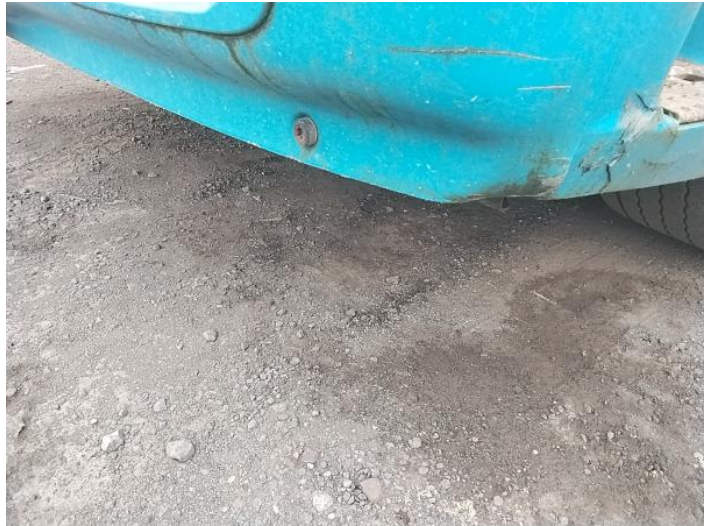
4: Bumper Front
Dented
With Paint Damage

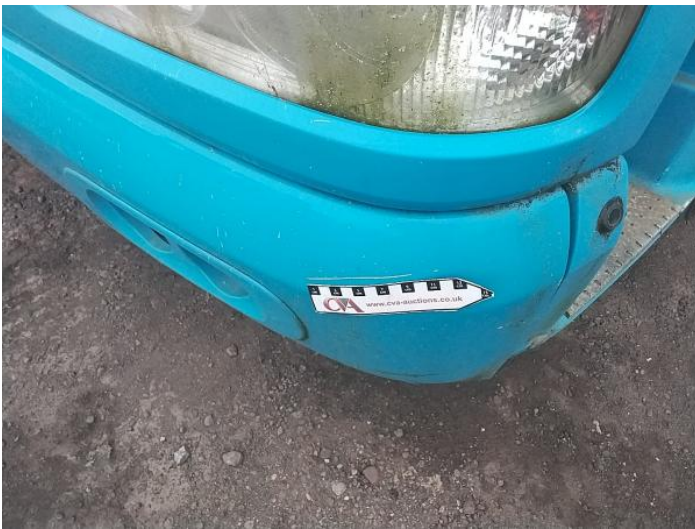
5: Bumper Front
Scratched
Over 100mm Thru Paint

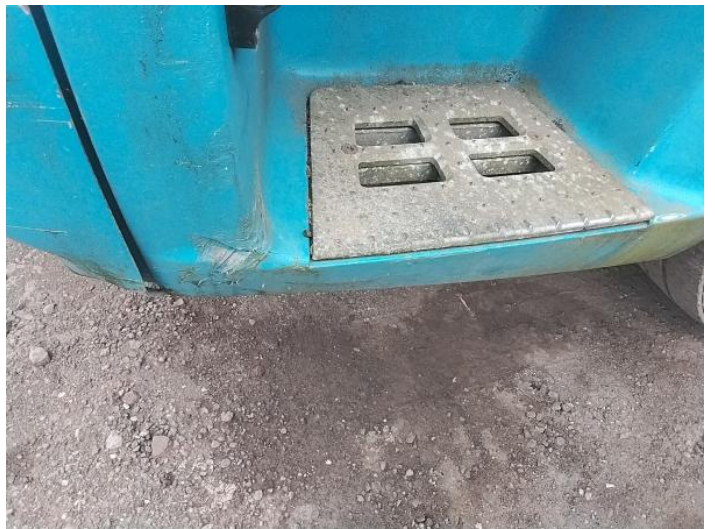
6: Bumper Front Moulding
Broken
Replace

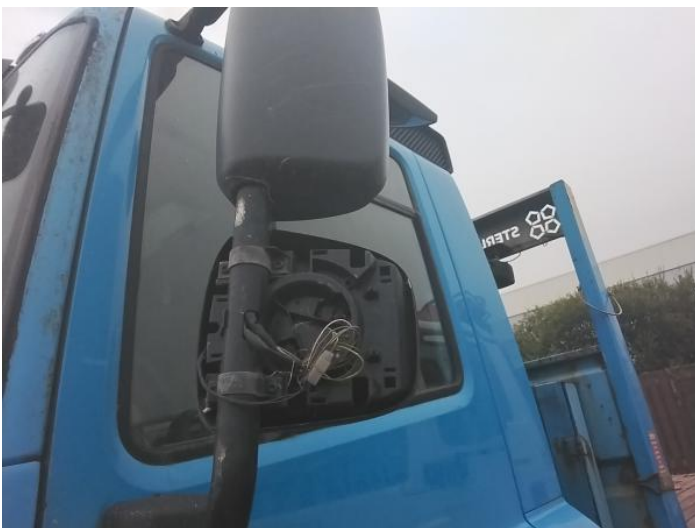
7: Door Mirror Assy nsf
Broken
Replace

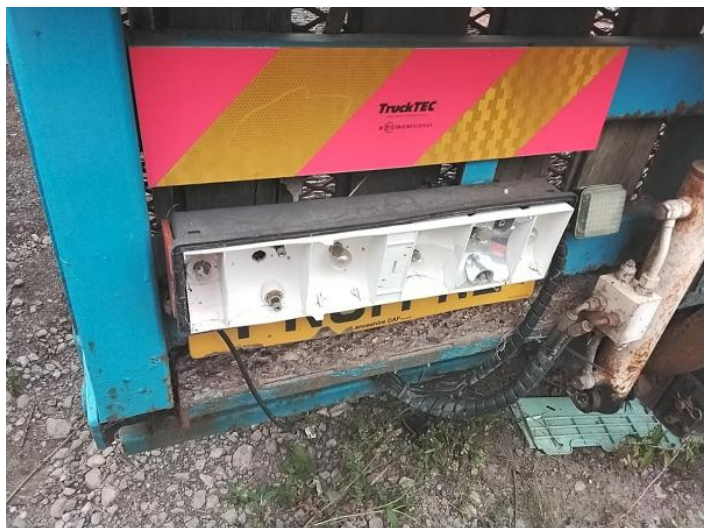
8: Lamp nsr
Broken
Replace

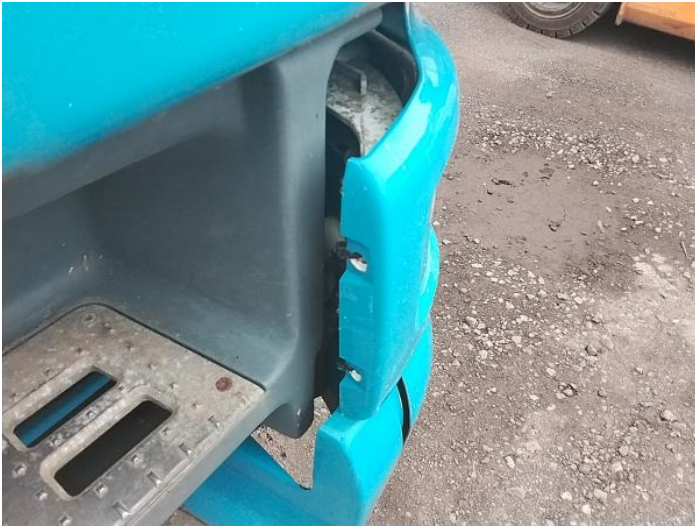
9: Panel Front
Cracked
Replace

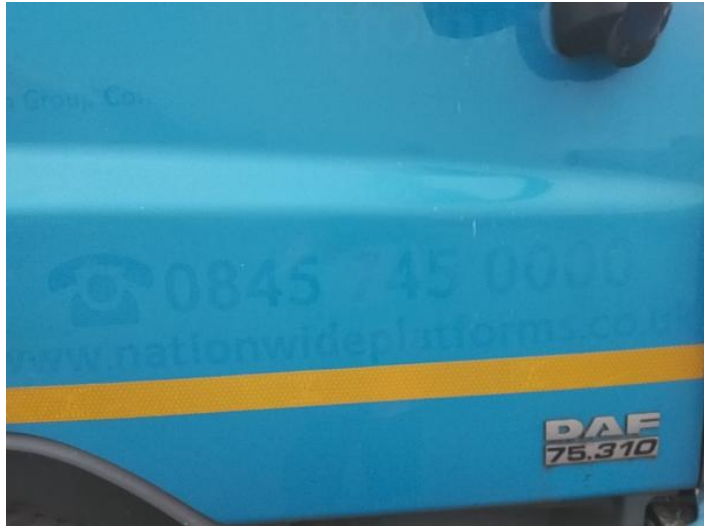
10: Door osf
Chipped
Multiple Chips

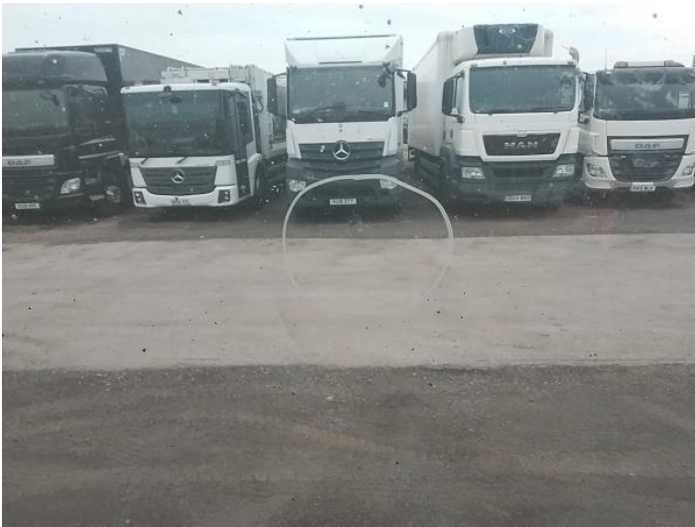
11: Screen Front
Chipped
Over 10mm

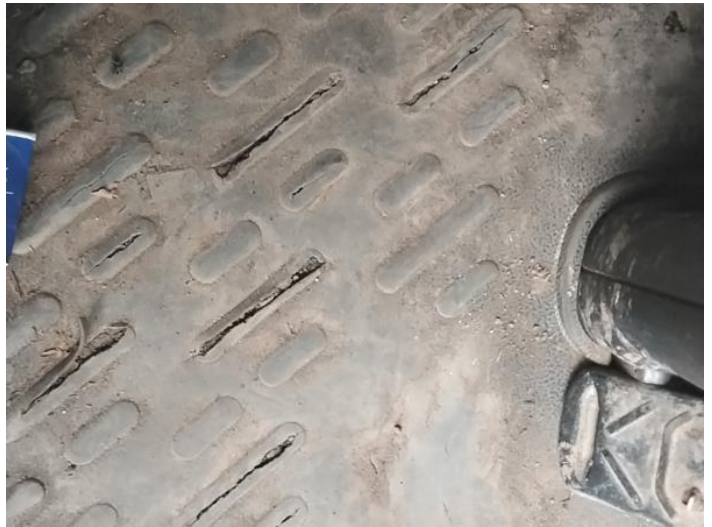
12: Carpets Front
Torn
Over 10mm

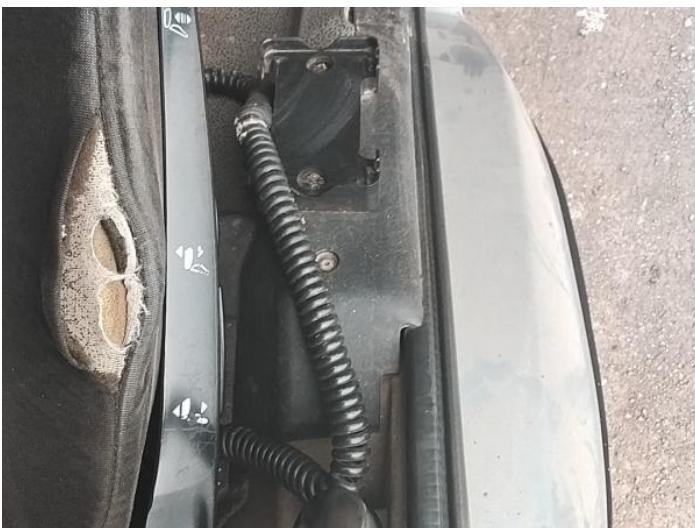
13: Seat Base Cover osf
Torn
Over 3mm

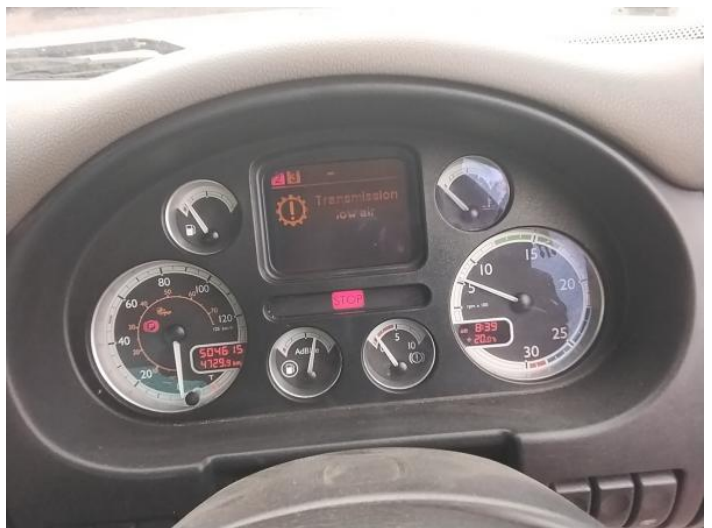
WARNING LIGHT ON DASH *DOES NOT CHANGE GEAR* SURROUND CAMERA SYSTEM, REAR LIFT, WINCH

14: Dash Warning Lights
Displayed
No Action
