VEHICLE INSPECTION REPORT

HK71PXU

Ford Transit 350 2.0 ECOBLUE 130PS

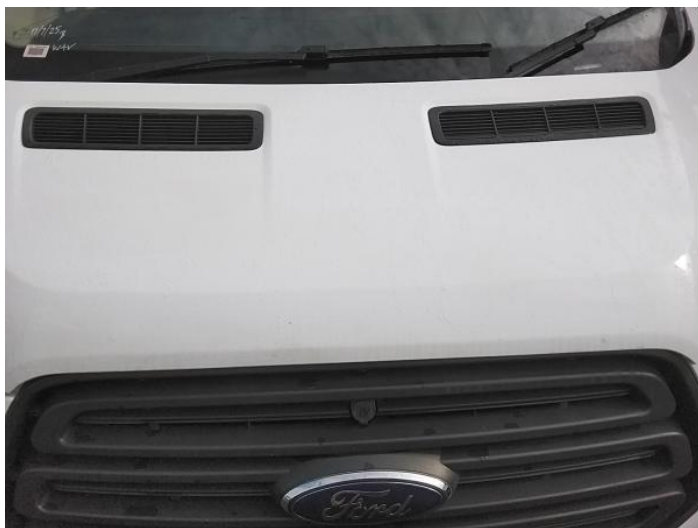
1: Bonnet
Chipped
Multiple Chips

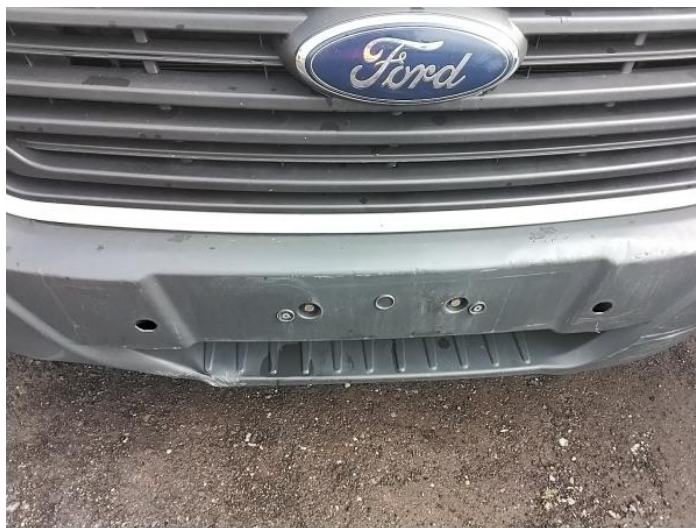
2: Number Plate Front
Missing
Replace

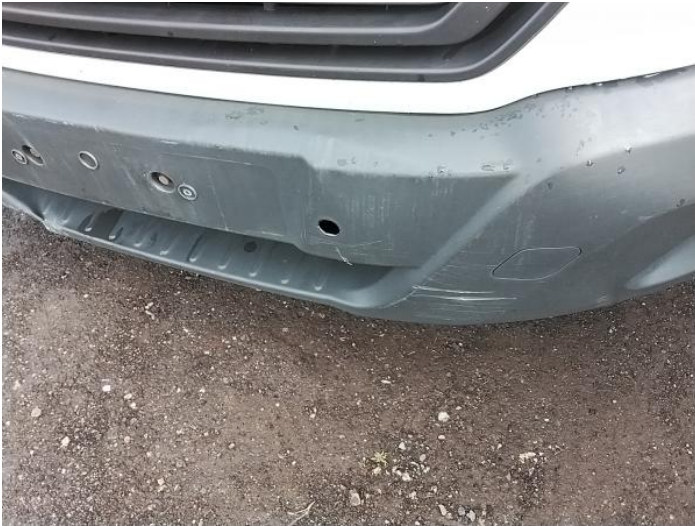
3: Bumper Front
Scratched
Over 100mm Thru Paint

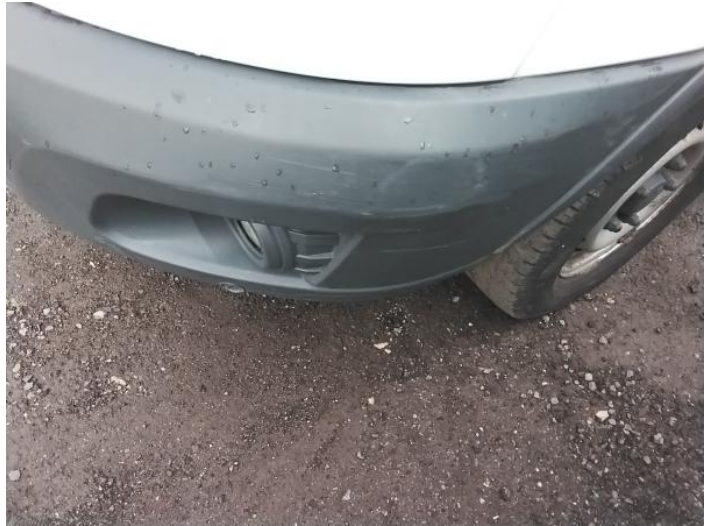
4: Bumper Front
Scratched
Over 100mm Thru Paint

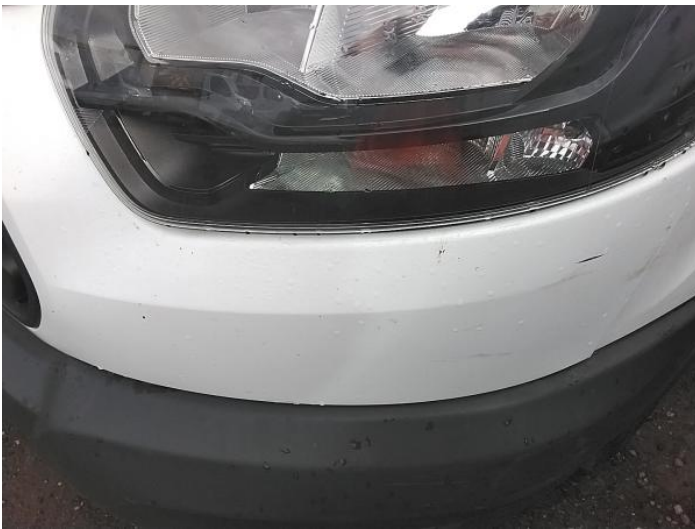
5: Panel Front
Scratched
Over 25mm Thru Paint

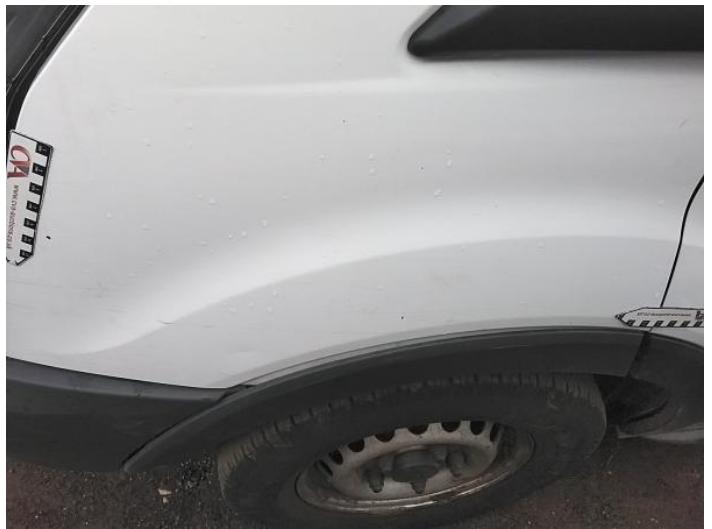
6: Wing nsf
Scratched
Over 25mm Thru Paint

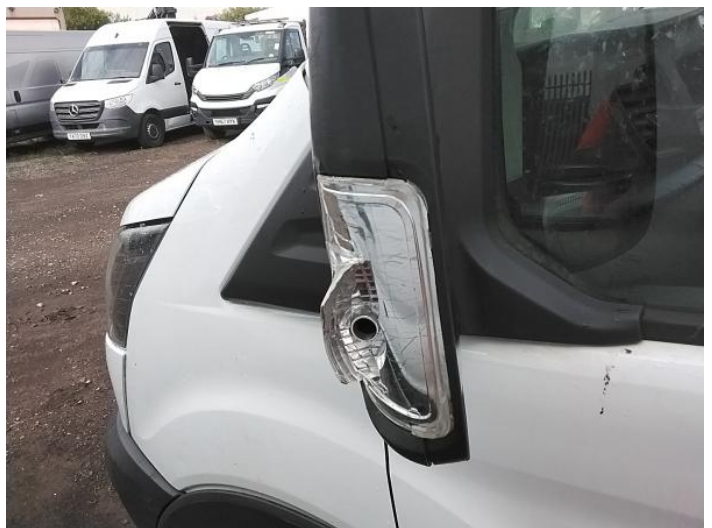
8: Door Mirror Assy nsf
Broken
Replace

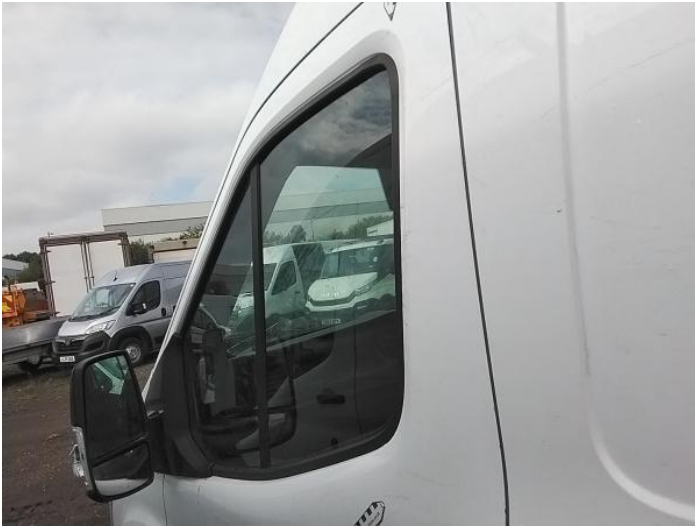
9: Door nsf
Scratched
Over 25mm Thru Paint

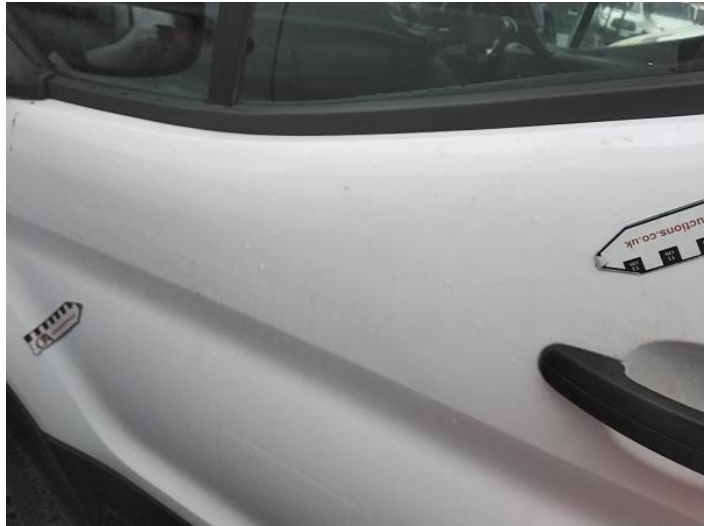
10: Door nsf
Scratched
Over 25mm Thru Paint

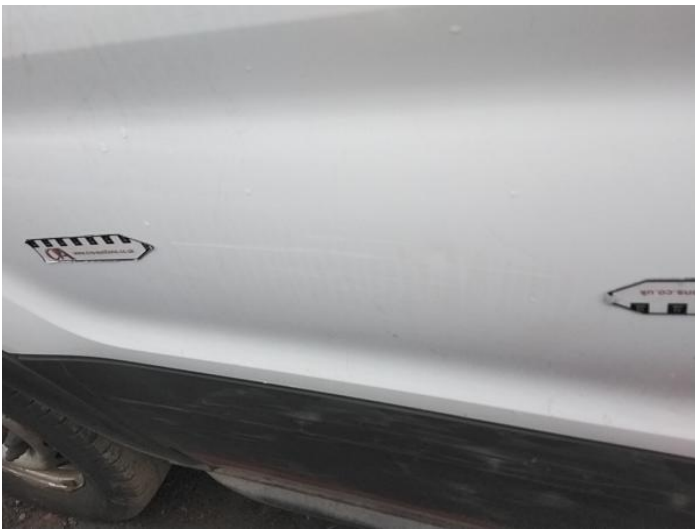
11: Door nsf
Scratched
Over 25mm Thru Paint

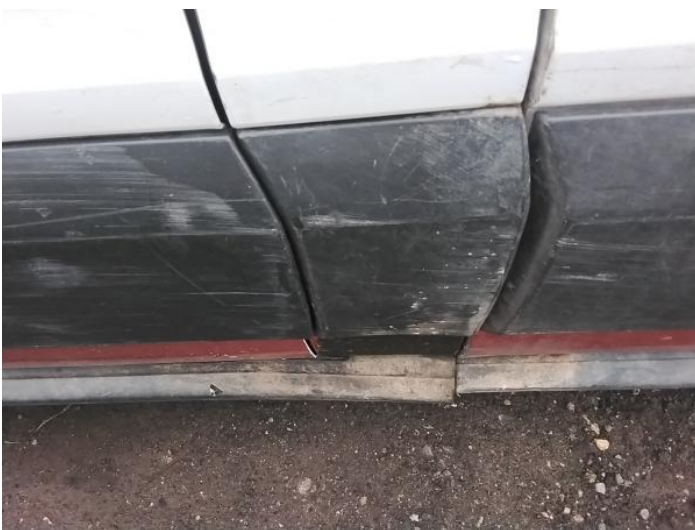
13: Door Moulding nsf
Scuffed (Unpainted)
Over 100mm

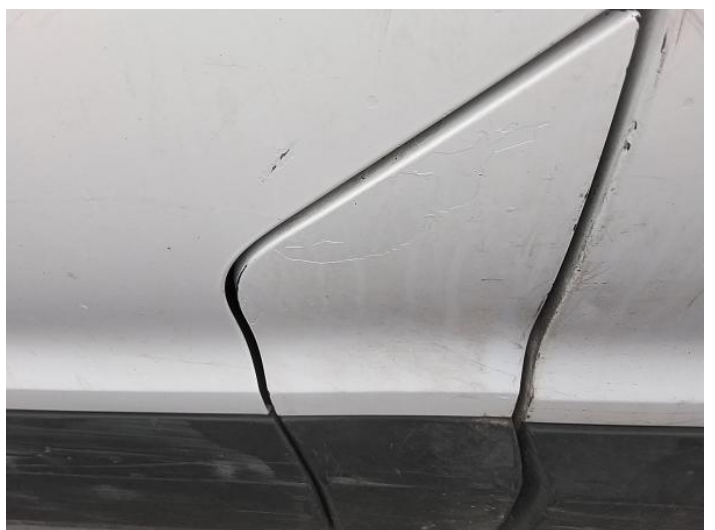
14: Fuel Flap
Scratched
Over 25mm Thru Paint

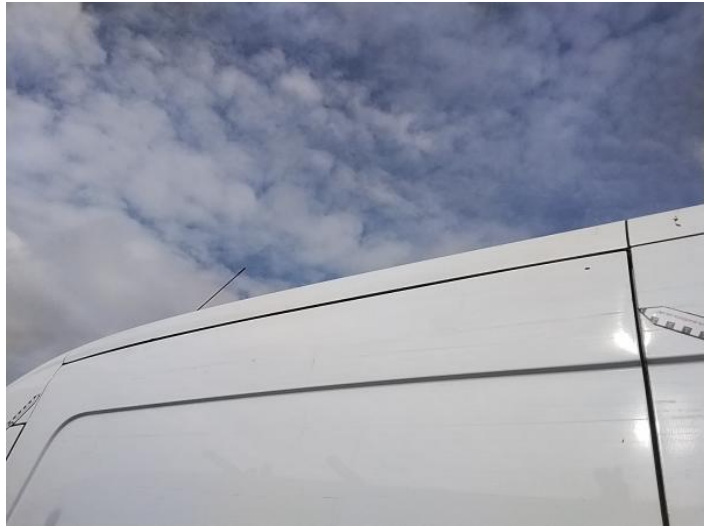
16: Qtr Panel nsr
Scratched
Over 25mm Thru Paint

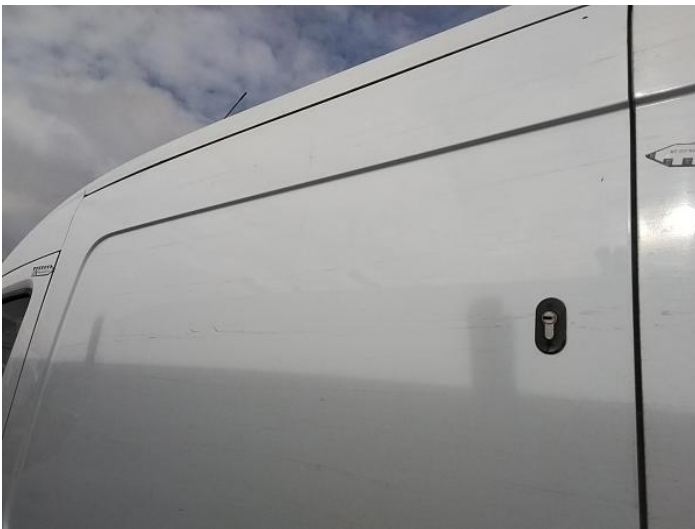
17: Qtr Panel nsr
Scratched
Over 25mm Thru Paint

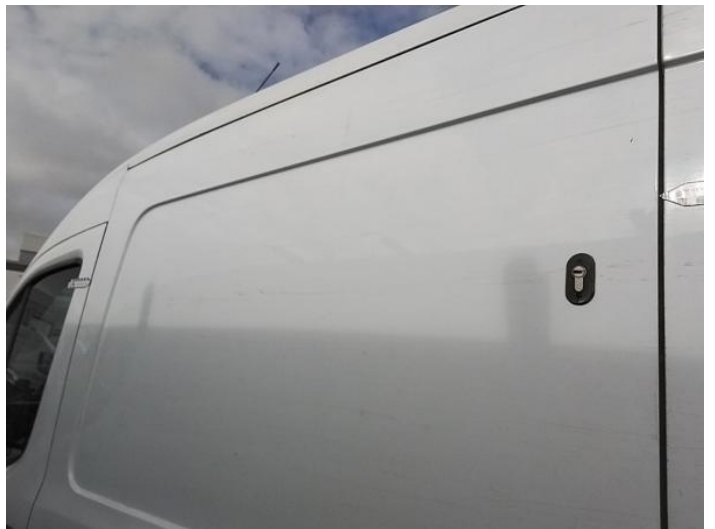
18: Qtr Panel nsr
Scratched
Over 25mm Thru Paint

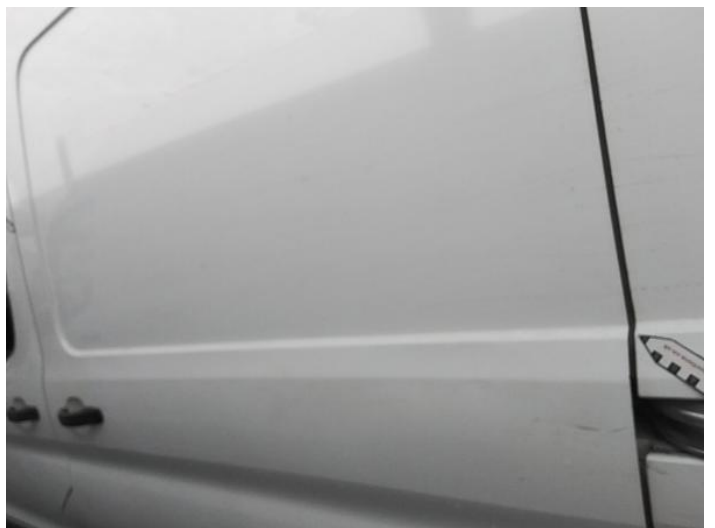
20: Qtr Panel nsr
Scratched
Over 25mm Thru Paint

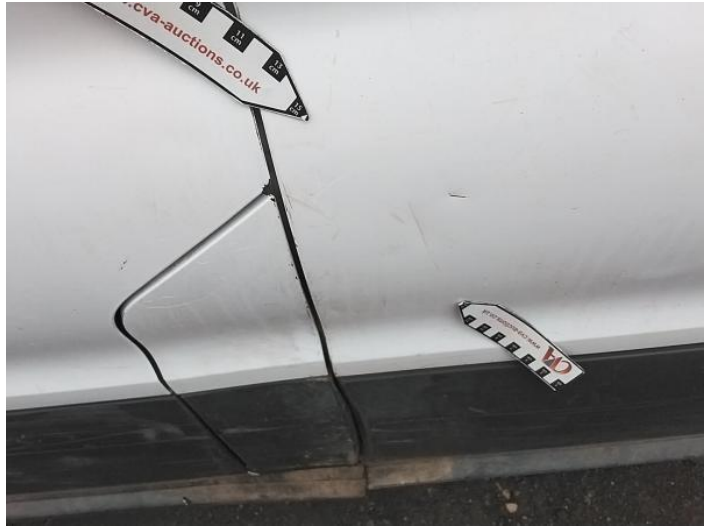
22: Qtr Panel nsr
Dented
With Paint Damage

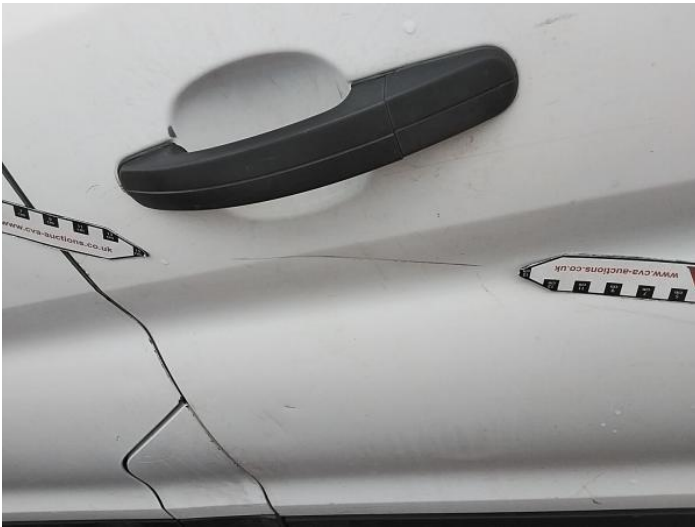
23: Qtr Panel nsr
Dented
With Paint Damage

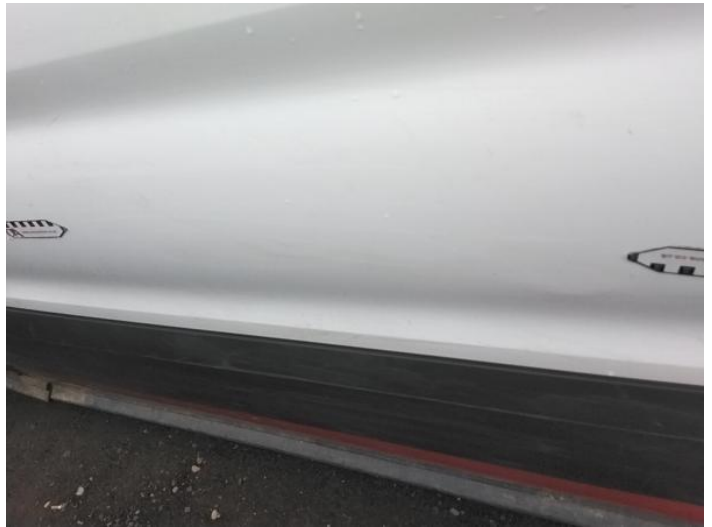
24: Qtr Panel nsr
Scratched
Over 25mm Thru Paint

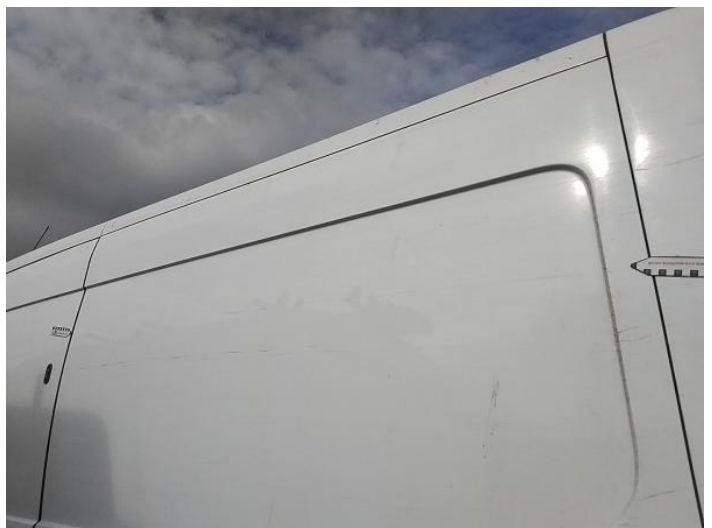
26: Qtr Panel nsr
Scratched
Over 25mm Thru Paint

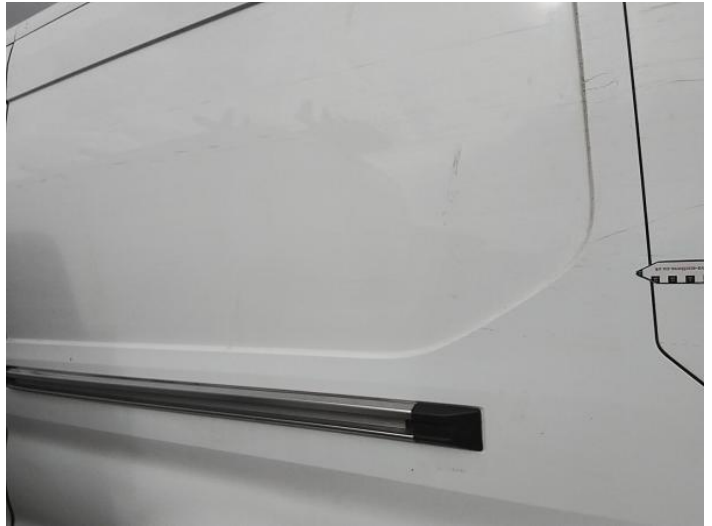
28: Qtr Panel nsr
Scratched
Over 25mm Thru Paint

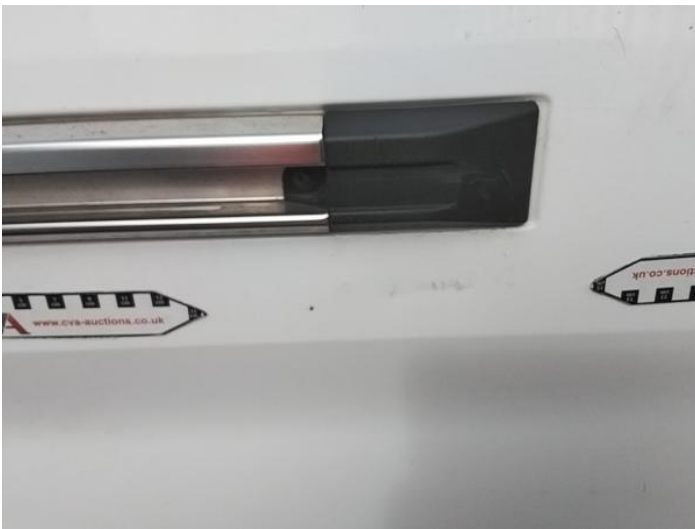
29: Qtr Panel nsr
Dented
With Paint Damage

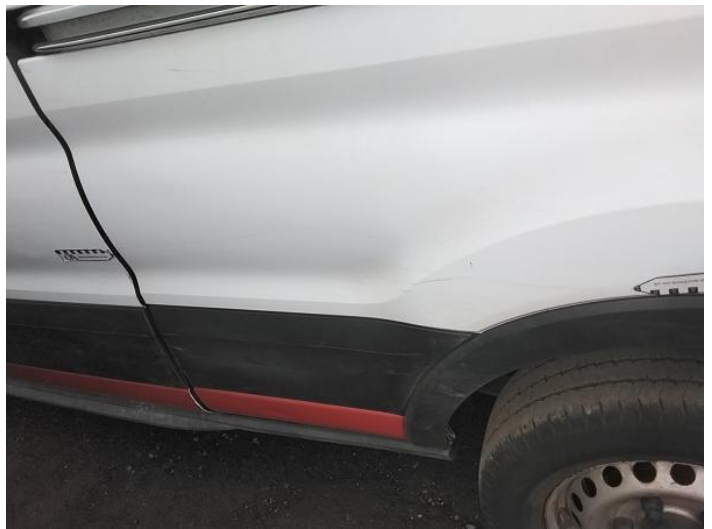
30: Qtr Panel nsr
Scratched
Over 25mm Thru Paint

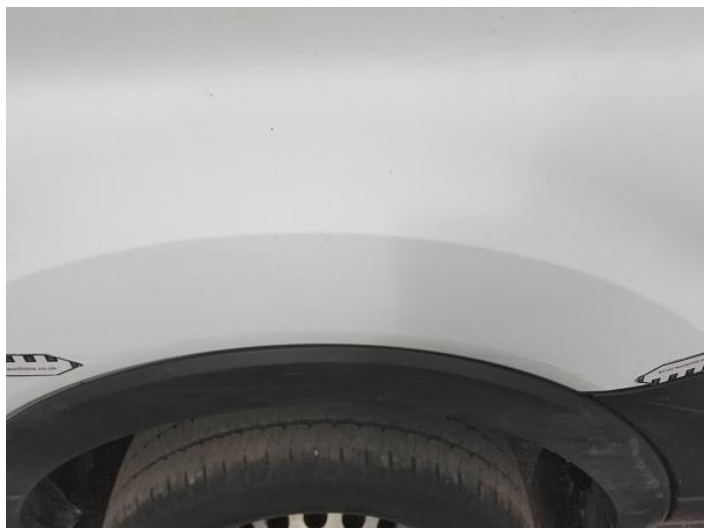
32: Qtr Panel nsr
Scratched
Over 25mm Thru Paint

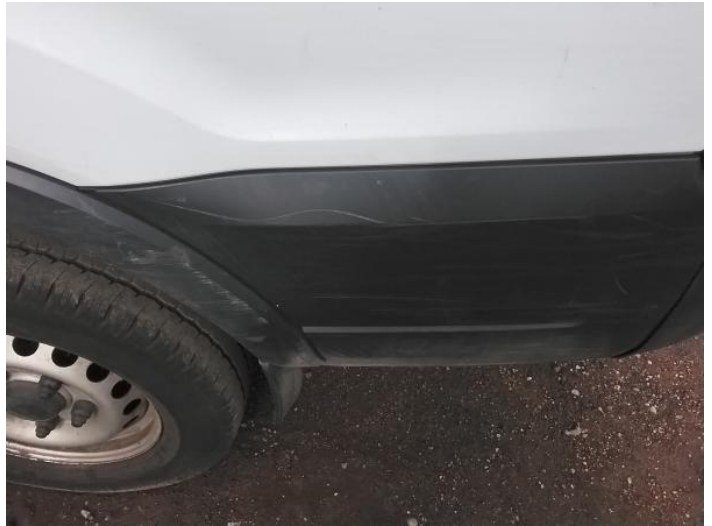
34: Qtr Panel Moulding ns
Scuffed (Unpainted)
Over 100mm

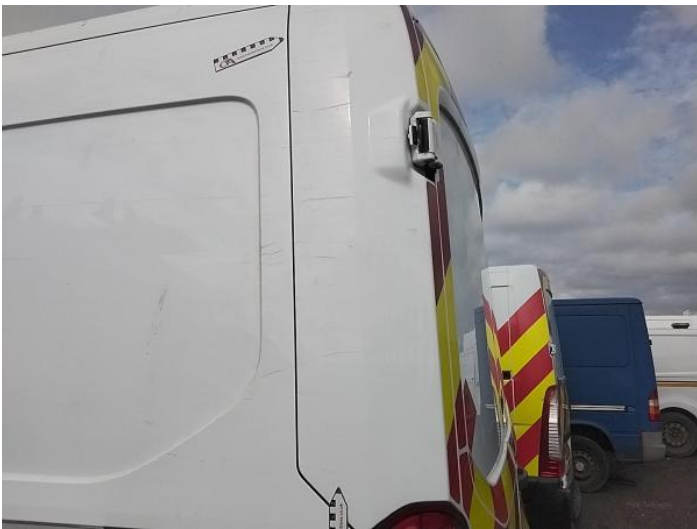
35: C Post ns
Scratched
Over 25mm Thru Paint

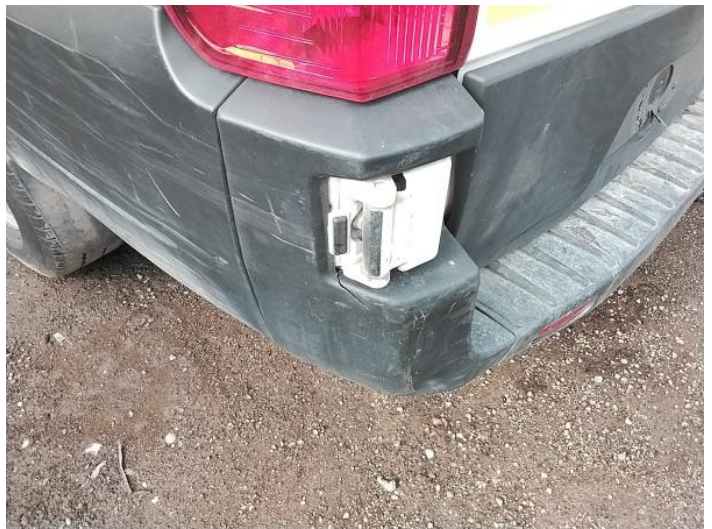
36: Bumper Rear Moulding
Broken
Replace

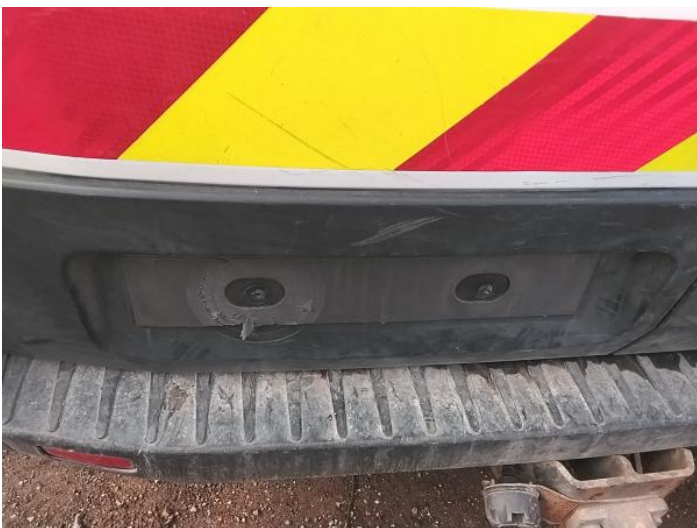
37: Number Plate Rear
Missing
Replace

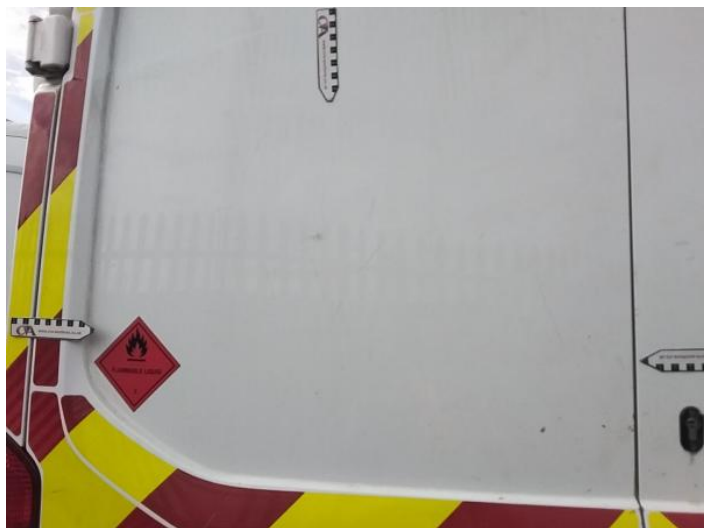
38: Door nsr
Scratched
Over 25mm Thru Paint

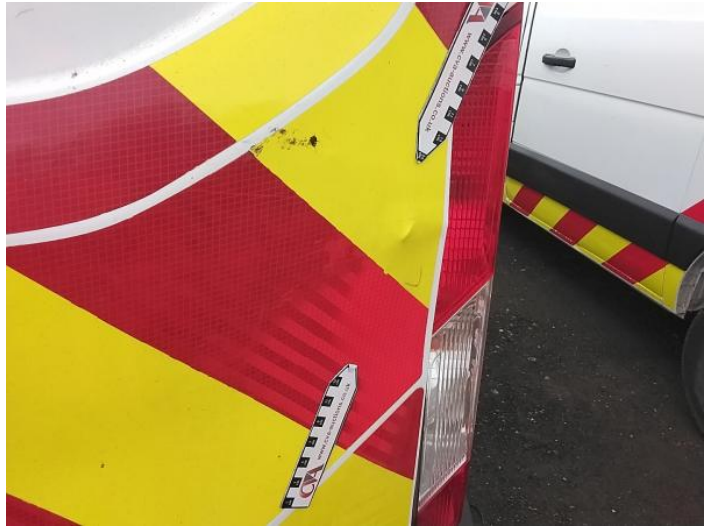
40: Door osr
Dented
Over 30mm

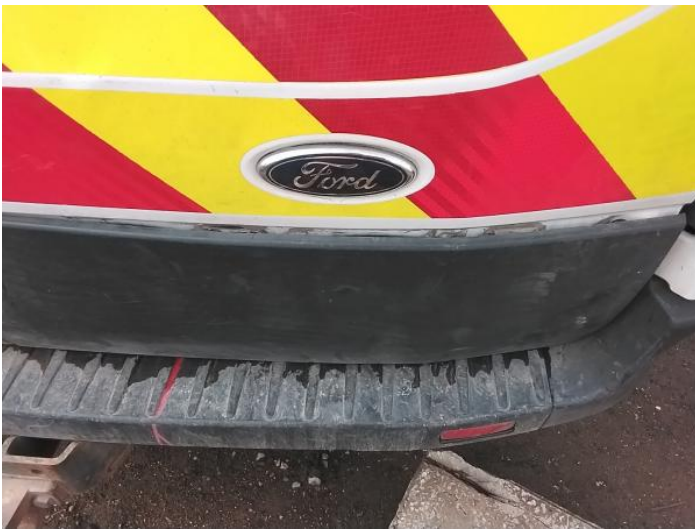
41: Door Moulding osr
Broken
Replace

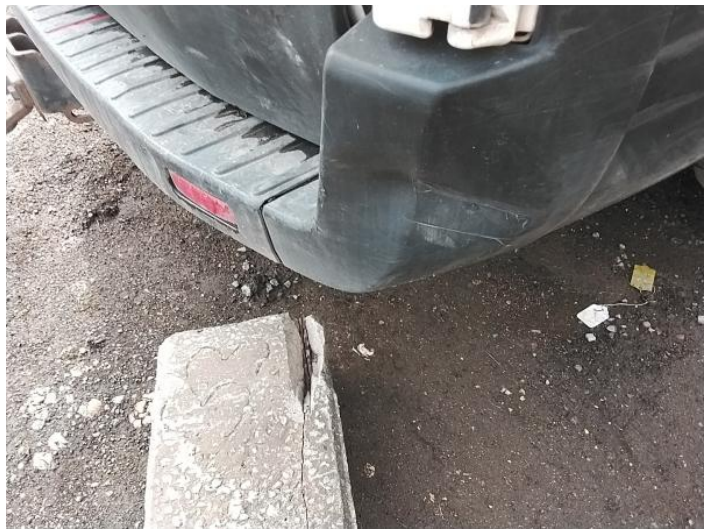
42: Bumper Rear Moulding
Broken
Replace

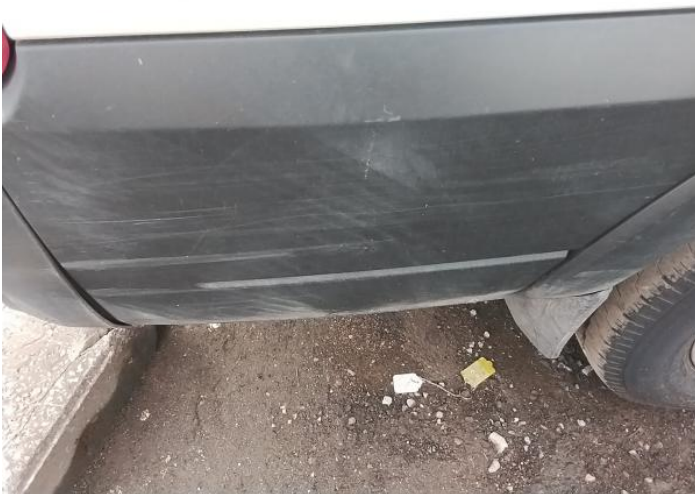
43: Qtr Panel Moulding os
Scuffed (Unpainted)
Over 100mm

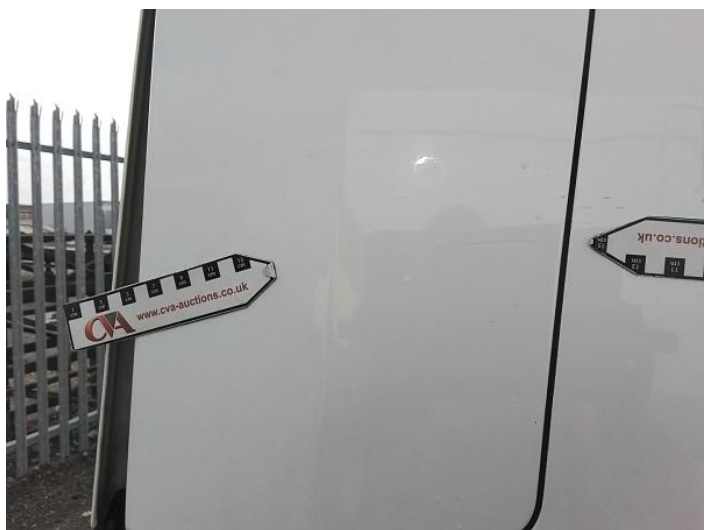
44: C Post os
Scratched
Over 25mm Thru Paint

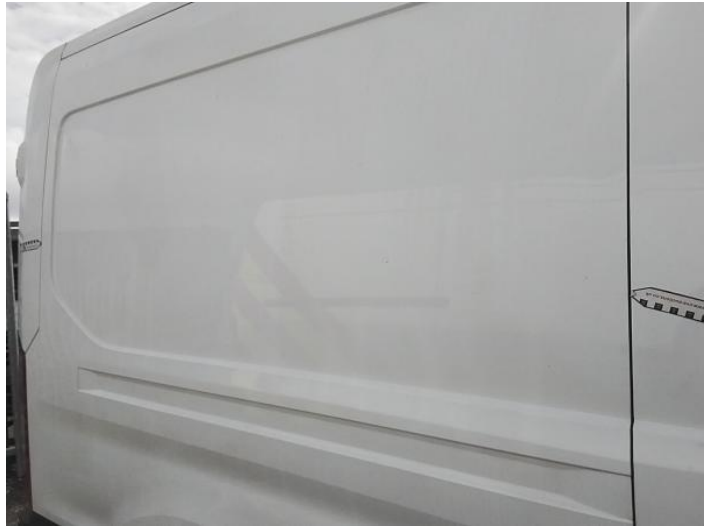
46: Qtr Panel osr
Scratched
Over 25mm Thru Paint

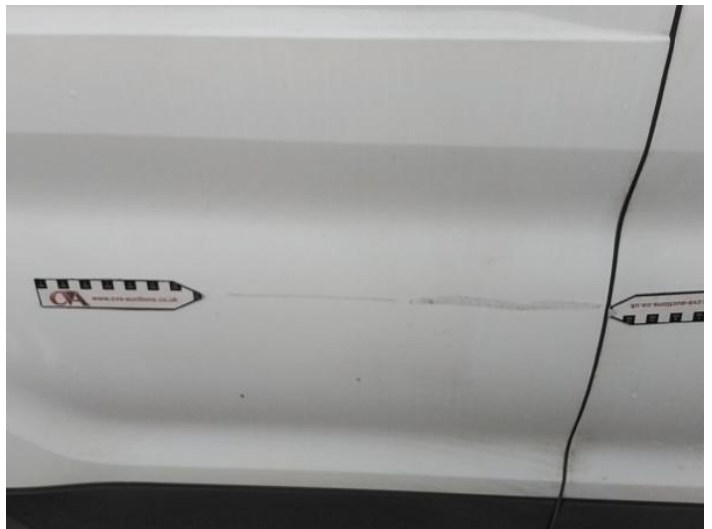
48: Qtr Panel osr
Scratched
Over 25mm Not Thru Paint

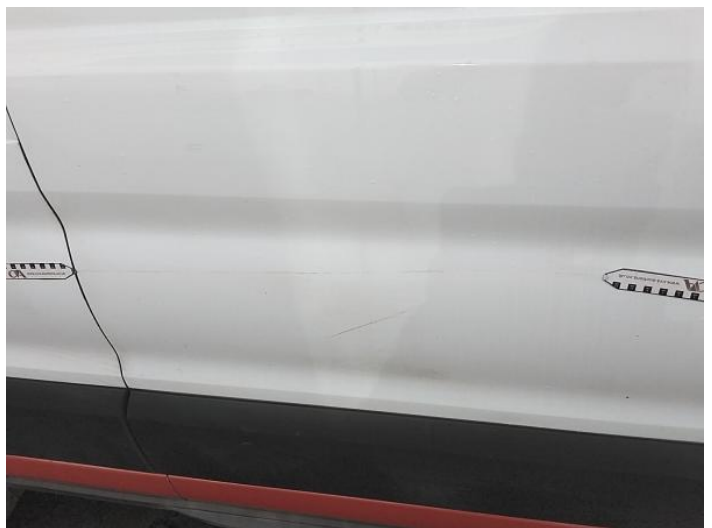
50: Qtr Panel osr
Scratched
Over 25mm Thru Paint

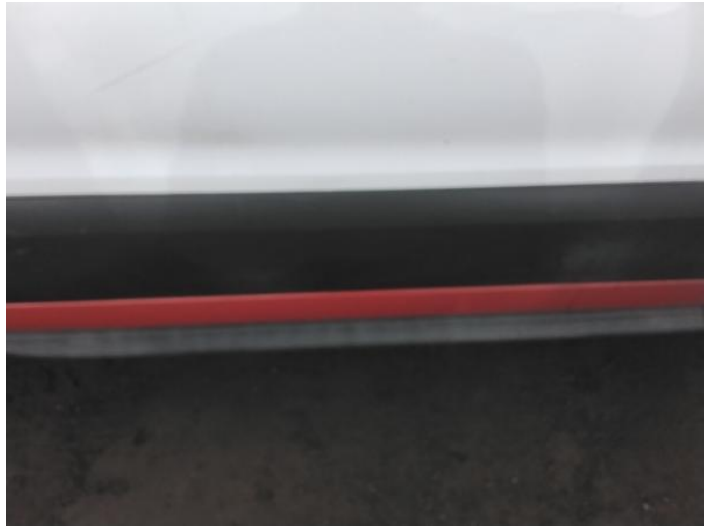
52: Qtr Panel Moulding os
Scuffed (Unpainted)
Over 100mm

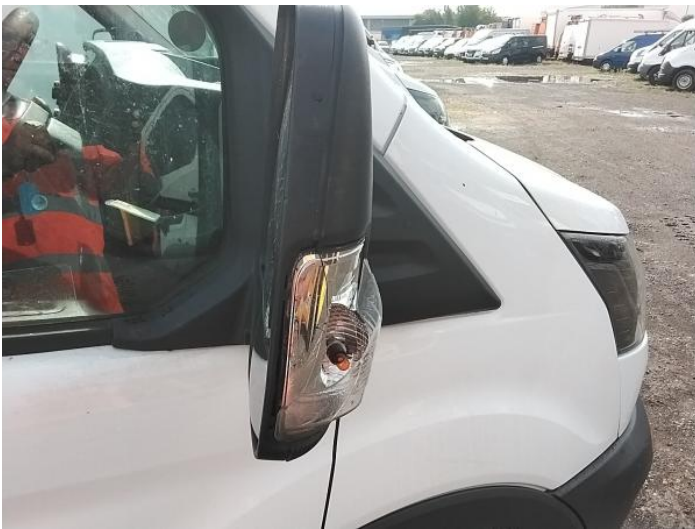
53: Door Mirror Assy osf
Broken
Replace

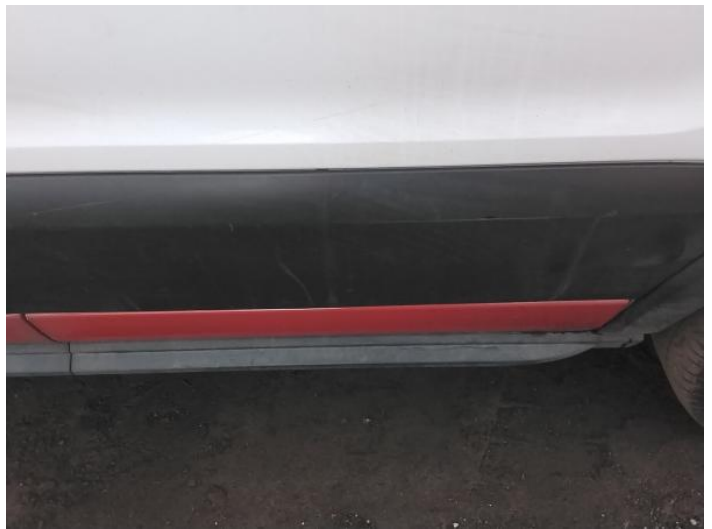
54: Door Moulding osf
Scuffed (Unpainted)
Over 100mm

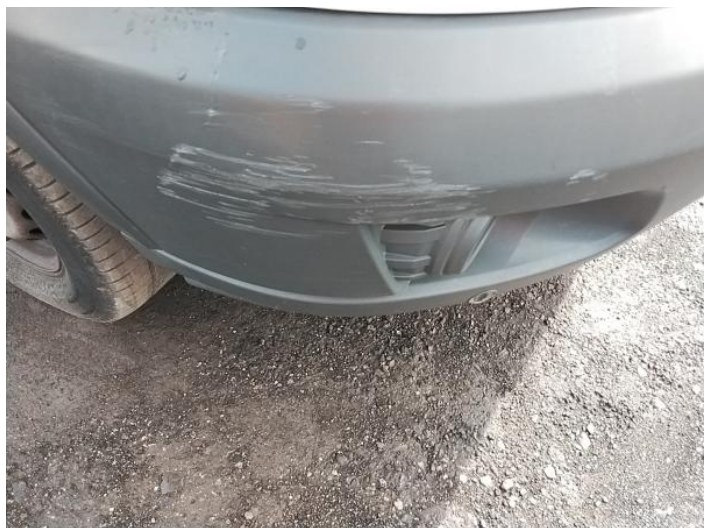
56: Bumper Front
Scratched
Over 100mm Thru Paint

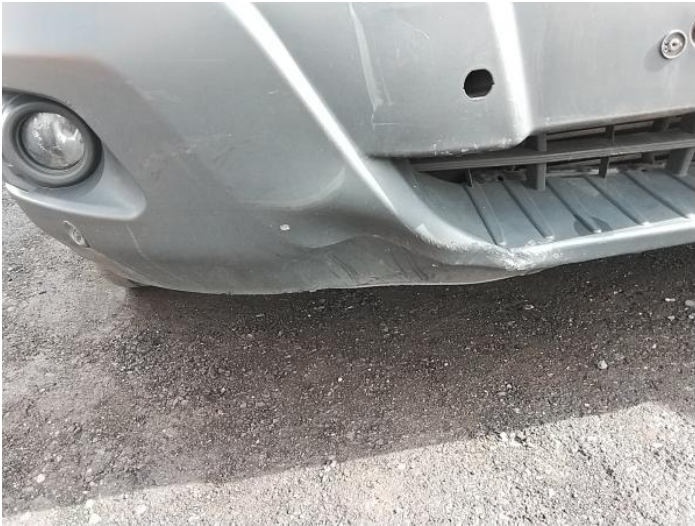
57: Bumper Front
Dented
With Paint Damage

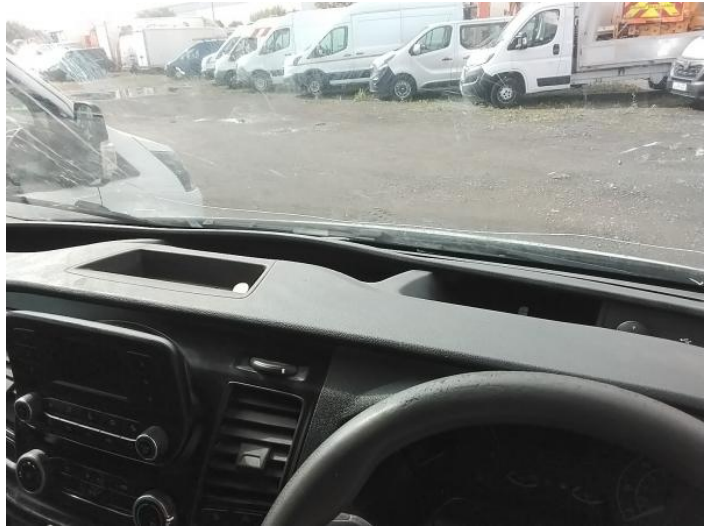
58: Screen Front
Cracked
Replace

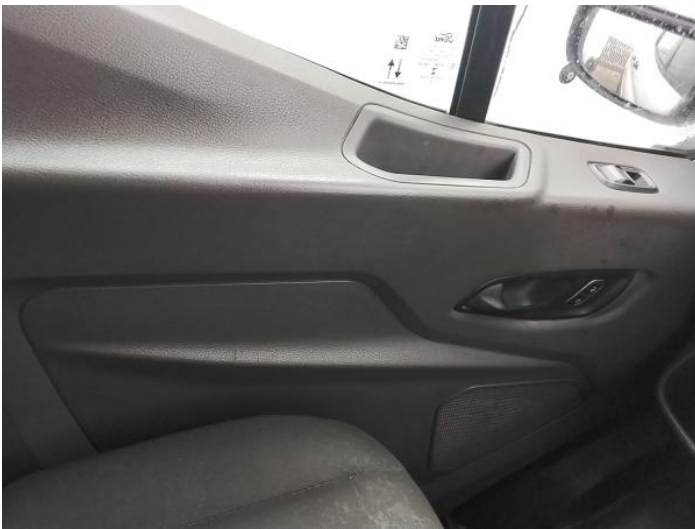
59: Door Pad nsf
Soiled
Heavy

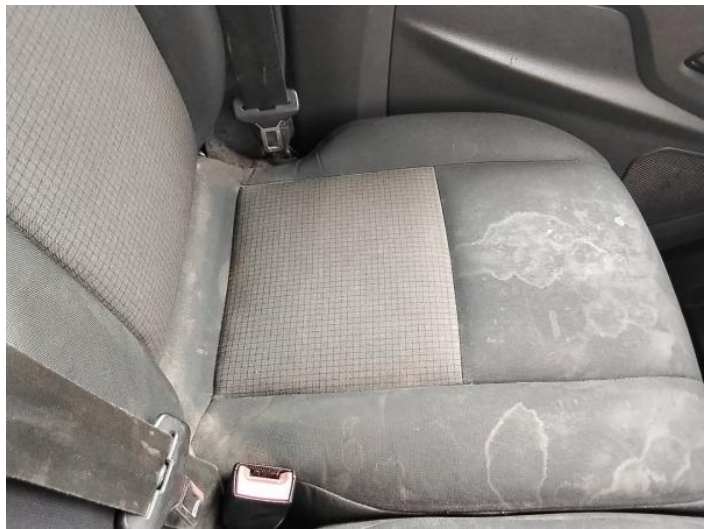
60: Seat Base Cover nsf
Soiled
Heavy

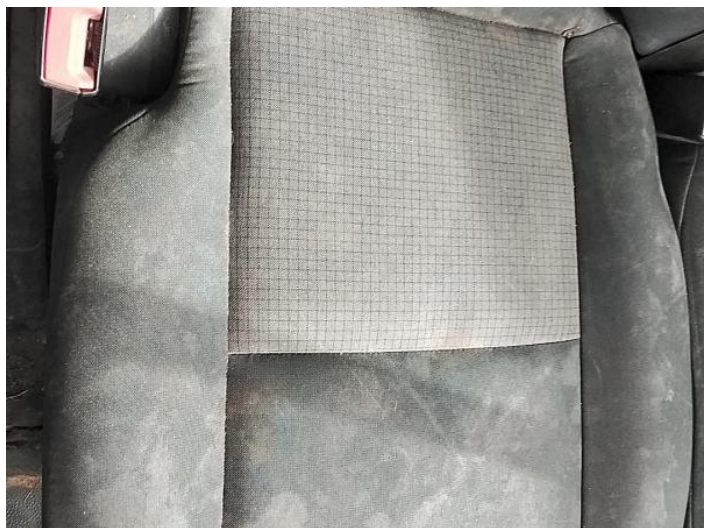
62: Seat Base Cover nsf
Soiled
Heavy

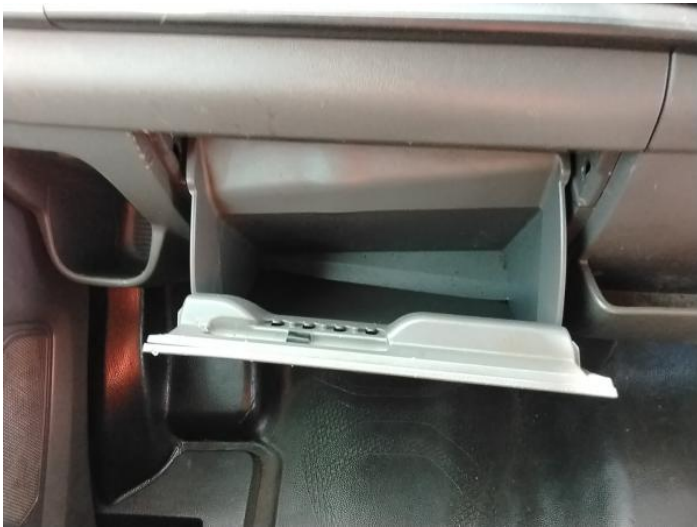
66: Glove Box Lid
Broken
Replace
