VEHICLE INSPECTION REPORT

YF71GVR

Maxus Deliver 3

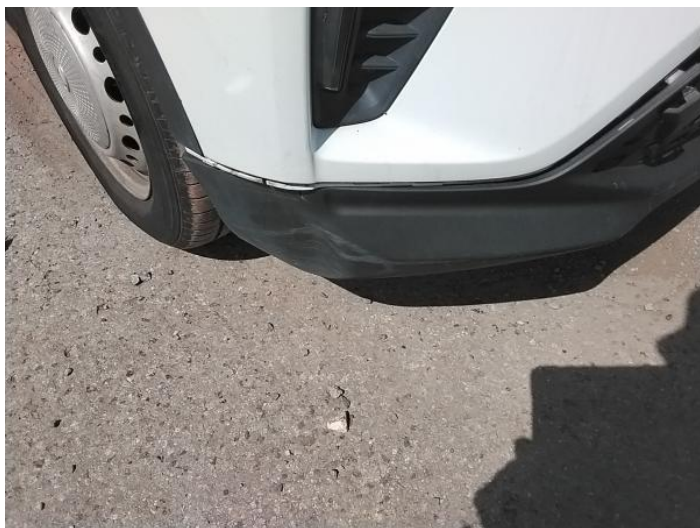
1: Bumper Front
Cracked
Over 25mm

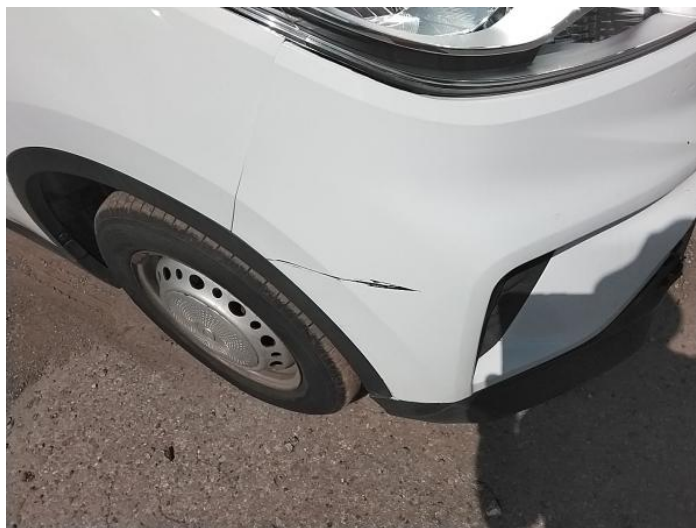
2: Panel Front
Scratched
Over 25mm Thru Paint

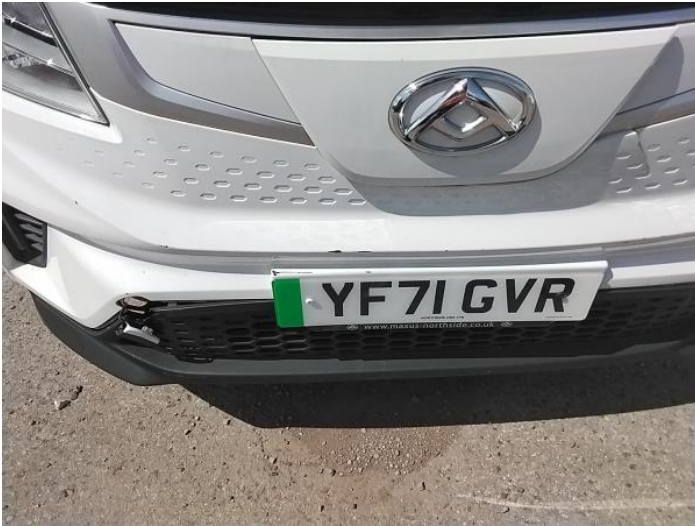
3: Panel Front
Scratched
Over 25mm Thru Paint

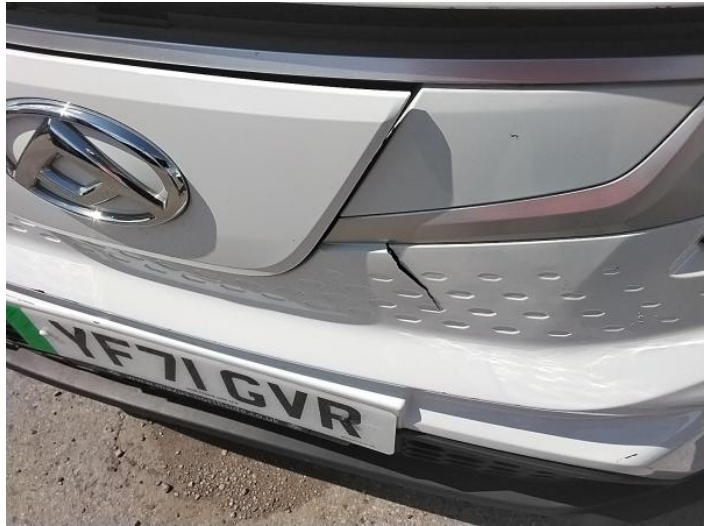
4: Panel Front
Cracked
Replace

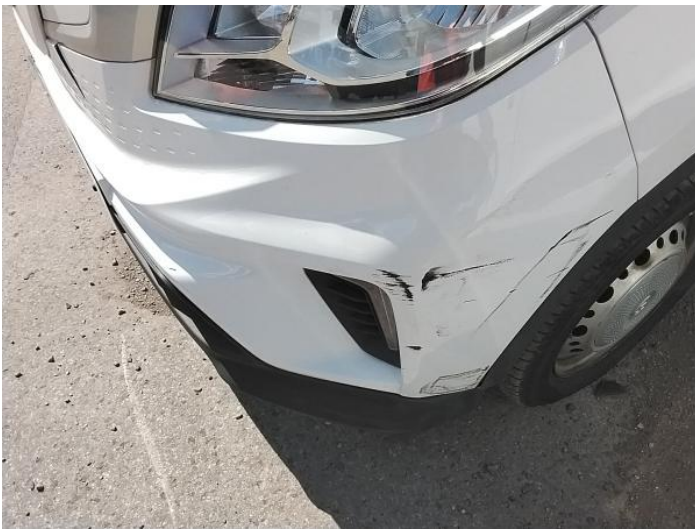
5: Panel Front
Scratched
Over 25mm Thru Paint

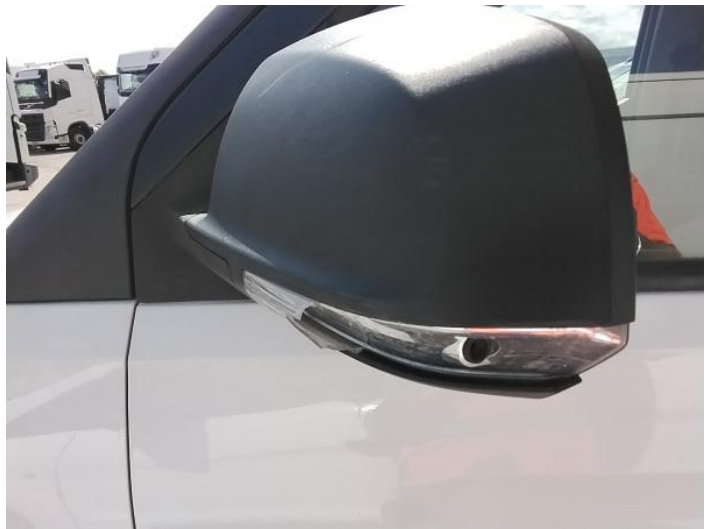
6: Door Mirror Assy nsf
Broken
Replace

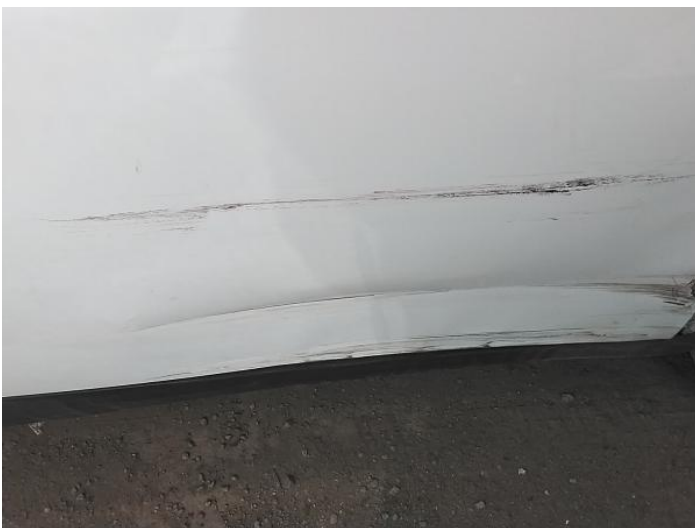
7: Qtr Panel nsr
Dented
With Paint Damage

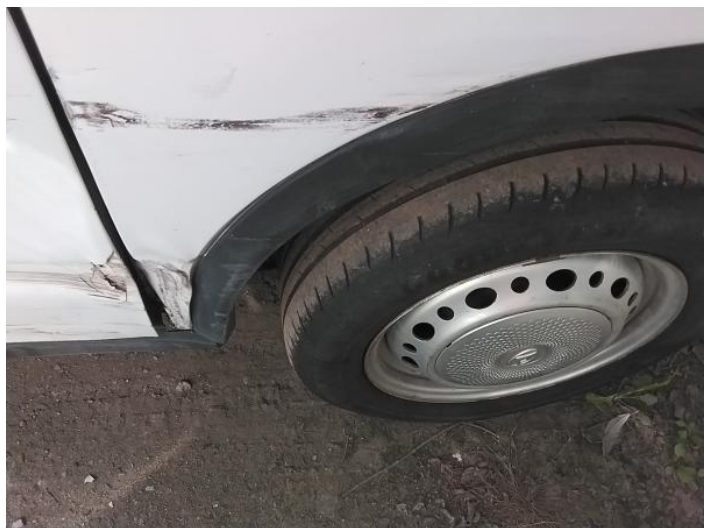
8: Qtr Panel nsr
Dented
With Paint Damage

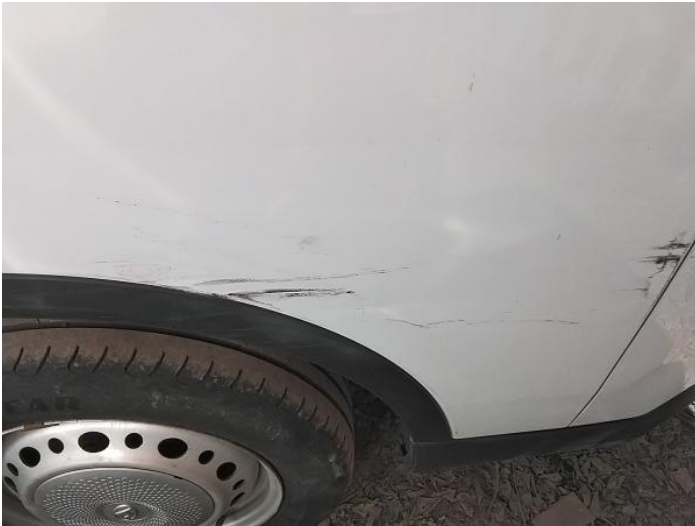
9: Qtr Panel nsr
Dented
With Paint Damage

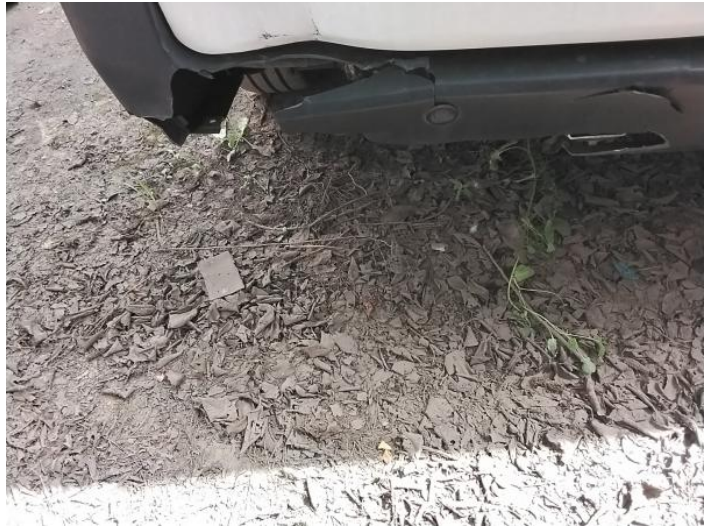
10: Bumper Rear
Cracked
Over 25mm

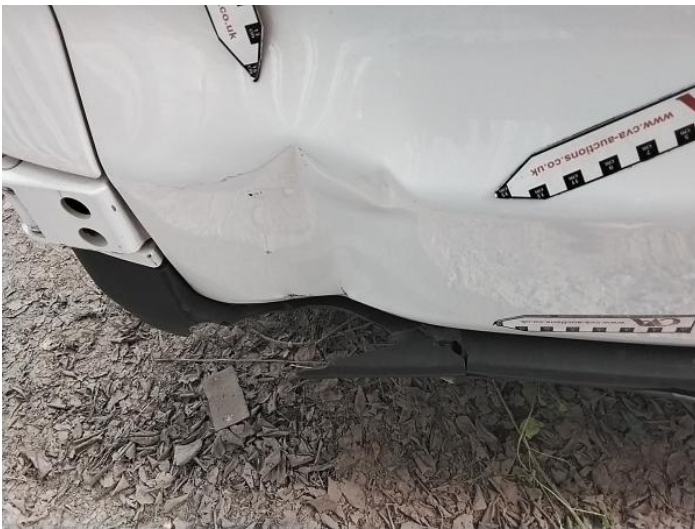
11: Door nsr
Dented
With Paint Damage

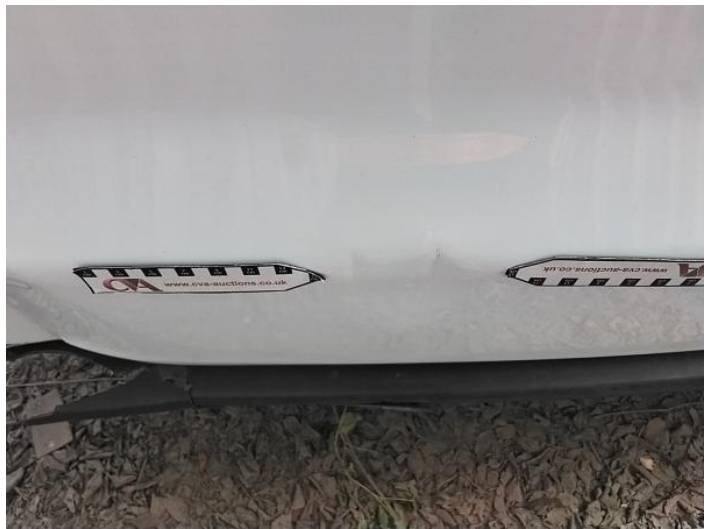
12: Door nsr
Dented
With Paint Damage

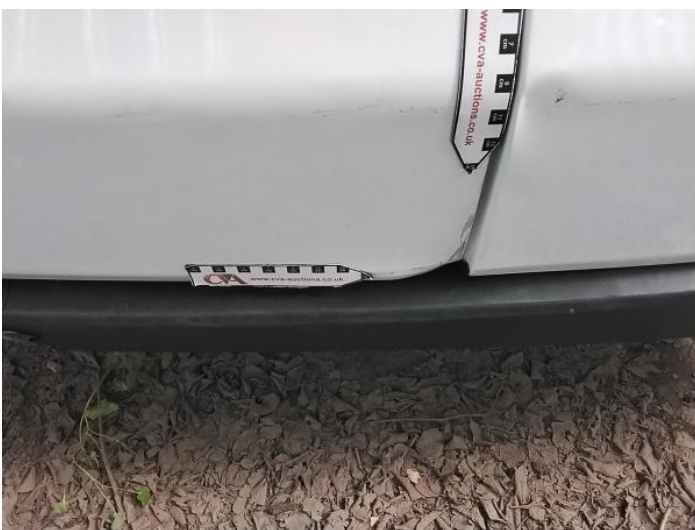
13: Door nsr
Dented
With Paint Damage

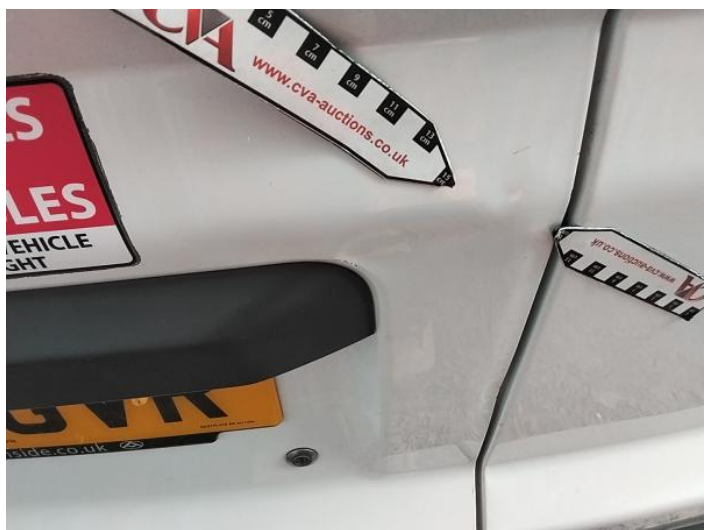
14: Door nsr
Dented
Over 30mm

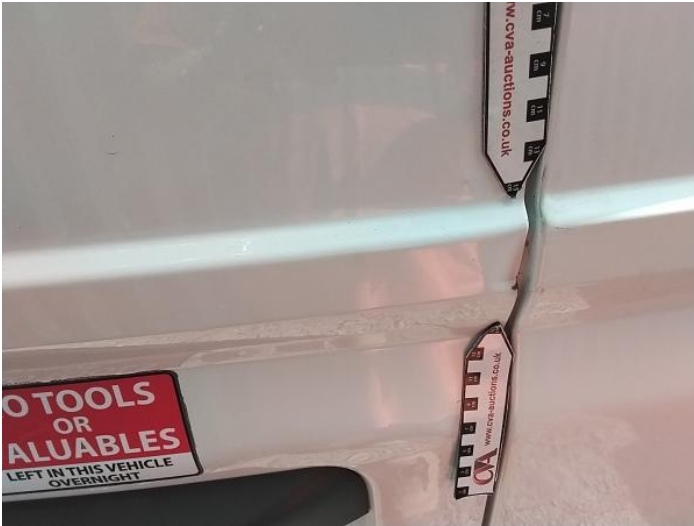
15: Door nsr
Dented
With Paint Damage

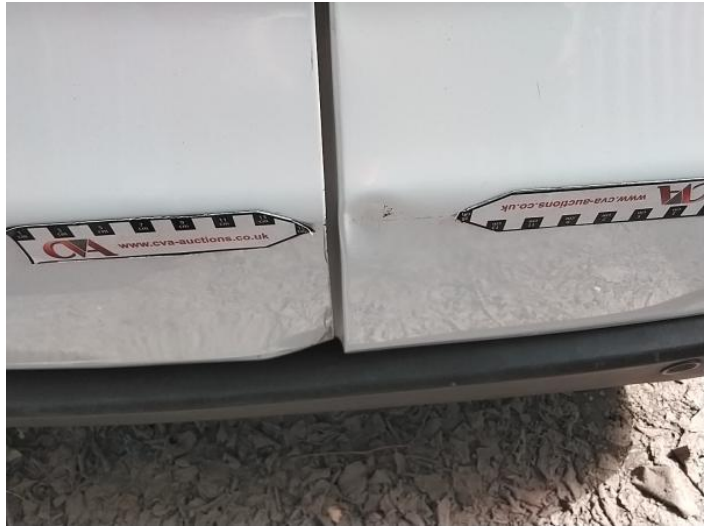
16: Door osr
Dented
With Paint Damage

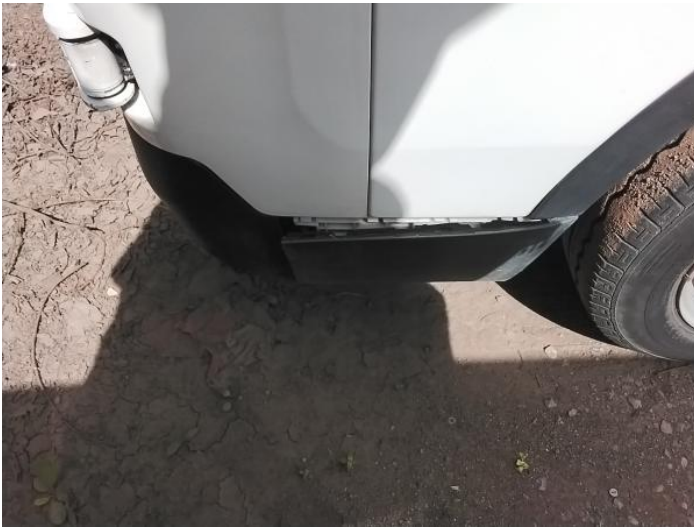
17: Qtr Panel Moulding os
Broken
Replace

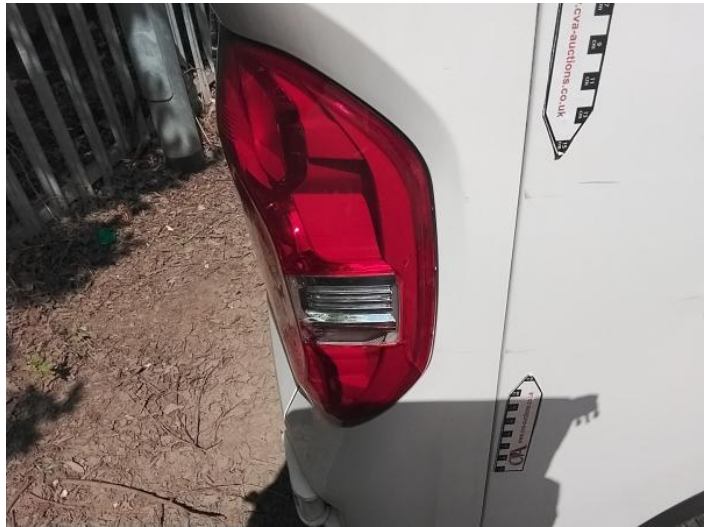
18: Qtr Panel osr
Scratched
Over 25mm Thru Paint

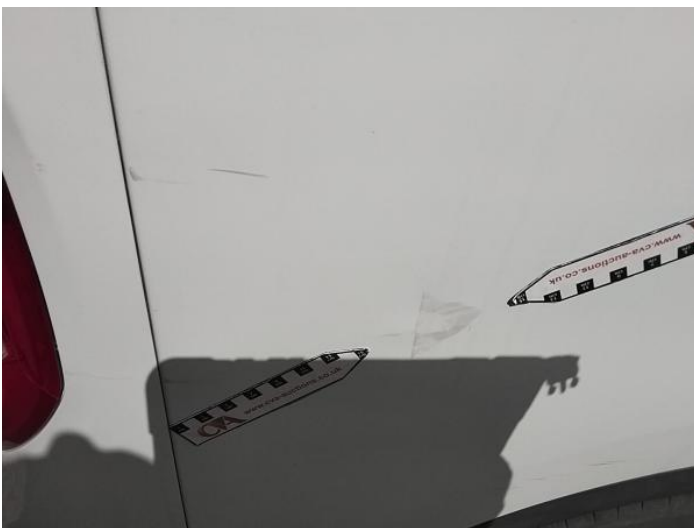
19: Qtr Panel osr
Dented
With Paint Damage

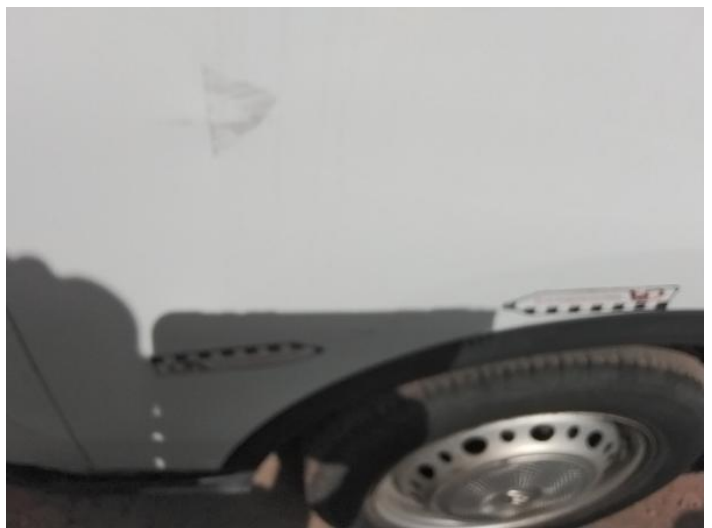
20: Qtr Panel osr
Scratched
Over 25mm Thru Paint

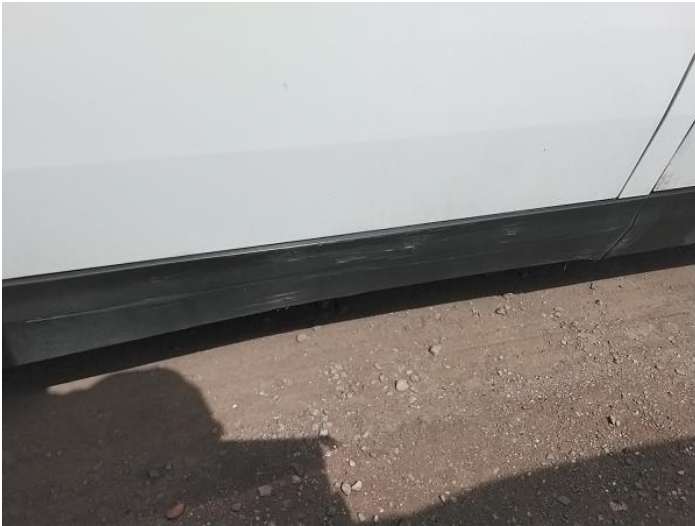
21: Qtr Panel Moulding os
Scuffed (Unpainted)
Over 100mm

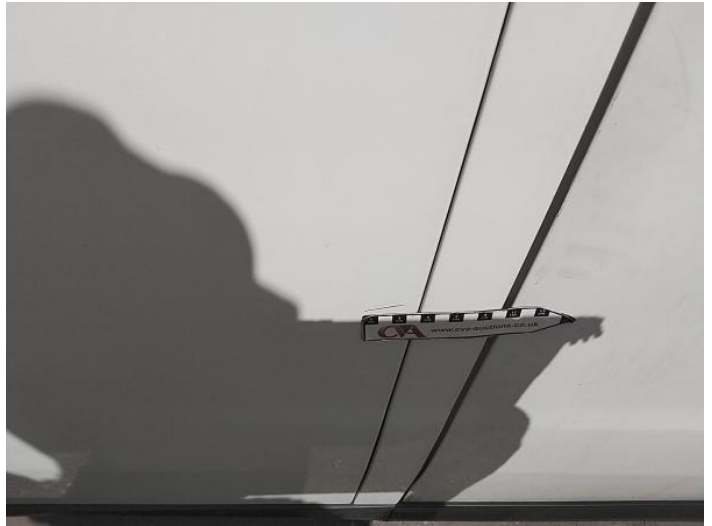
22: Qtr Panel osr
Scratched
Over 25mm Thru Paint

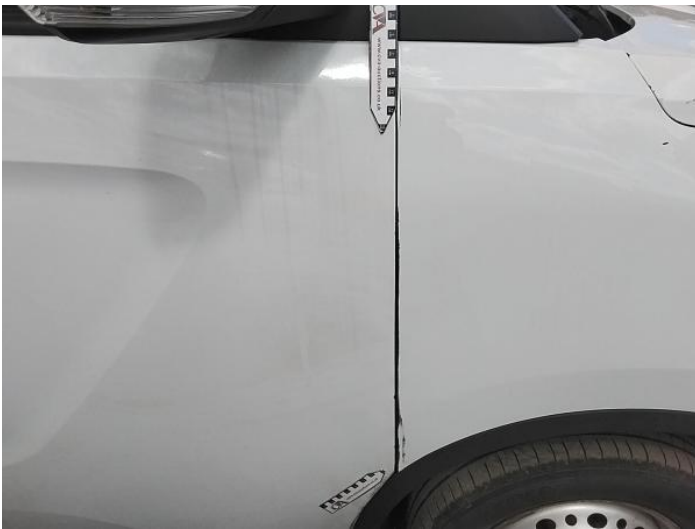
23: Door osf
Dented
Over 30mm

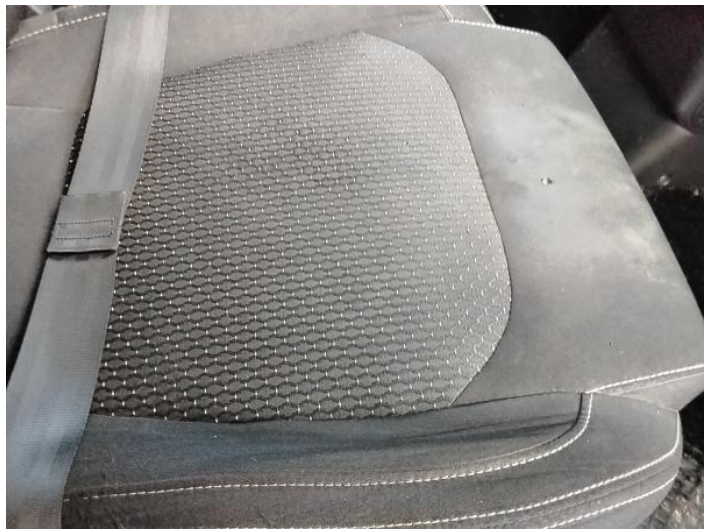
24: Seat Base Cover osf
Burn
Over 3mm

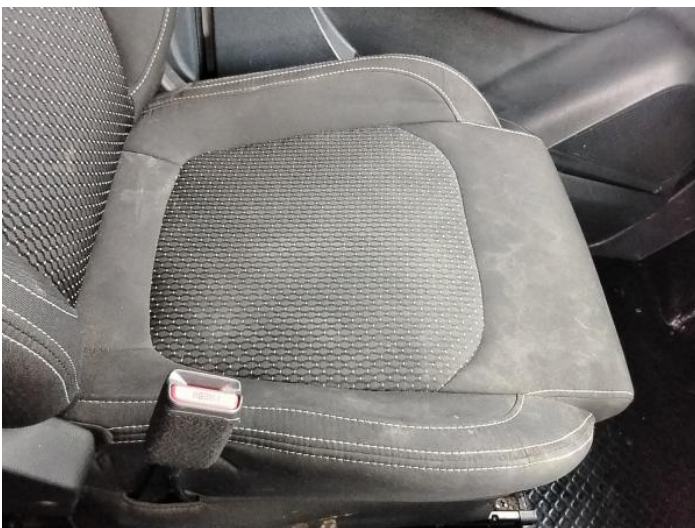
25: Seat Base Cover nsf
Soiled
Heavy

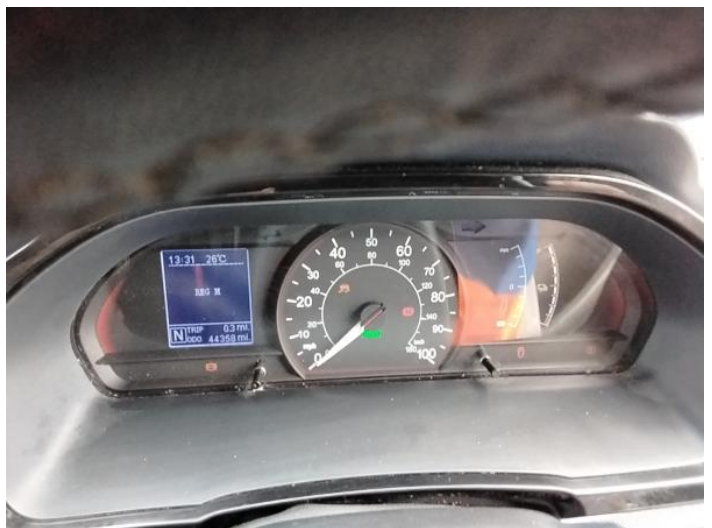
26: Dash Warning Lights
Displayed
No Action
