# VEHICLE INSPECTION REPORT

**YF71GVX**

## Maxus Deliver 3 90KW 35KWH

**Non Runner** **Serious Damage**  
Inspection

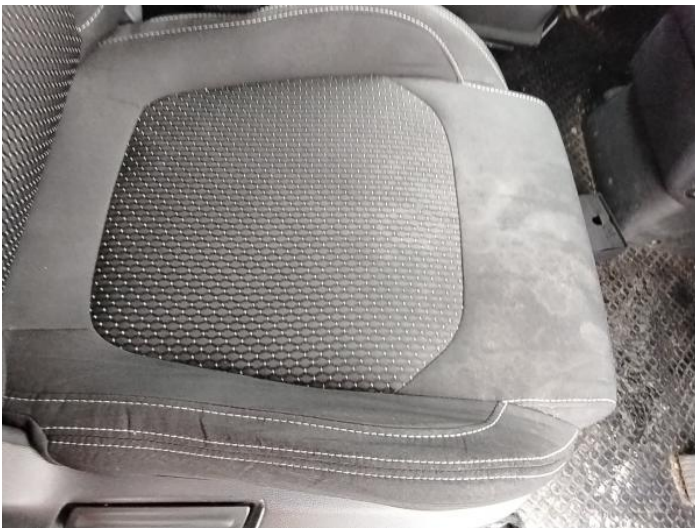
1: Seat Base Cover osf  
Soiled  
Heavy

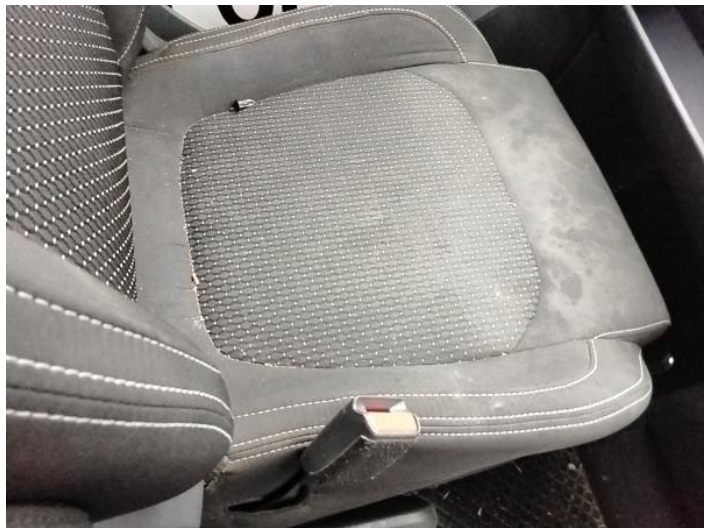
2: Seat Base Cover nsf  
Soiled  
Heavy

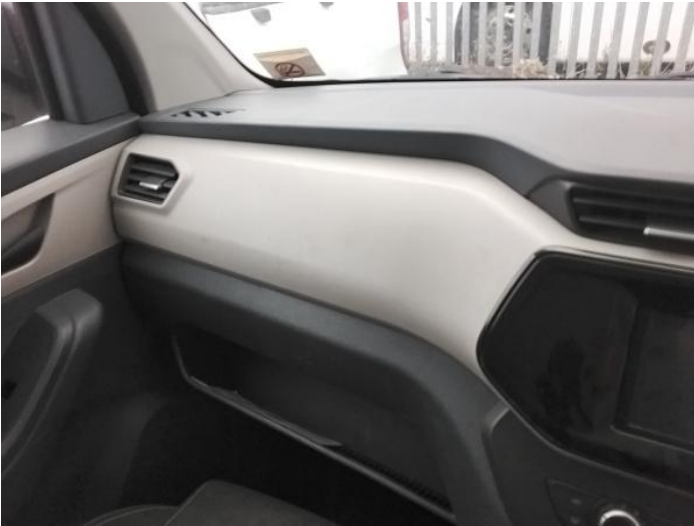
3: Fascia Panel  
Soiled  
Heavy

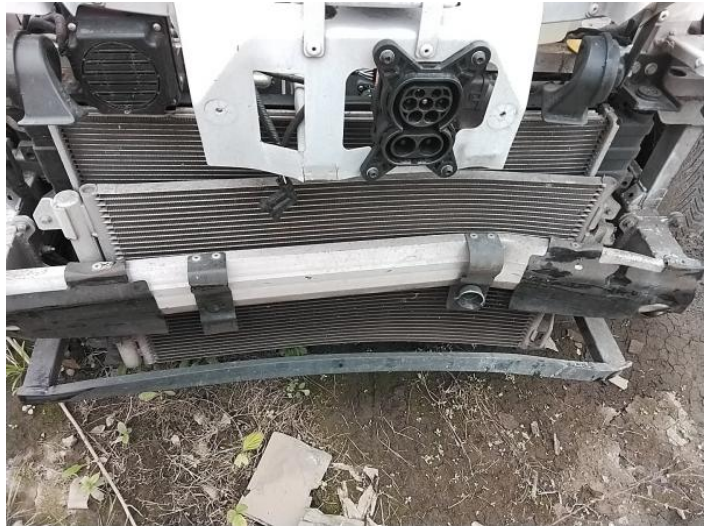
4: Unclassified  
Substantial Accident Damage  
Report Only

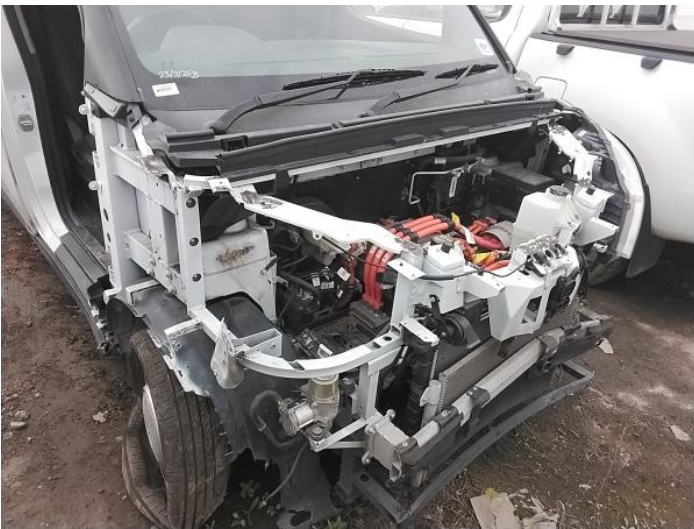
5: Unclassified  
Major Parts Missing  
Report Only

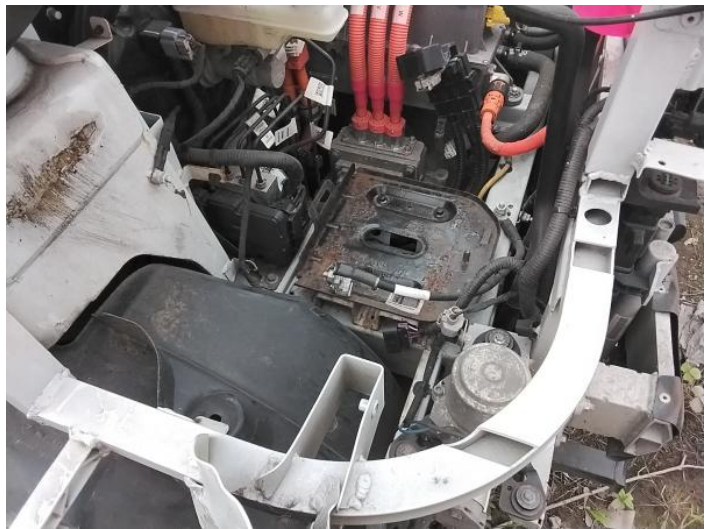
6: Unclassified  
Major Parts Missing  
Report Only

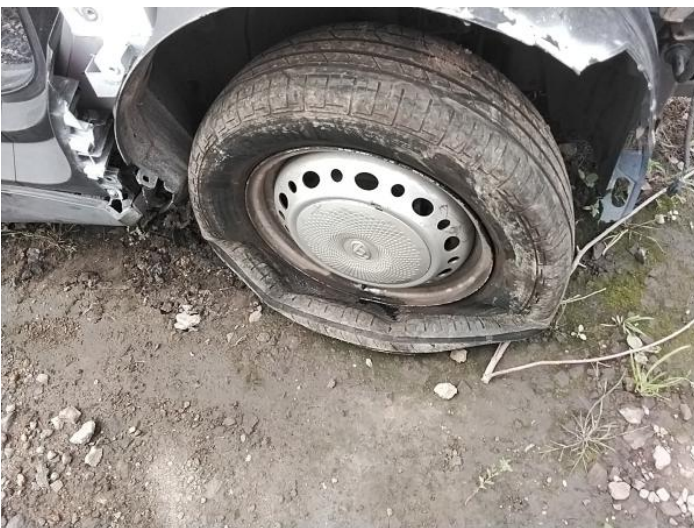
7: Wheel osf  
Damaged  
Replace

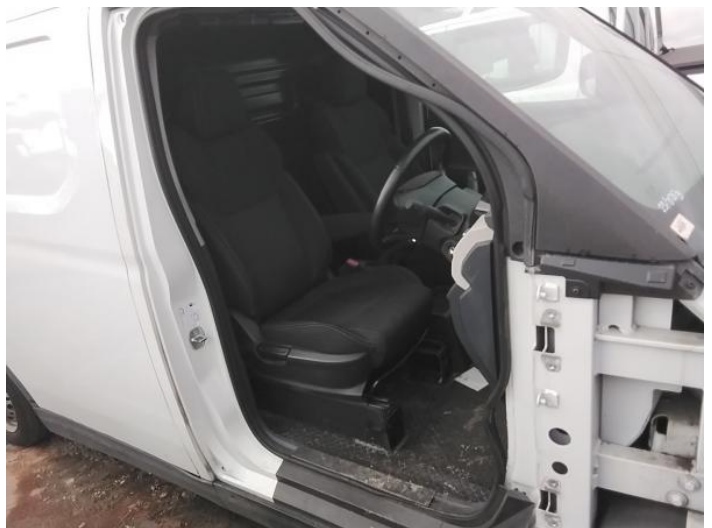
8: Door osf  
Missing  
Replace

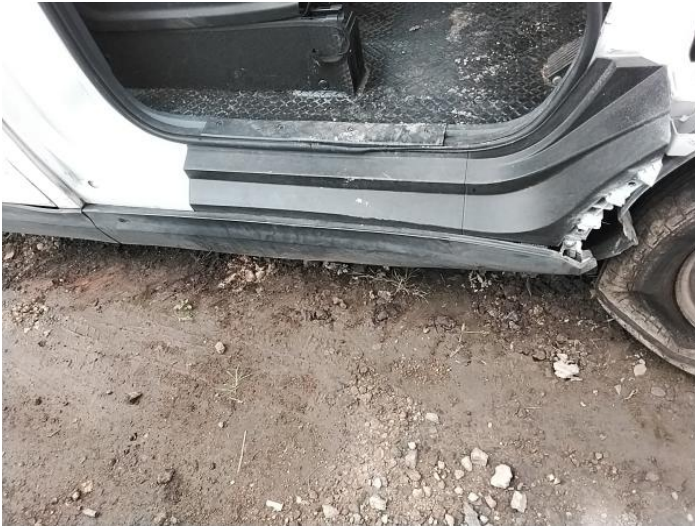
9: Door Moulding osf  
Broken  
Replace

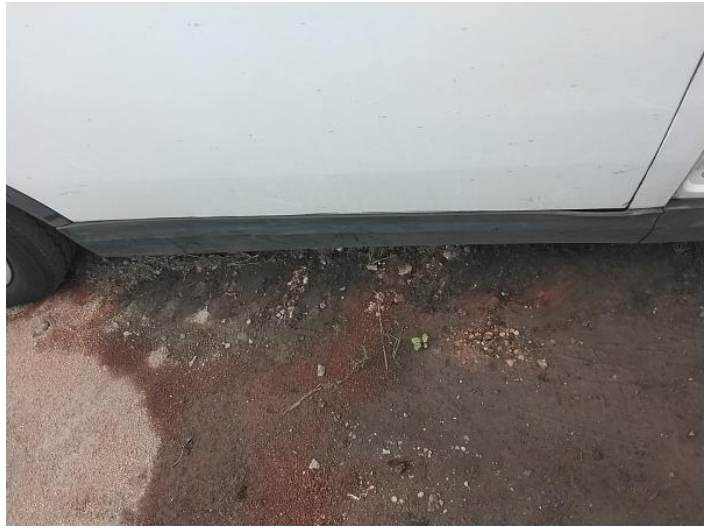
10: Qtr Panel Moulding os  
Broken  
Replace

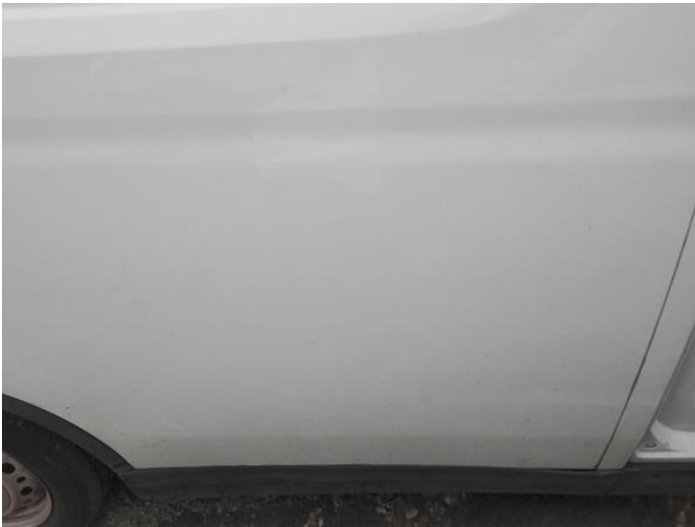
11: Qtr Panel osr  
Chipped  
Multiple Chips

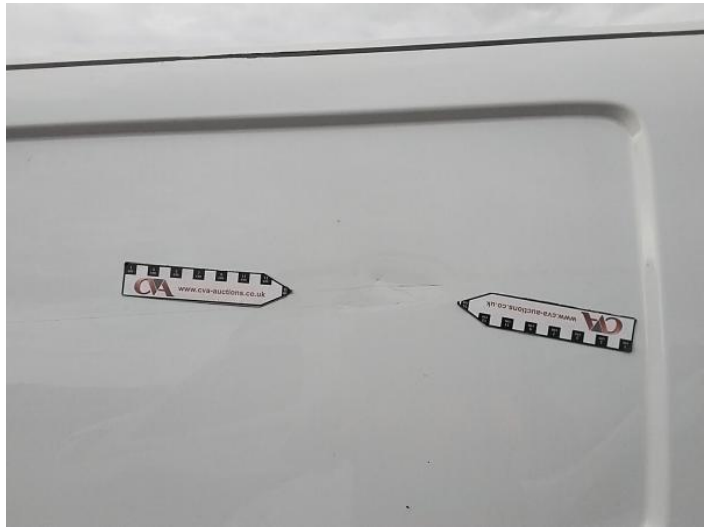
12: Qtr Panel osr  
Dented  
With Paint Damage

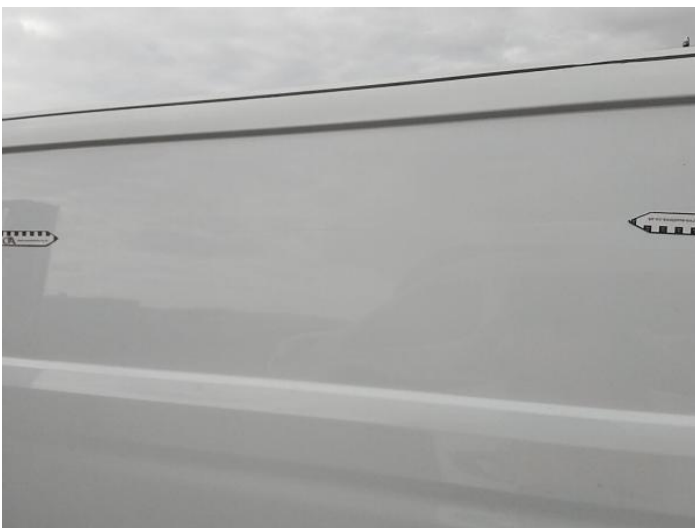
13: Qtr Panel osr  
Scratched  
Over 25mm Thru Paint

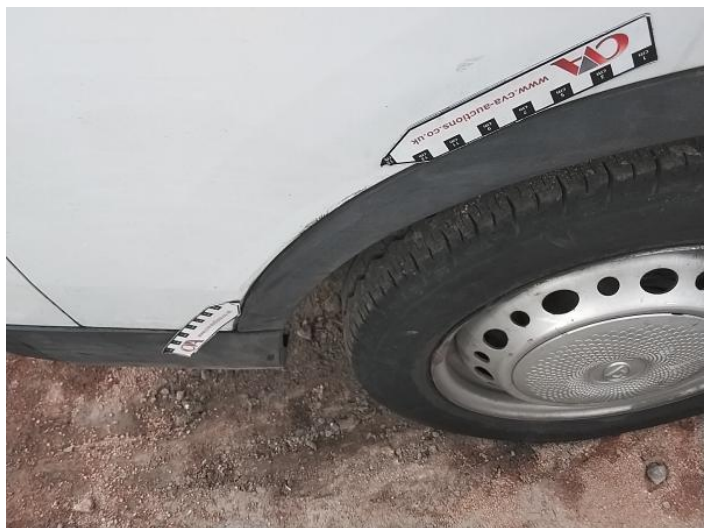
14: Qtr Panel osr  
Dented  
With Paint Damage

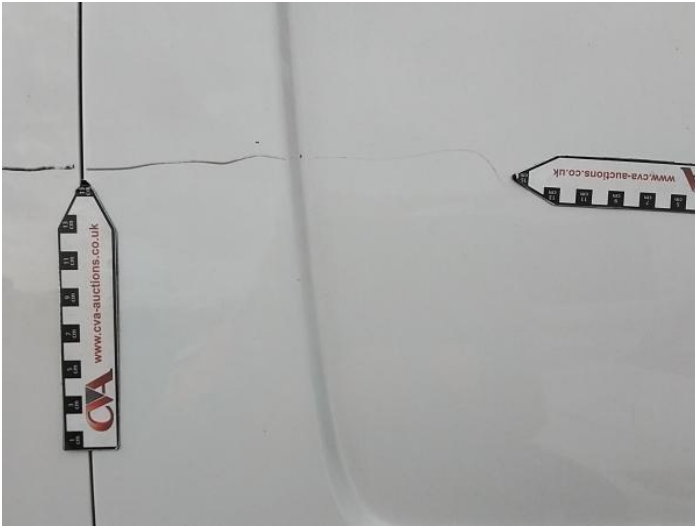
15: Qtr Panel osr  
Scratched  
Over 25mm Thru Paint

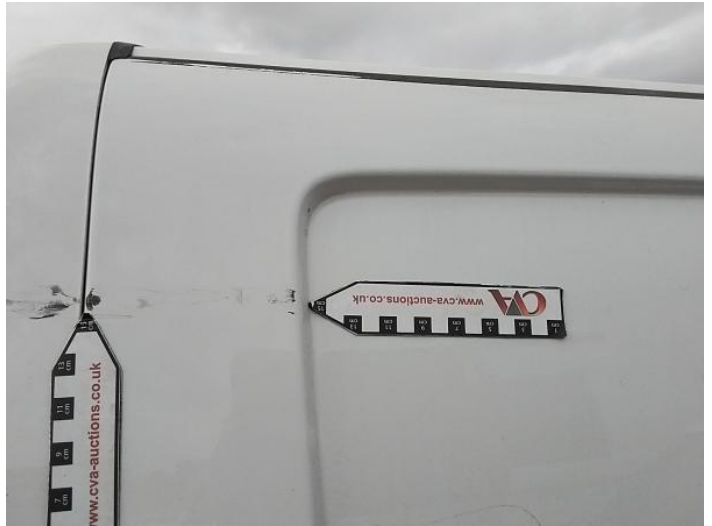
16: Qtr Panel osr  
Scratched  
Over 25mm Thru Paint

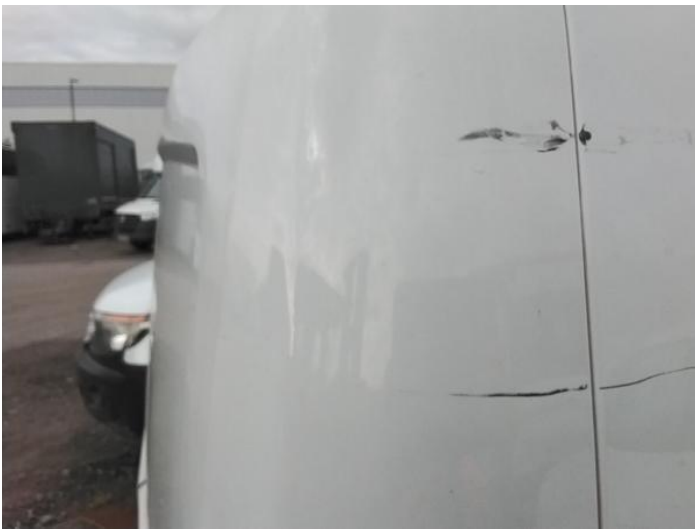
17: C Post os  
Scratched  
Over 25mm Thru Paint

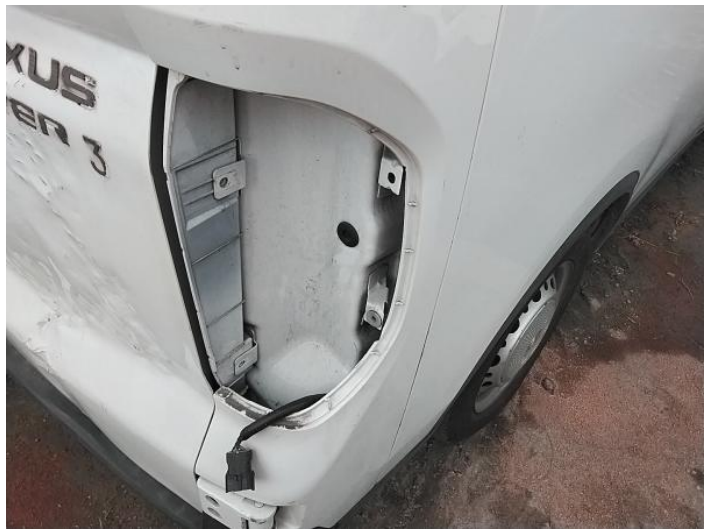
18: Lamp osr  
Missing  
Replace

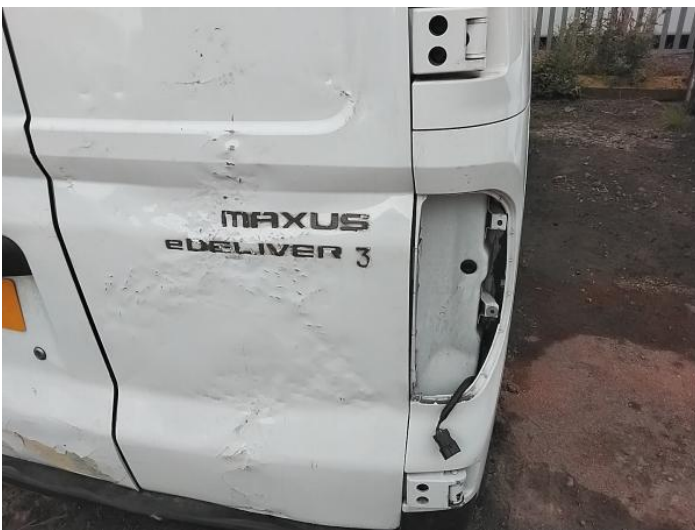
19: Door osr  
Dented  
Over 30% Of Panel

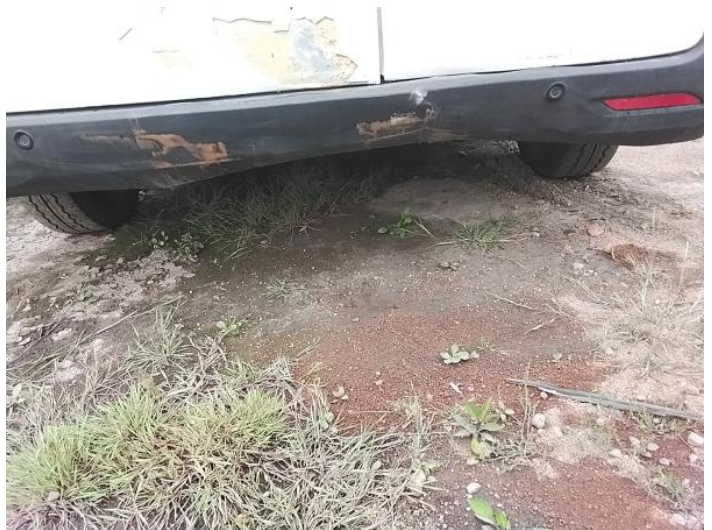
20: Bumper Rear  
Dented  
Over 30% Of Panel

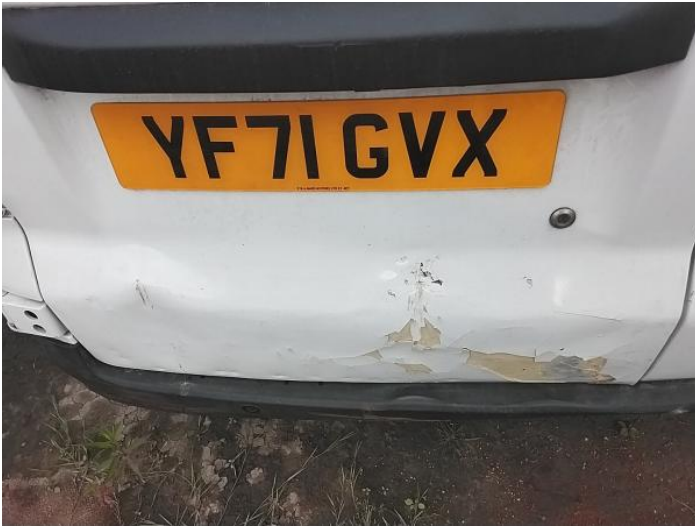
21: Door nsr  
Dented  
Over 30% Of Panel

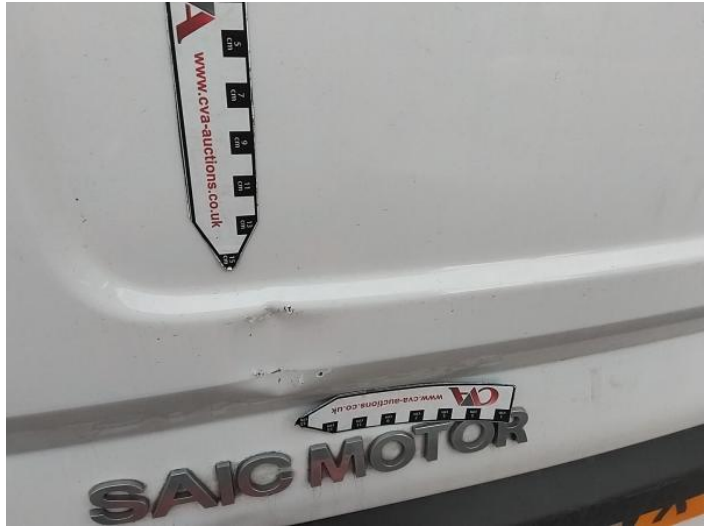
22: Door nsr  
Dented  
With Paint Damage

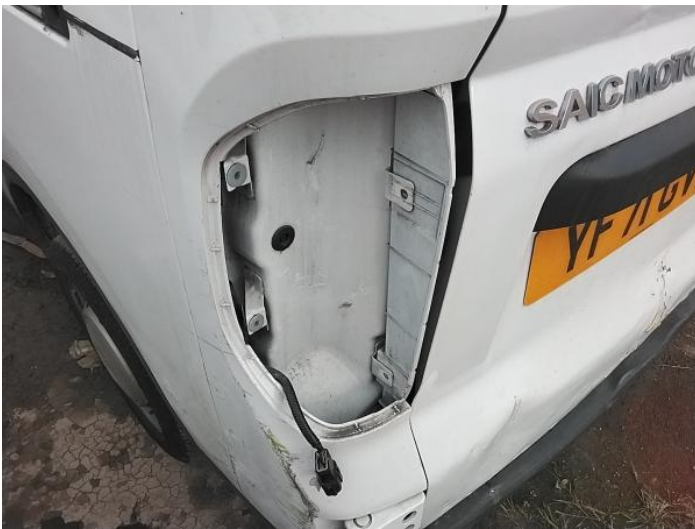
23: Lamp nsr  
Missing  
Replace

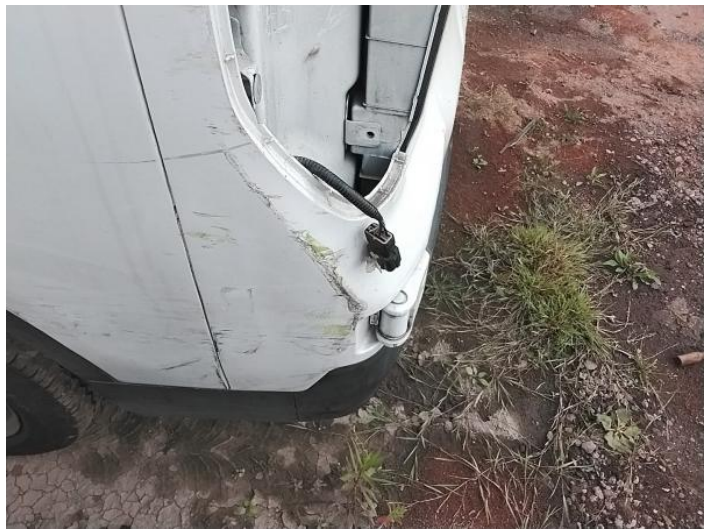
24: C Post ns  
Scratched  
Over 25mm Thru Paint

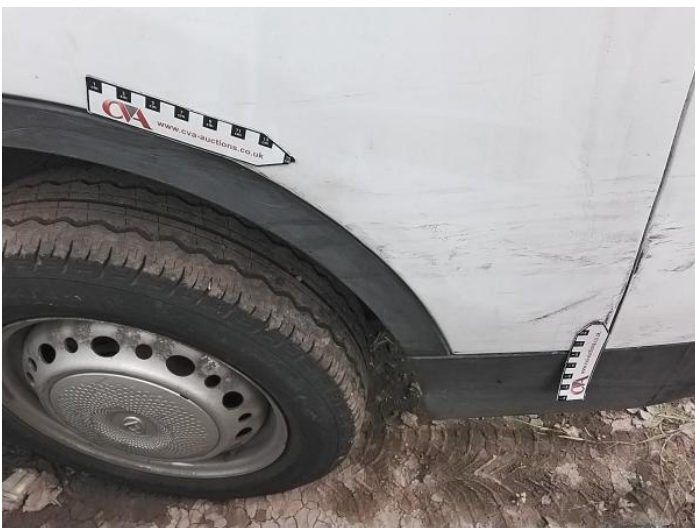
25: Qtr Panel nsr  
Poor Previous Repair  
Rippled UpTo 30%

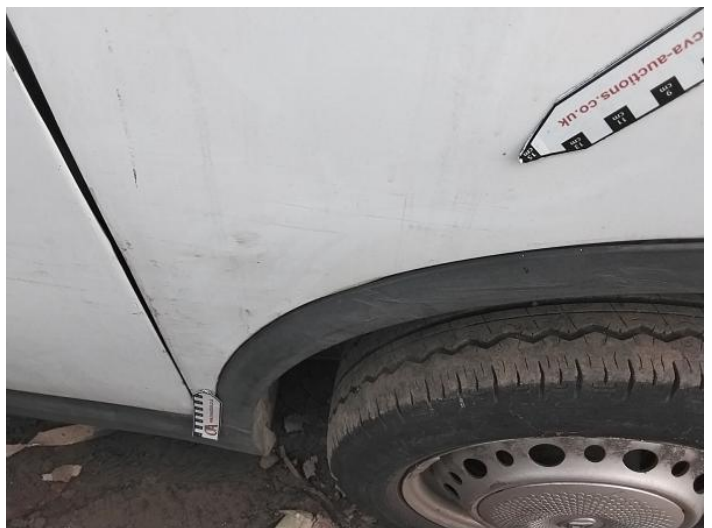
26: Qtr Panel nsr  
Poor Previous Repair  
Rippled UpTo 30%

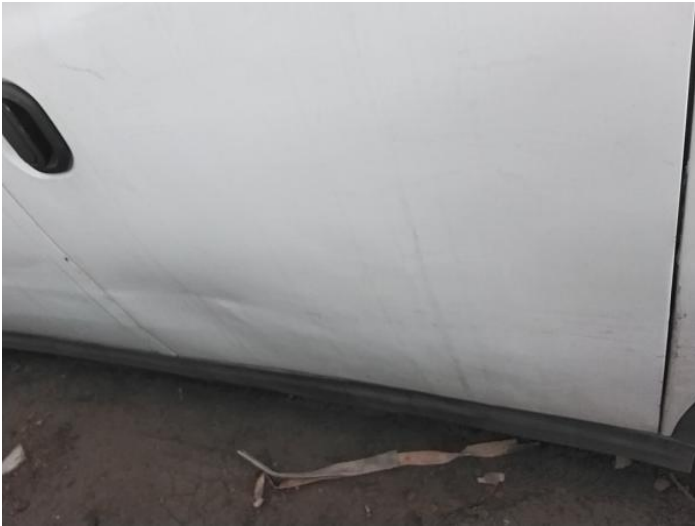
27: Qtr Panel nsr  
Poor Previous Repair  
Rippled Over 30%

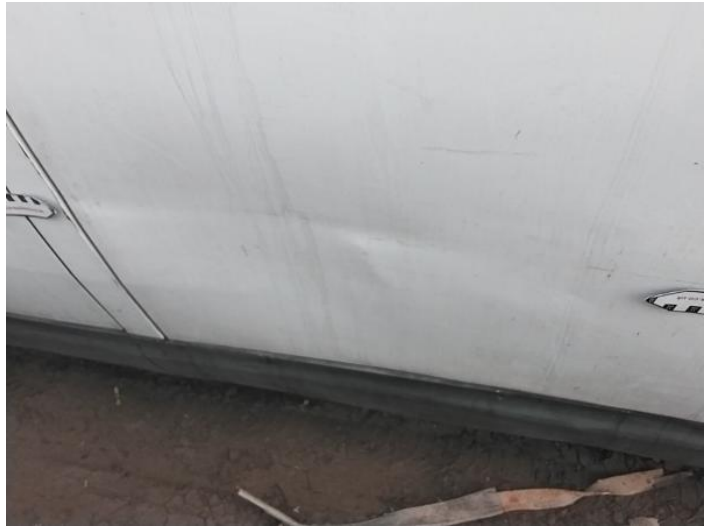
28: Qtr Panel nsr  
Dented  
Over 30mm

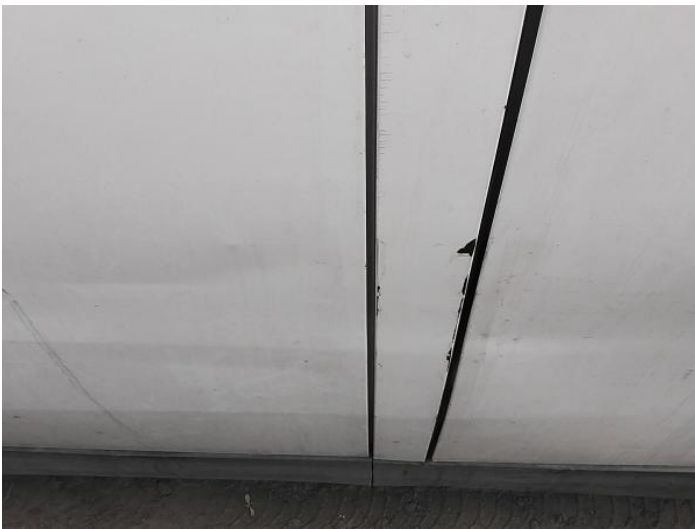
29: B Post ns  
Scratched  
Over 25mm Thru Paint

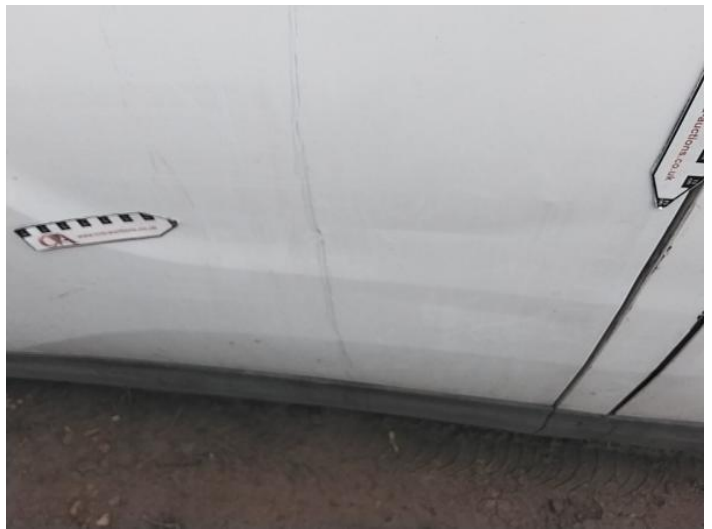
30: Door nsf  
Dented  
Over 30mm

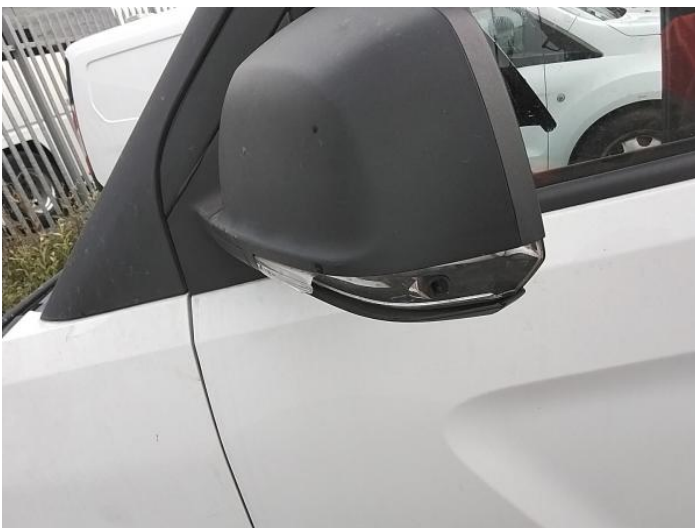
31: Door Mirror Assy nsf  
Broken  
Replace
