VEHICLE INSPECTION REPORT

YD68ZKP

Mercedes-Benz Sprinter 314 CDI

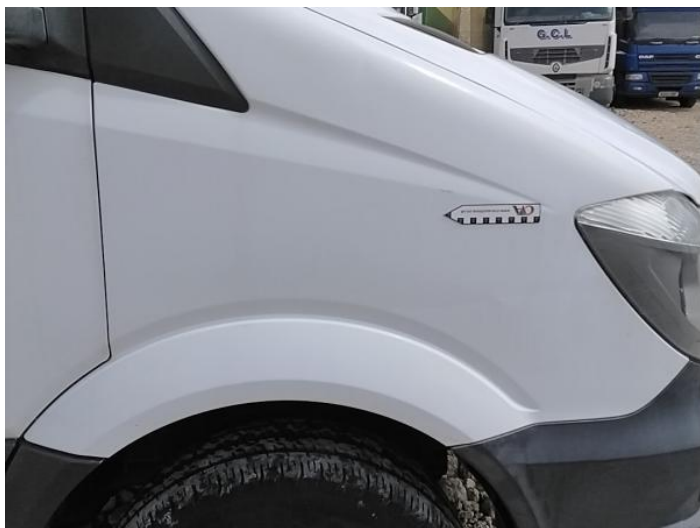
1: Wing osf
Scratched
Over 25mm Thru Paint

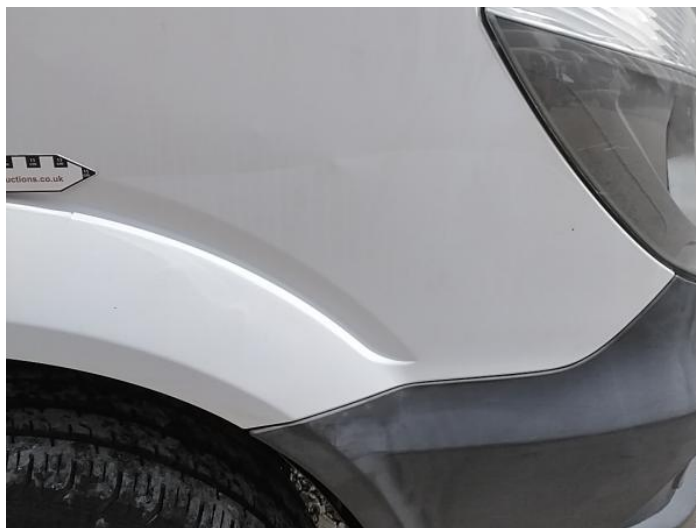
2: Wing osf
Scratched
Over 25mm Thru Paint

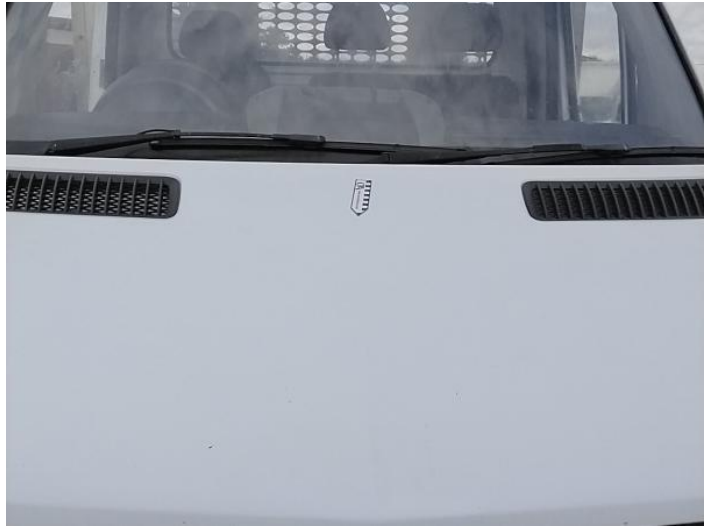
4: Bonnet
Chipped
Multiple Chips

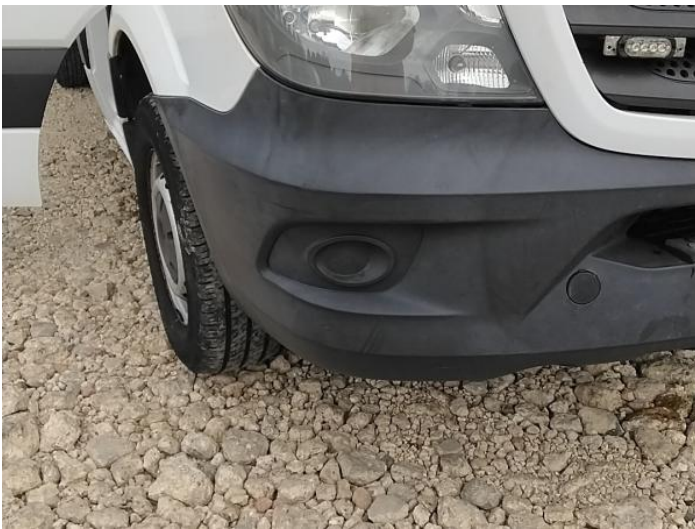
5: Bumper Front Moulding
Scuffed (Unpainted)
UpTo 100mm

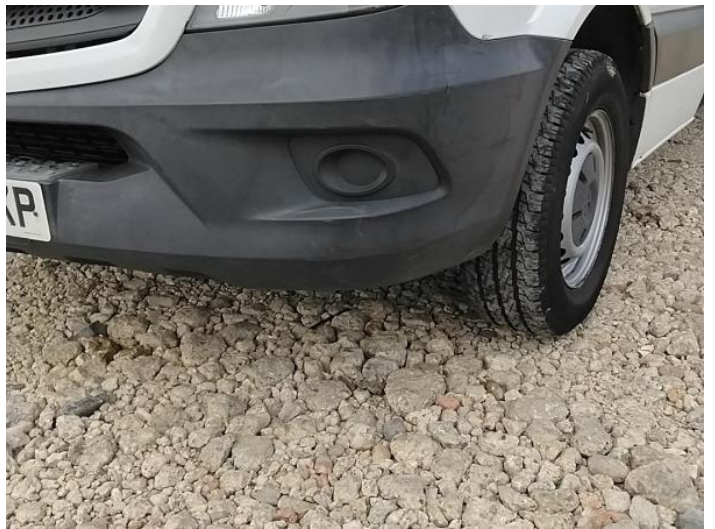
6: Bumper Front Moulding
Scuffed (Unpainted)
UpTo 100mm

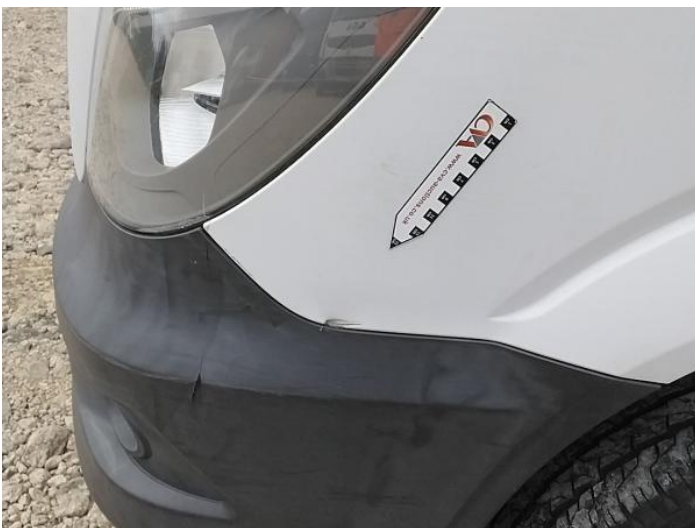
7: Wing nsf
Scratched
UpTo 25mm Thru Paint

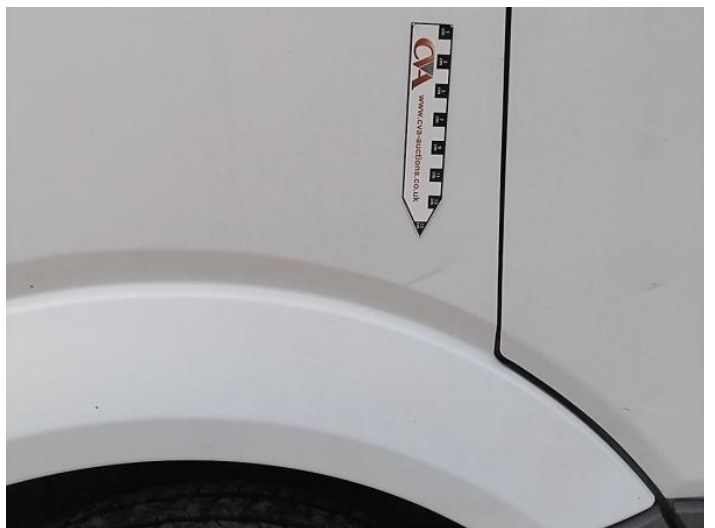
8: Wing nsf
Scratched
UpTo 25mm Thru Paint

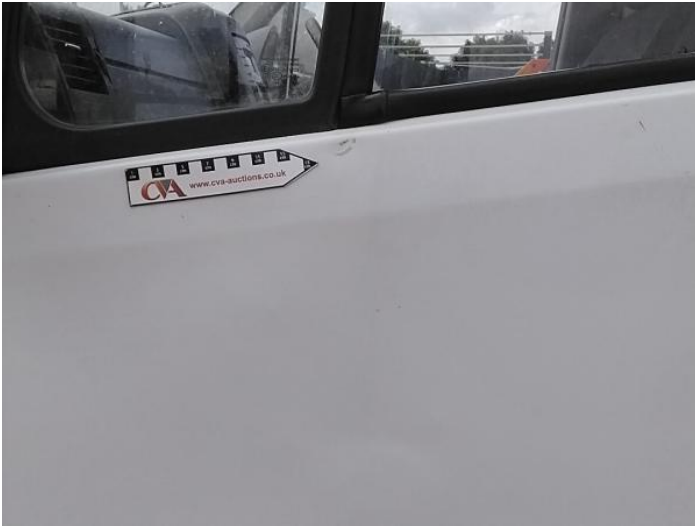
9: Door nsf
Dented
Between 10mm + 30mm

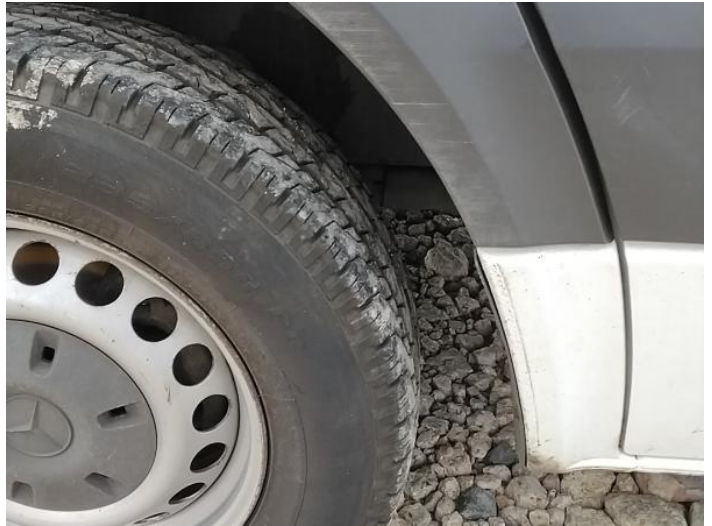
10: Moulding nsf Wing
Scuffed (Unpainted)
UpTo 100mm

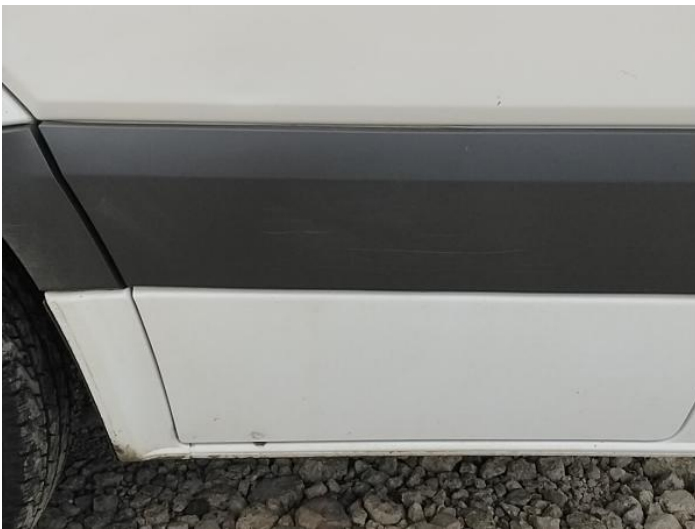
11: Door Moulding nsf
Scuffed (Unpainted)
UpTo 100mm

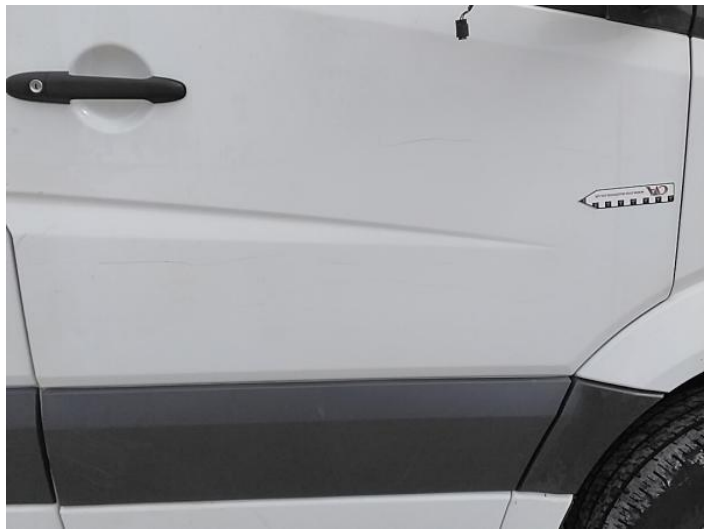
12: Door osf
Scratched
Over 25mm Thru Paint

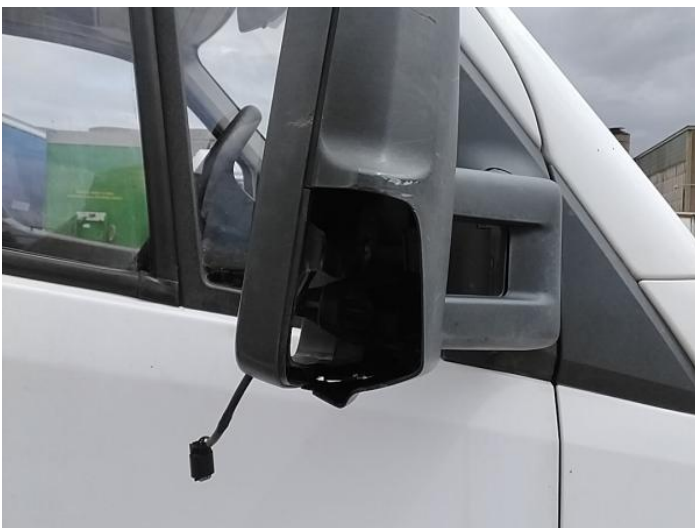
13: Door Mirror Assy osf
Missing
Replace

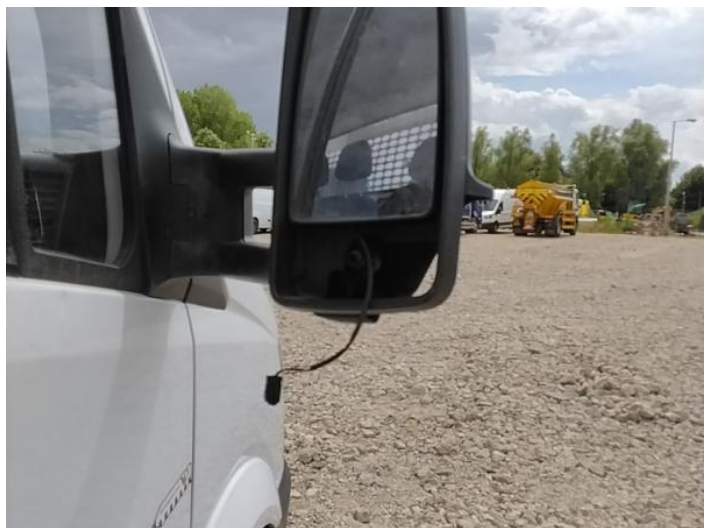
14: Door Mirror Glass os
Missing
Replace

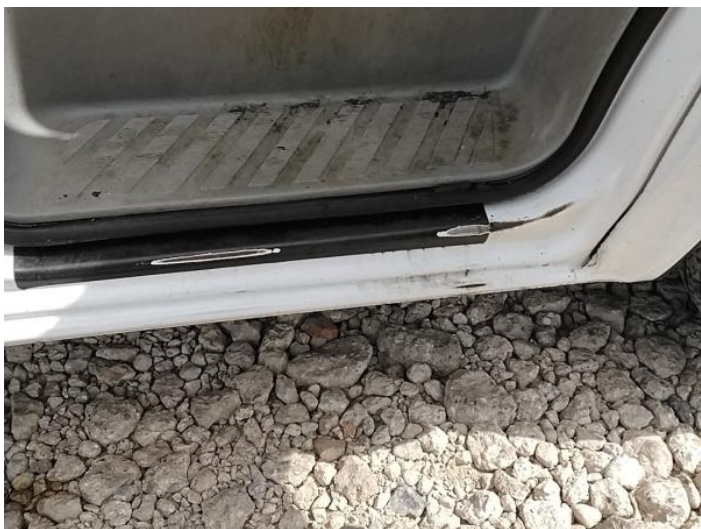
15: Sill os
Rusted
Over 5mm
