VEHICLE INSPECTION REPORT

BK72DWA

FORD TRANSIT 350 2.0 ECOBLUE 130PS

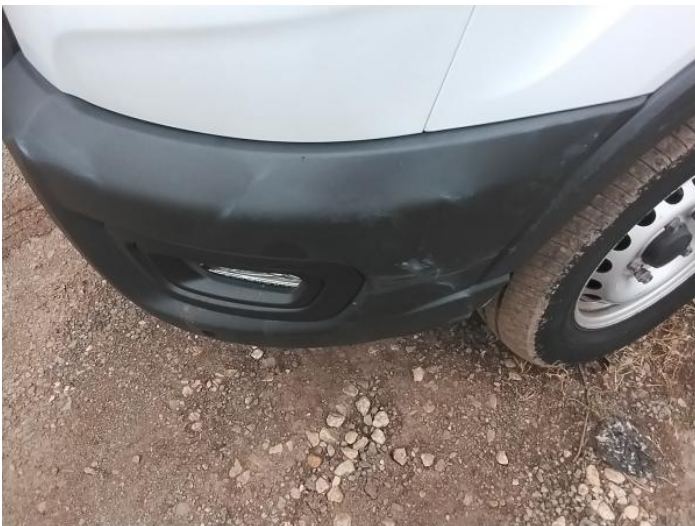
1: Bumper Front
Scratched
Over 100mm Thru Paint

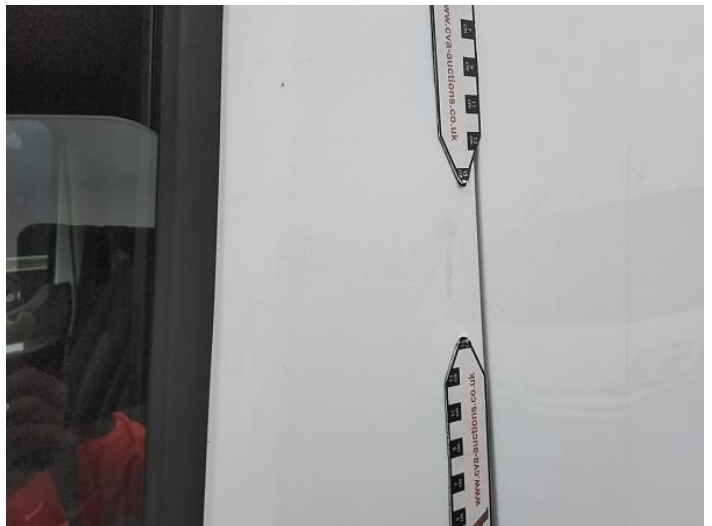
2: Door nsf
Dented
With Paint Damage

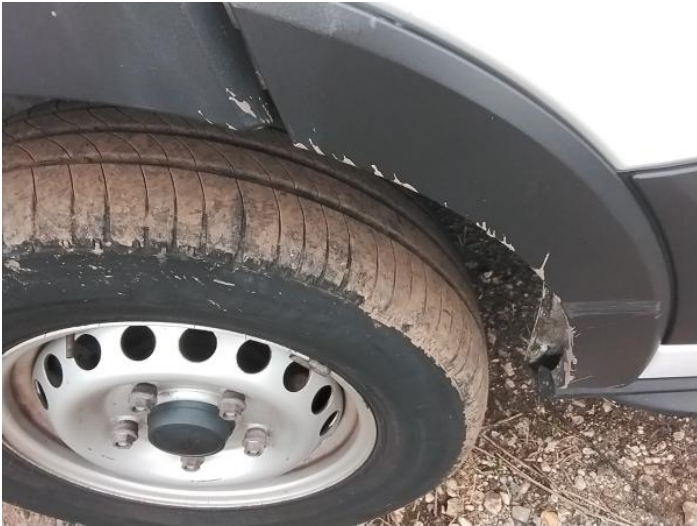
3: Door Moulding nsf
Scuffed (Unpainted)
UpTo 100mm

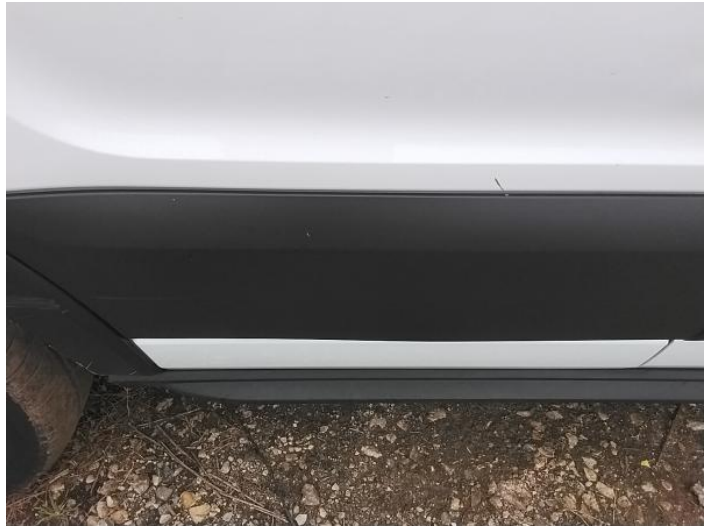
4: Door Moulding nsf
Scuffed (Unpainted)
Over 100mm

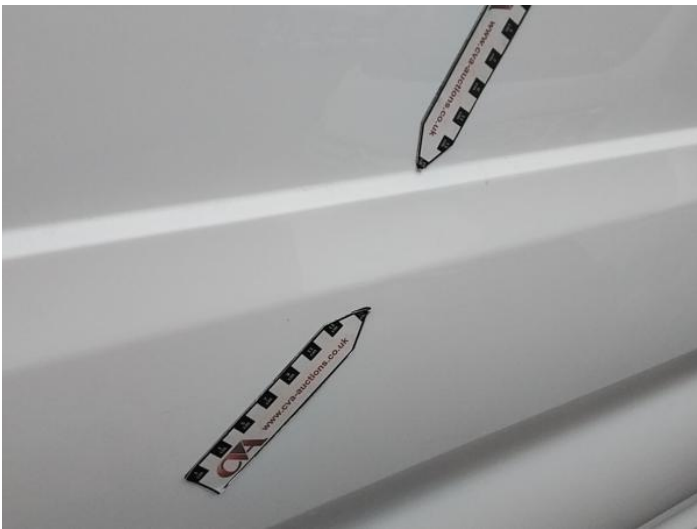
5: Qtr Panel nsr
Dented
Over 30mm

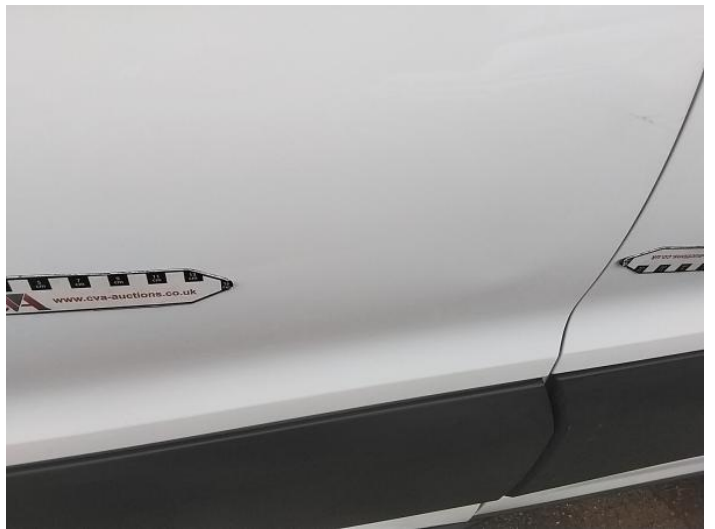
6: Qtr Panel nsr
Dented
Over 30mm

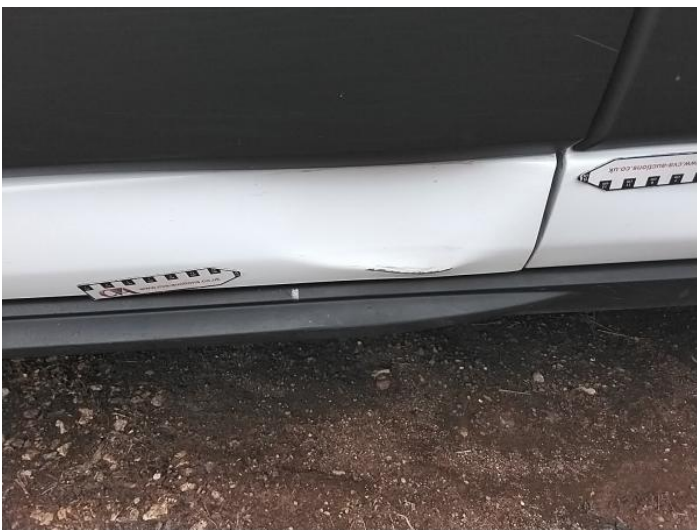
7: Qtr Panel nsr
Dented
With Paint Damage

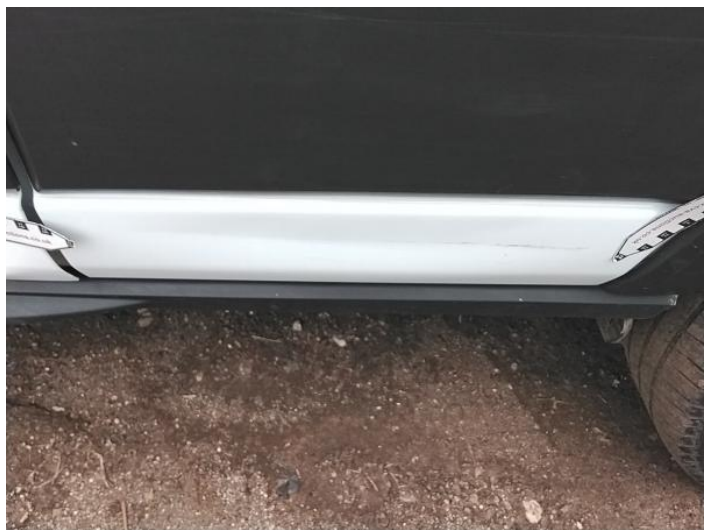
8: Qtr Panel nsr
Dented
With Paint Damage

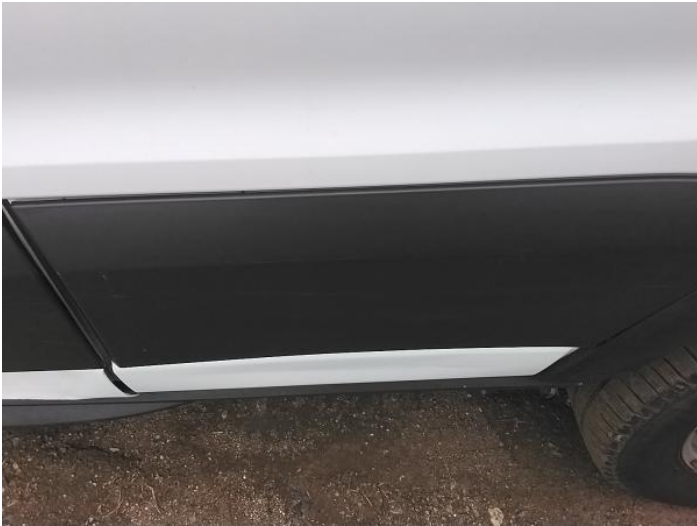
9: Qtr Panel Moulding ns
Scuffed (Unpainted)
Over 100mm

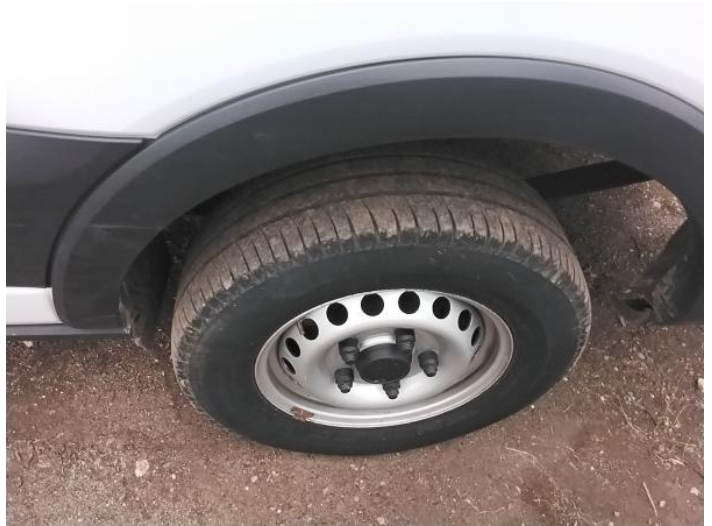
10: Qtr Panel Moulding ns
Scuffed (Unpainted)
Over 100mm

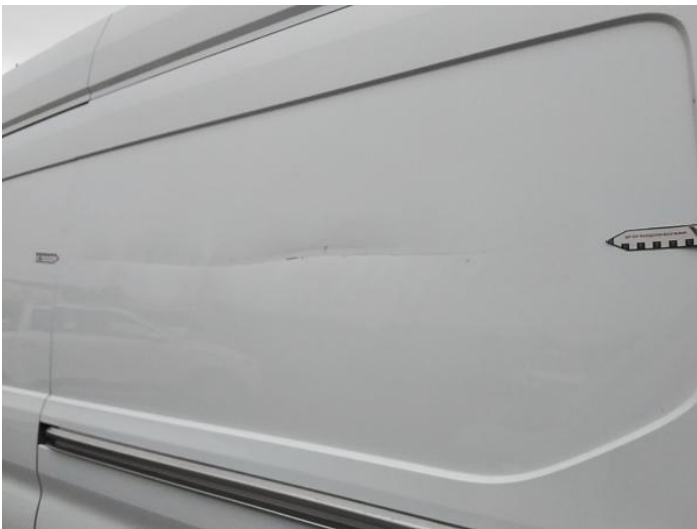
11: Qtr Panel nsr
Dented
With Paint Damage

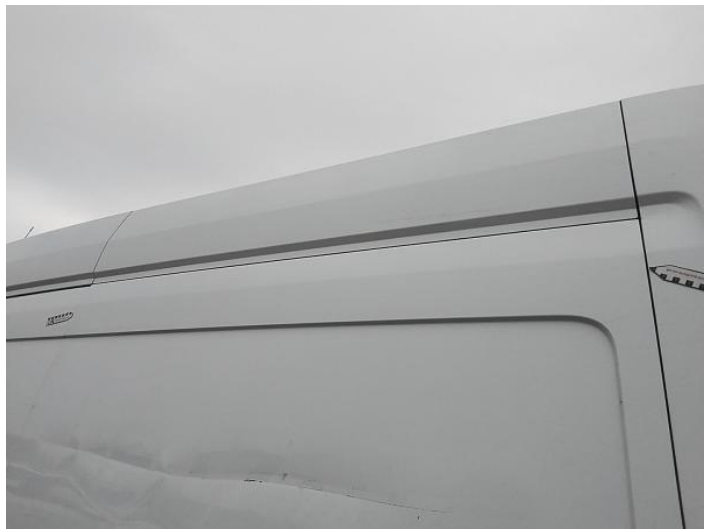
12: Qtr Panel nsr
Scratched
Over 25mm Thru Paint

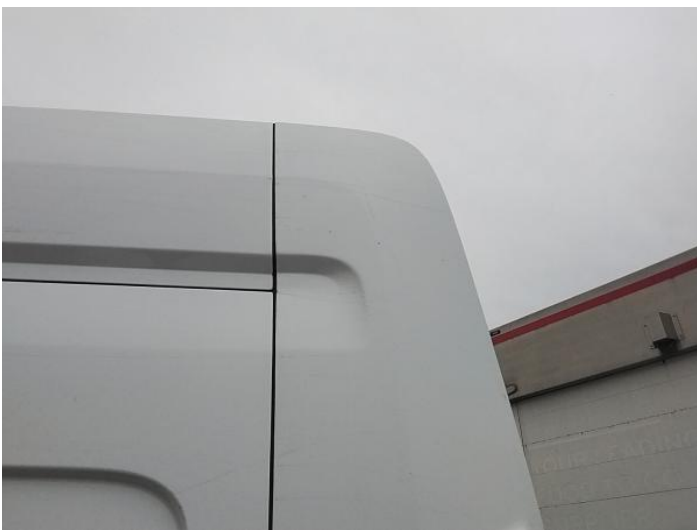
13: C Post ns
Scratched
Over 25mm Thru Paint

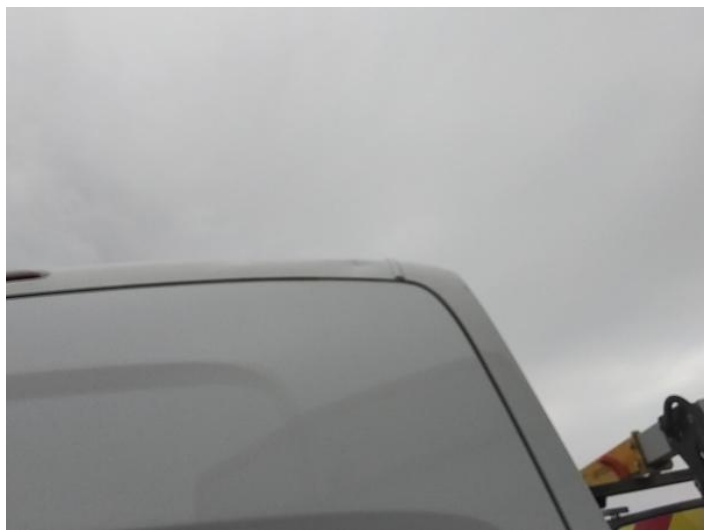
14: Roof
Dented
With Paint Damage

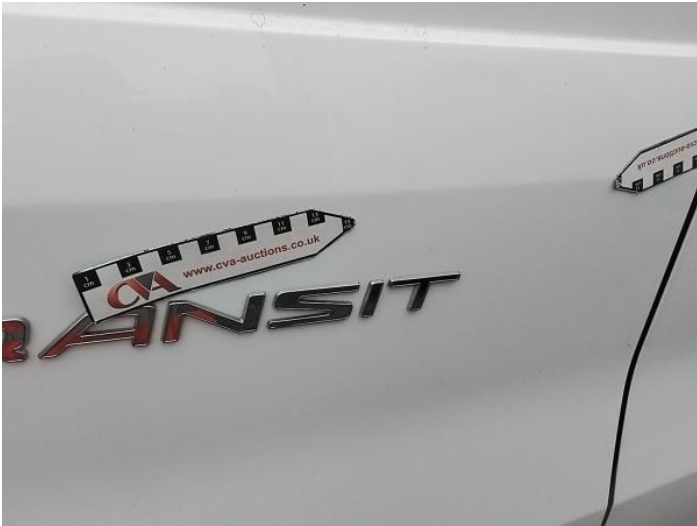
15: Door nsr
Dented
Over 30mm

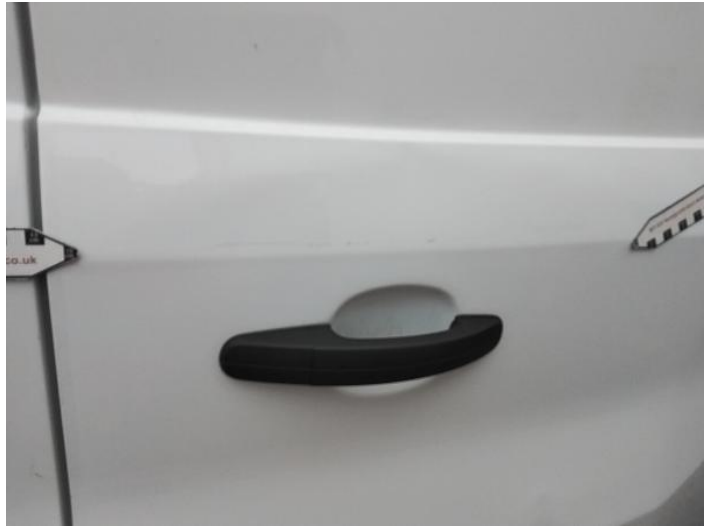
16: Door osr
Dented
With Paint Damage

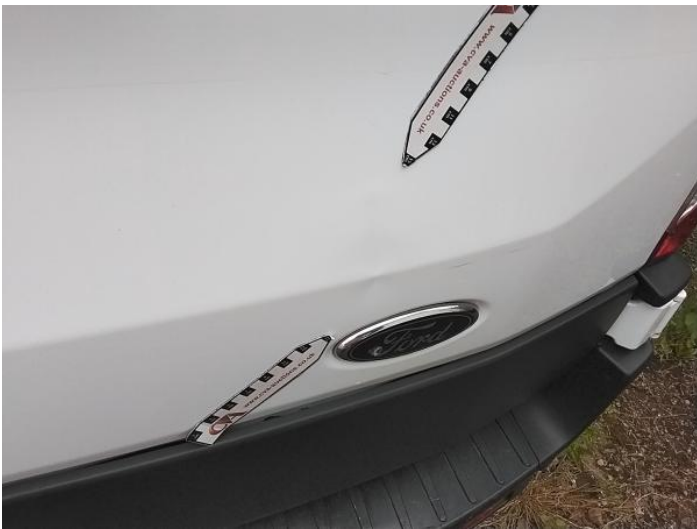
17: Door osr
Dented
Over 30mm

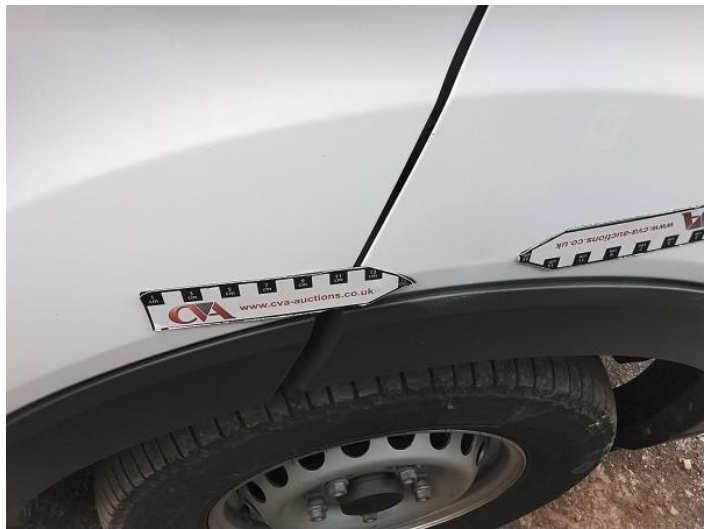
18: Wing osf
Dented
Over 30mm

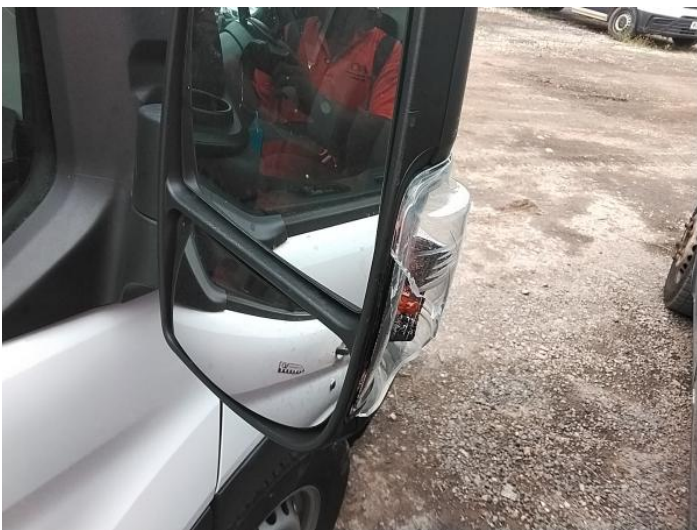
19: Door Mirror Assy osf
Broken
Replace

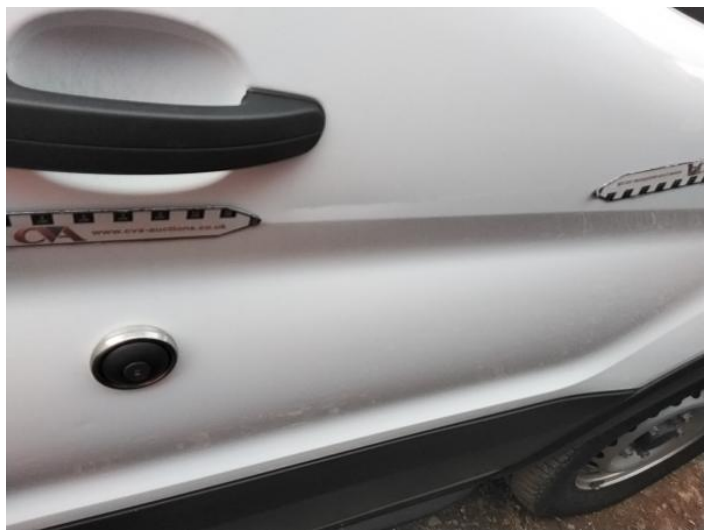
20: Door osf
Dented
With Paint Damage

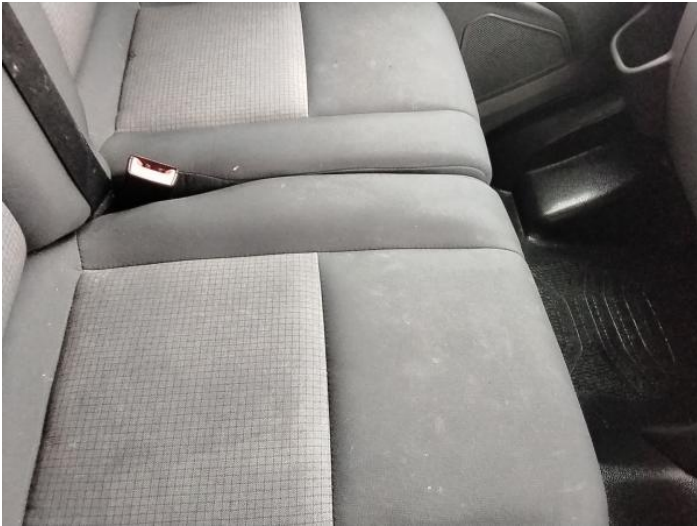
21: Seat Base Cover nsf
Soiled
Heavy

Poor
