VEHICLE INSPECTION REPORT

PK20MJV

Mercedes-Benz Sprinter 316 CDI

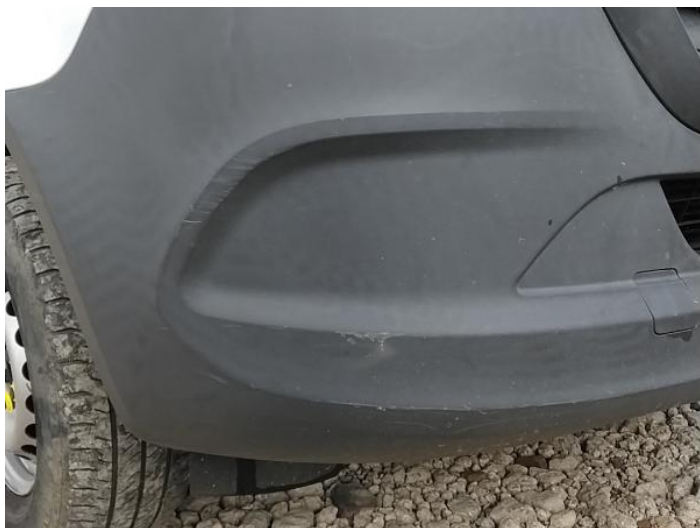
1: Bumper Front Moulding
Scuffed (Unpainted)
Over 100mm

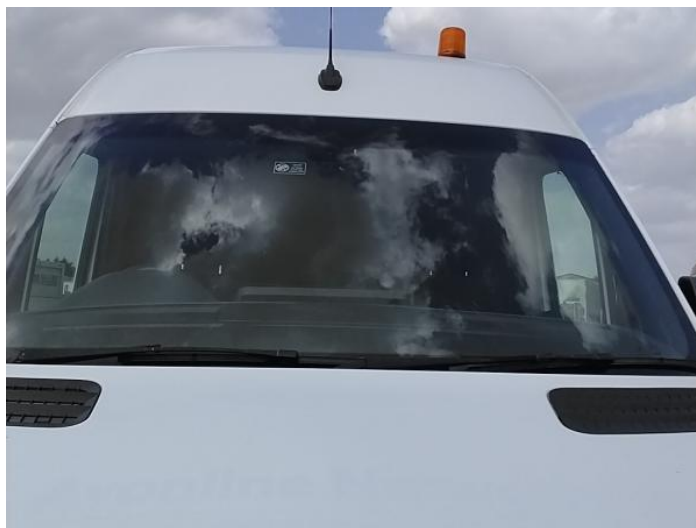
2: Screen Front
Chipped
Over 10mm

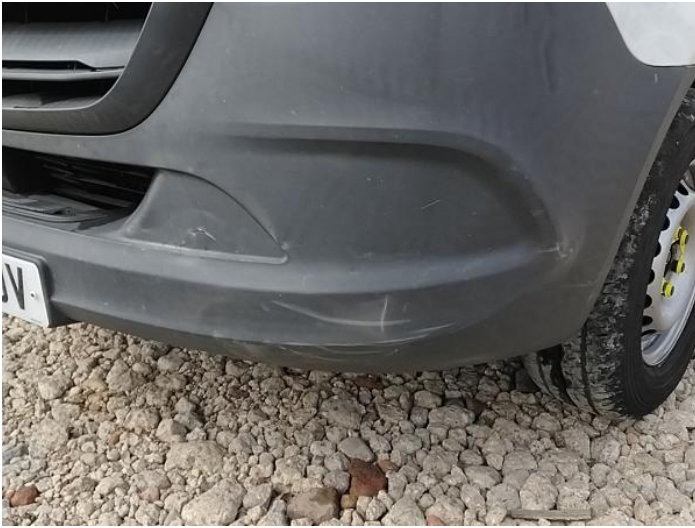
3: Bumper Front Moulding
Scuffed (Unpainted)
UpTo 100mm

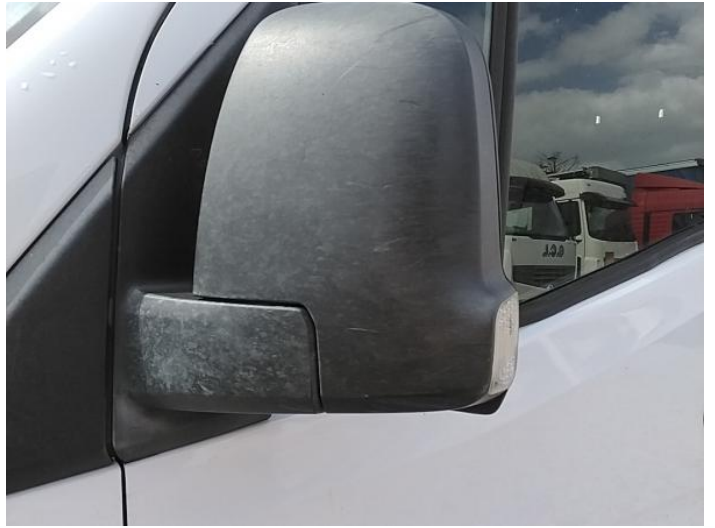
4: Door Mirror Assy nsf
Scuffed (Unpainted)
UpTo 100mm

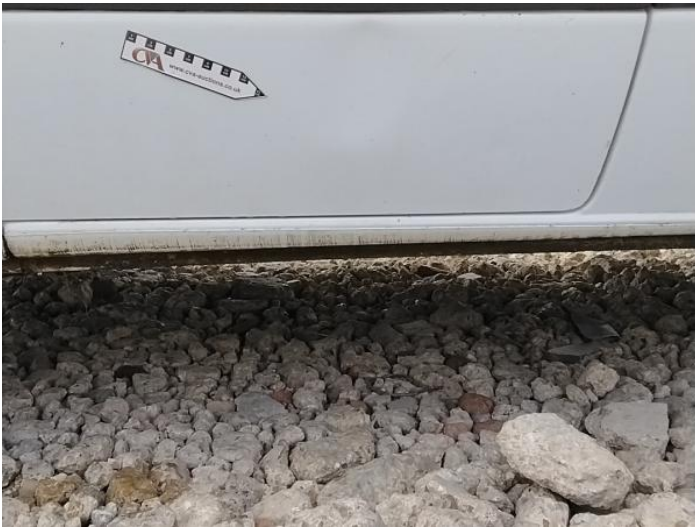
5: Door nsf
Dented
Between 10mm + 30mm

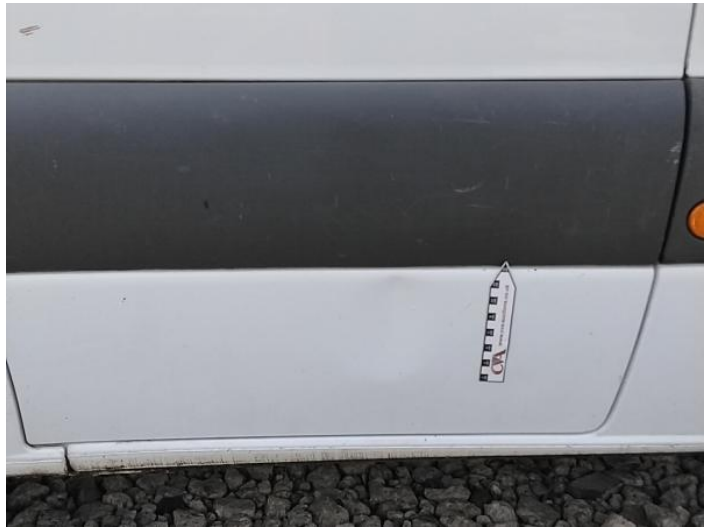
6: Door Moulding nsf
Scuffed (Unpainted)
Over 100mm

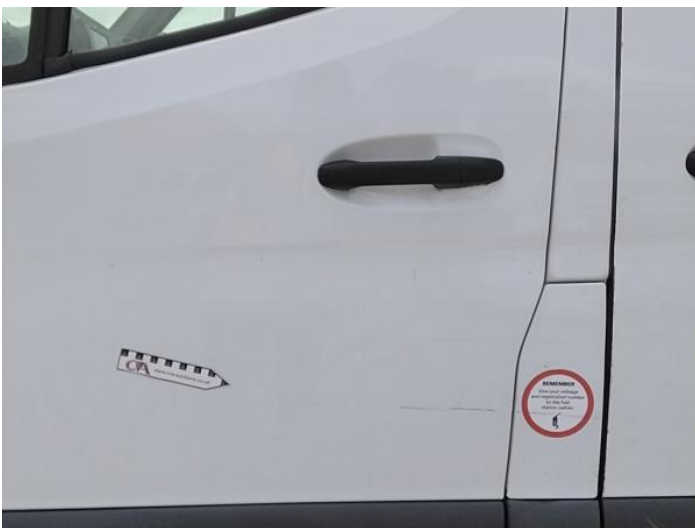
7: Door nsf
Scratched
Over 25mm Not Thru Paint

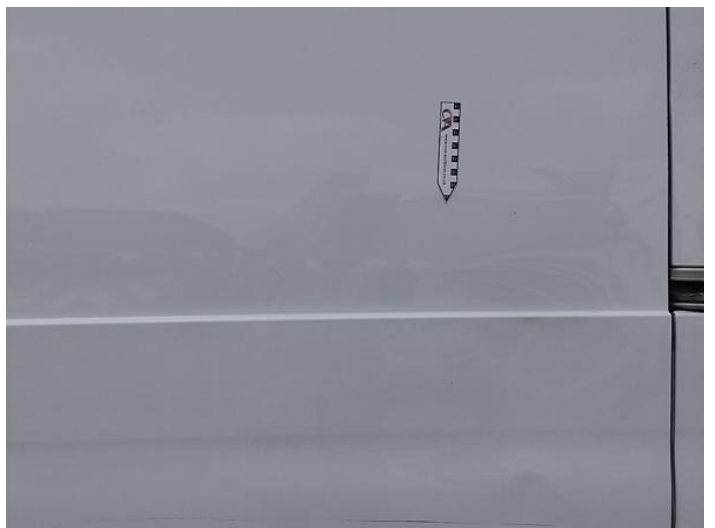
8: Door nsr
Dented
Between 10mm + 30mm

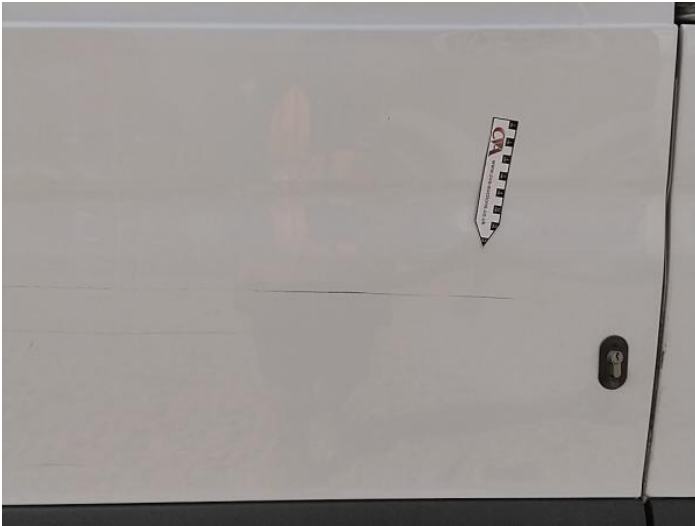
9: Door nsr
Dented
Between 10mm + 30mm

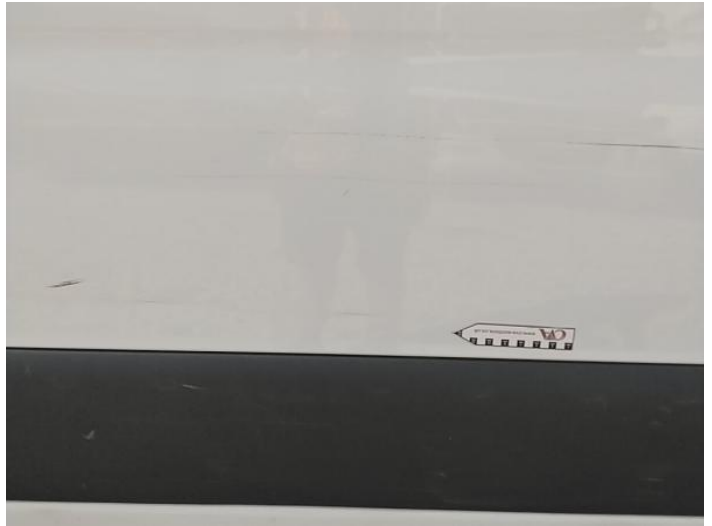
10: Door nsr
Scratched
Over 25mm Not Thru Paint

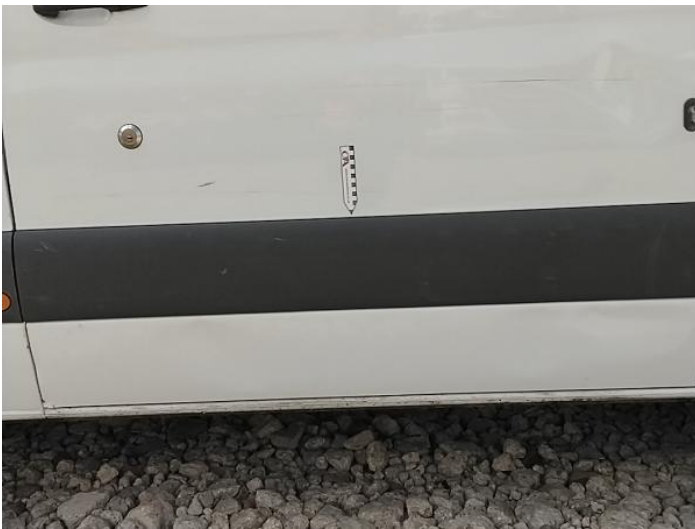
11: Door Moulding nsr
Scuffed (Unpainted)
Over 100mm

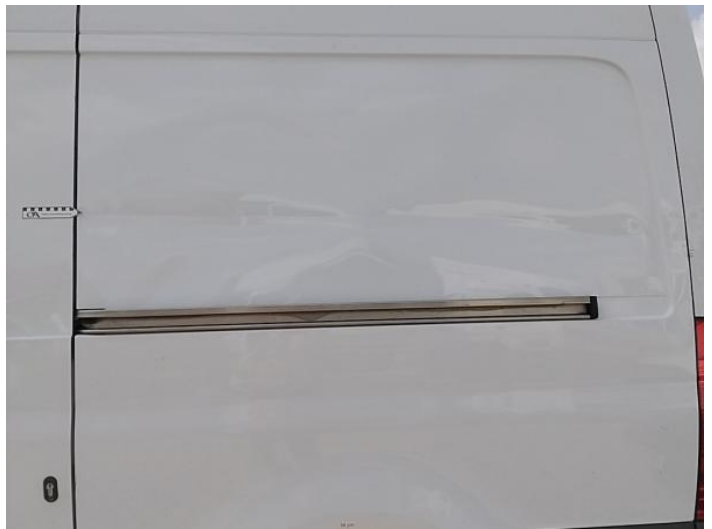
12: Qtr Panel nsr
Dented
Over 30mm

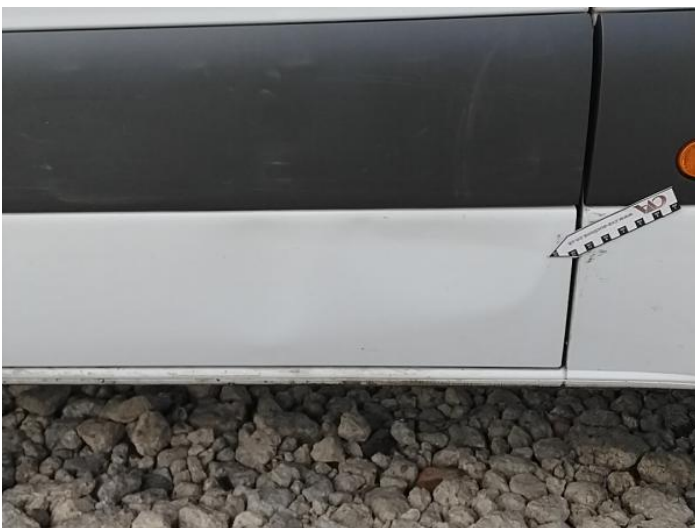
13: Door nsr
Dented
Over 30mm

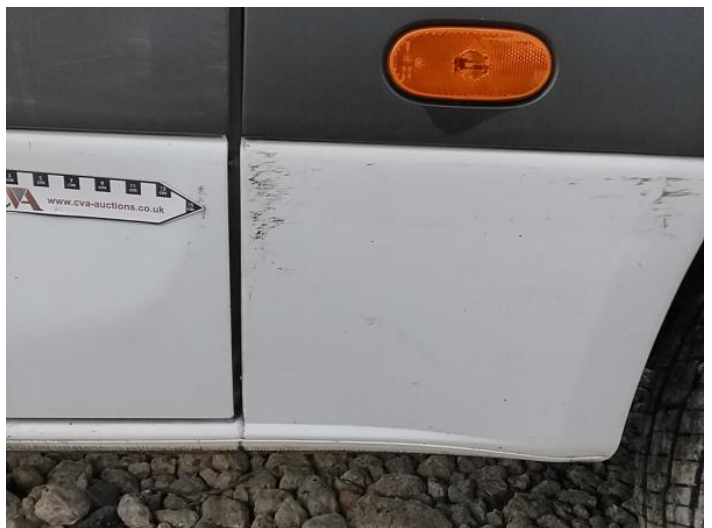
14: Qtr Panel nsr
Scratched
Over 25mm Not Thru Paint

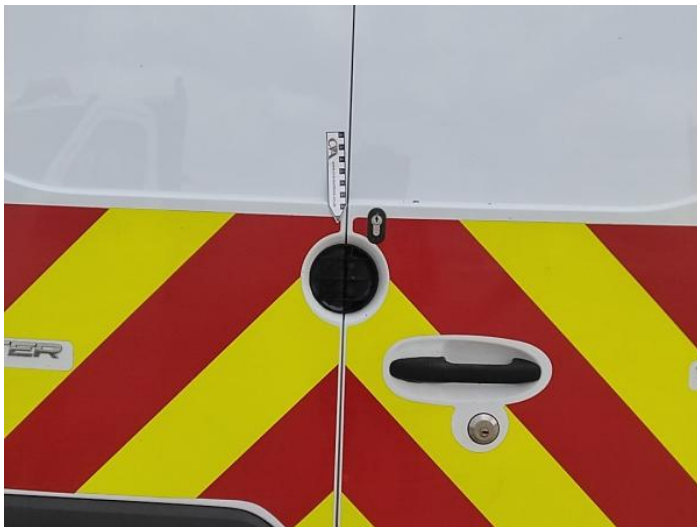
15: Badgedecal Rear
Missing
Replace

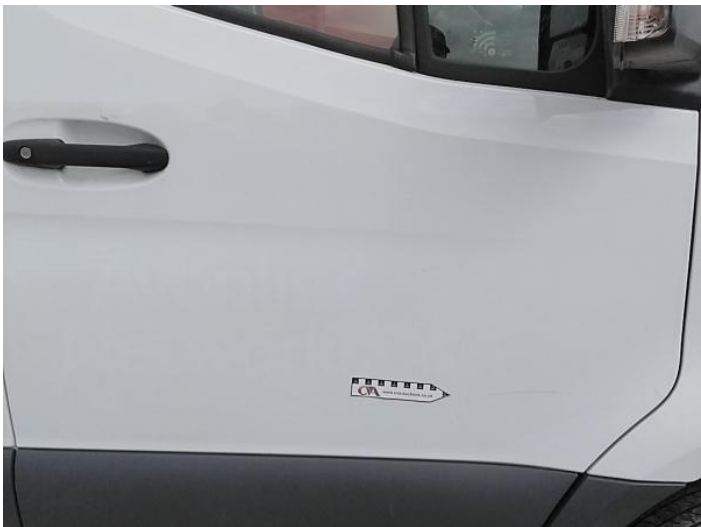
16: Door osf
Scratched
Over 25mm Not Thru Paint
