# VEHICLE INSPECTION REPORT

**PF14TZA**

## Daf LF 150

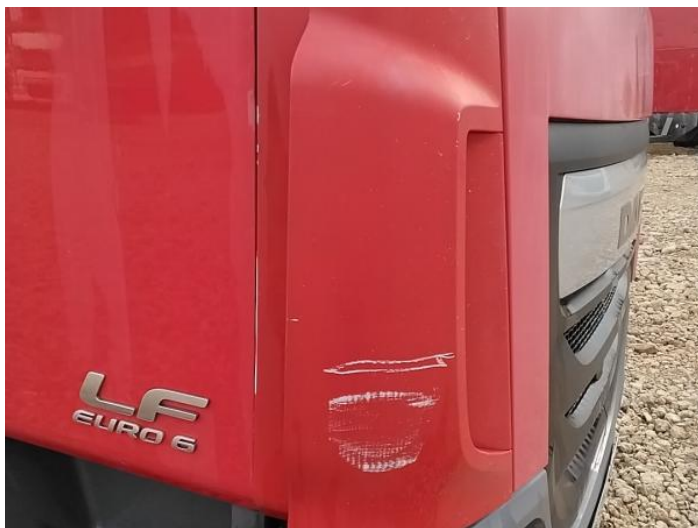
1: Wing osf  
Scratched  
Over 25mm Thru Paint

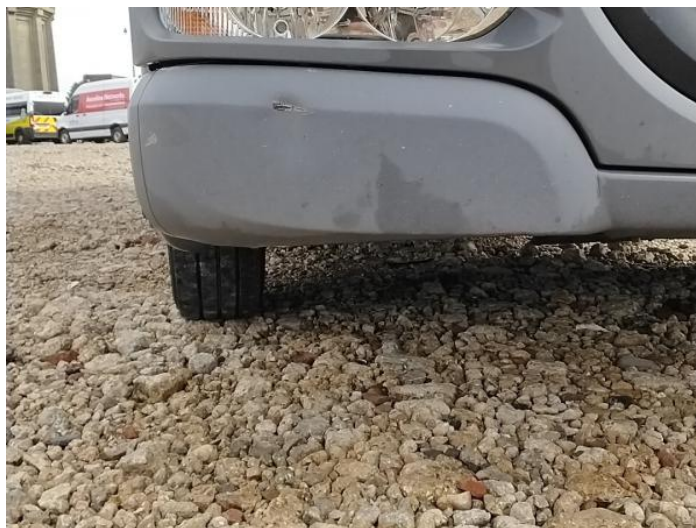
2: Bumper Front Moulding  
Scratched (Painted)  
UpTo 25mm Thru Paint

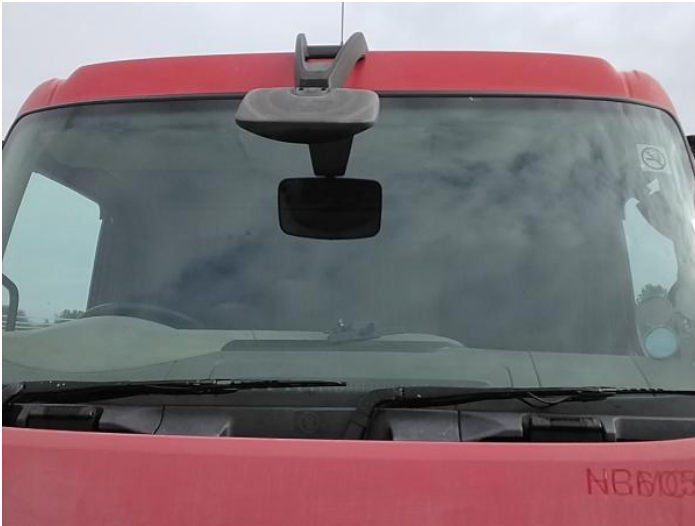
3: Screen Front  
Chipped  
Over 10mm

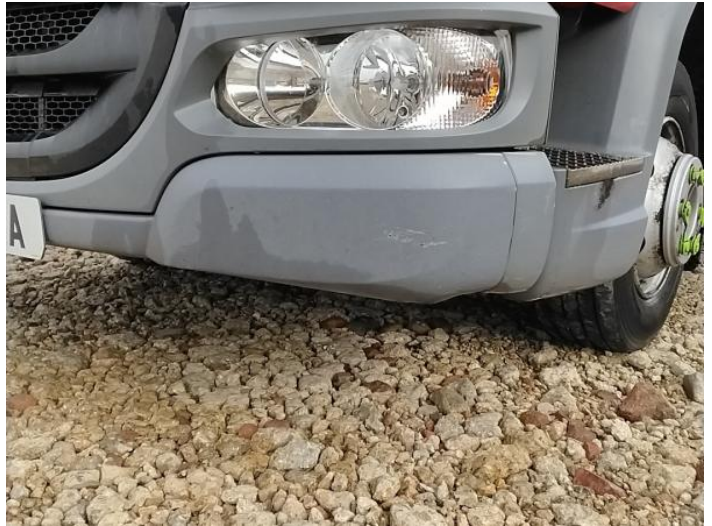
4: Bumper Front Moulding  
Scratched (Painted)  
UpTo 25mm Thru Paint

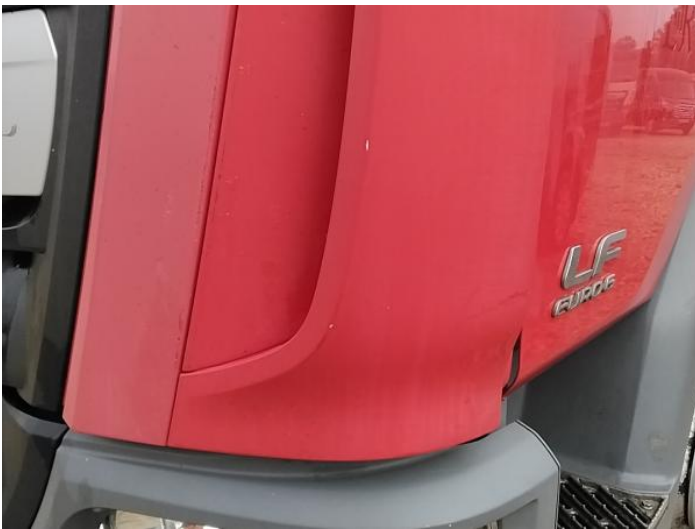
5: Wing nsf  
Scratched  
UpTo 25mm Thru Paint

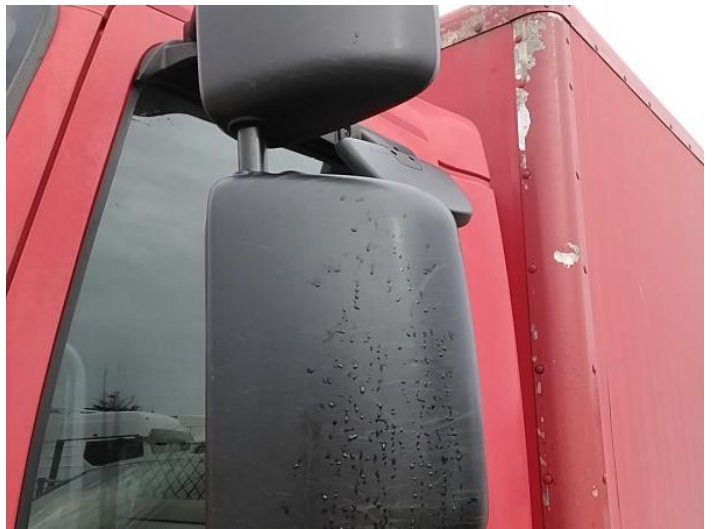
6: Door Mirror Assy nsf  
Scuffed (Unpainted)  
UpTo 100mm

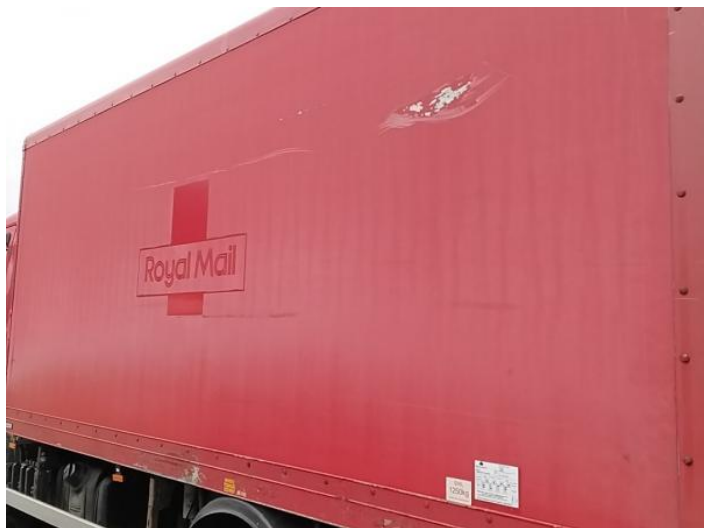
8: Qtr Panel nsr  
Scratched  
Over 25mm Thru Paint

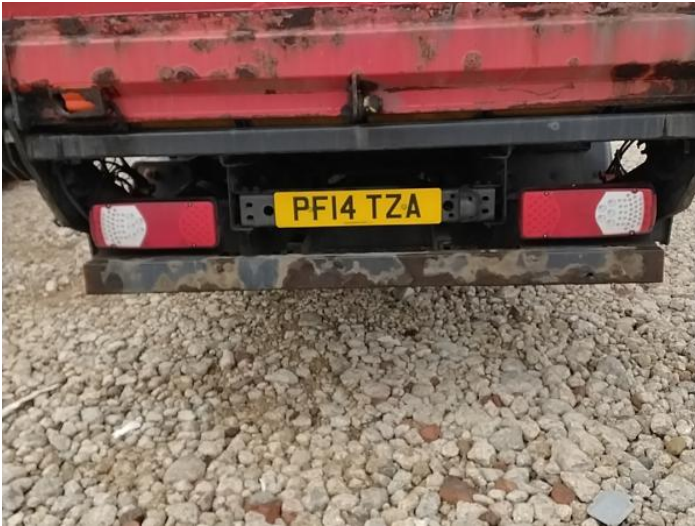
9: Bumper Rear  
Rusted  
Over 5mm

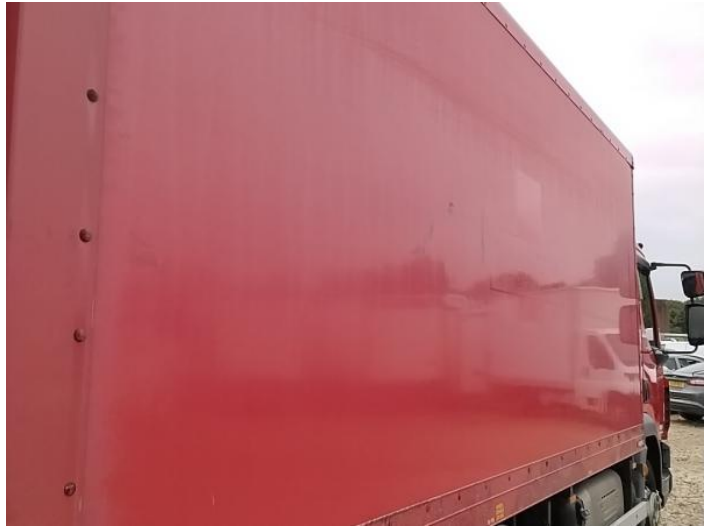
10: Qtr Panel osr  
Scratched  
Over 25mm Not Thru Paint

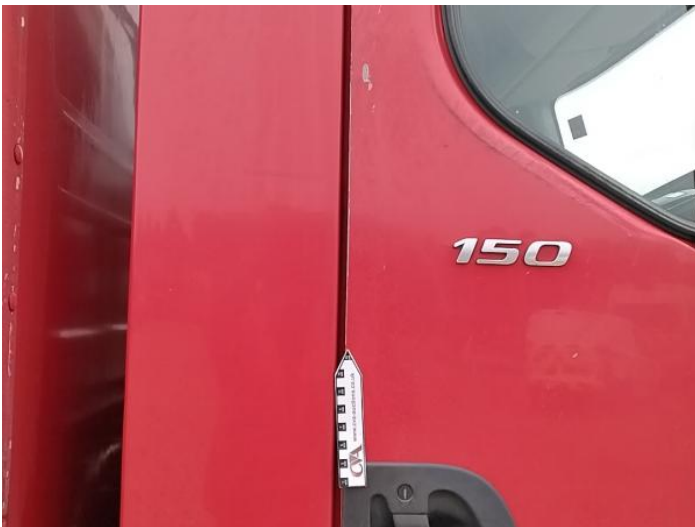
11: Door osf  
Chipped  
Edge Chip

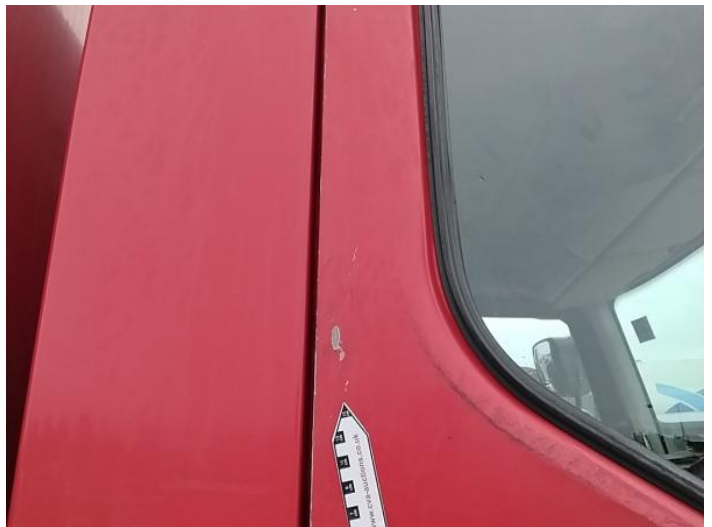
12: Door osf  
Scratched  
UpTo 25mm Thru Paint

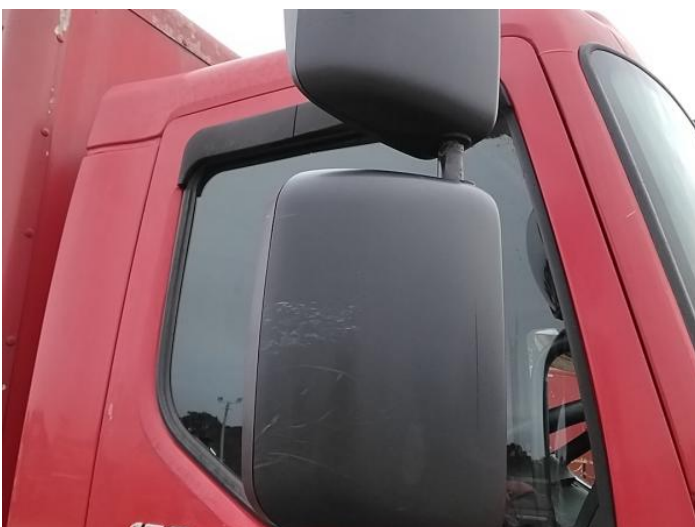
13: Door Mirror Assy osf  
Scuffed (Unpainted)  
Over 100mm

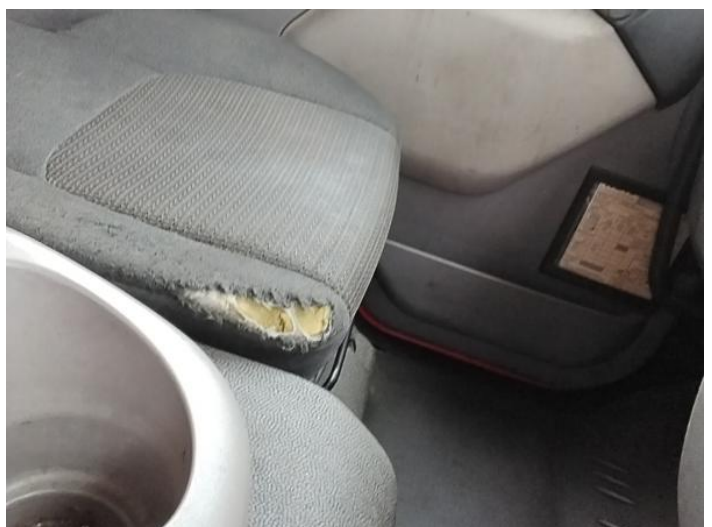
14: Seat Base Cover nsf  
Holed  
Over 3mm
