VEHICLE INSPECTION REPORT

PF66KKJ

Daf CF 440

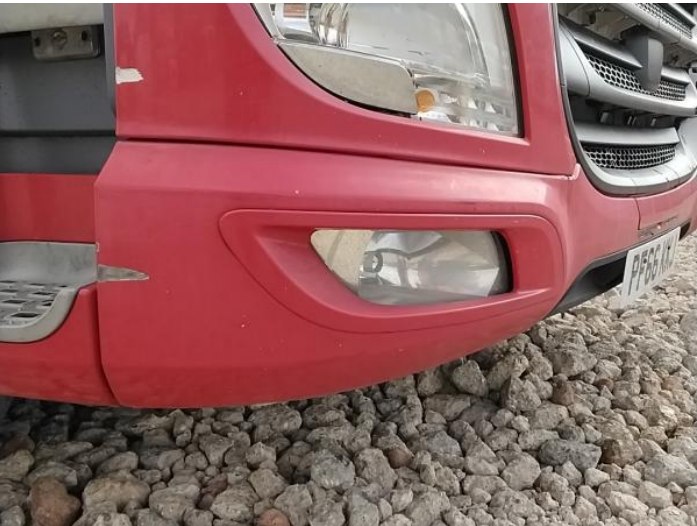
1: Bumper Front Moulding
Scratched (Painted)
UpTo 25mm Thru Paint

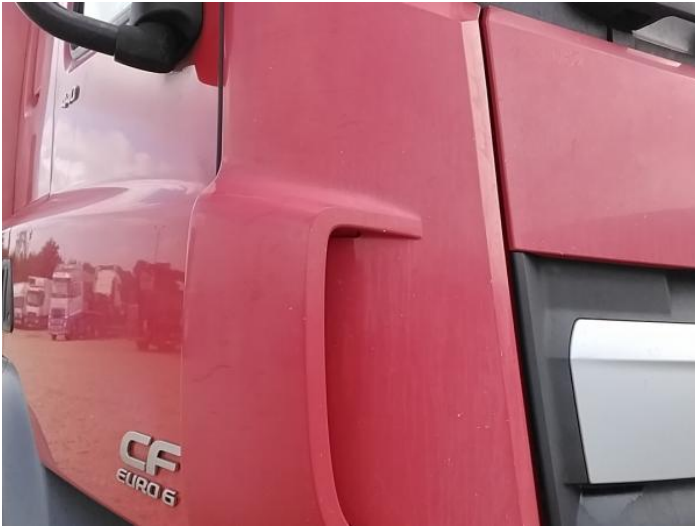
3: Wing osf
Chipped
Multiple Chips

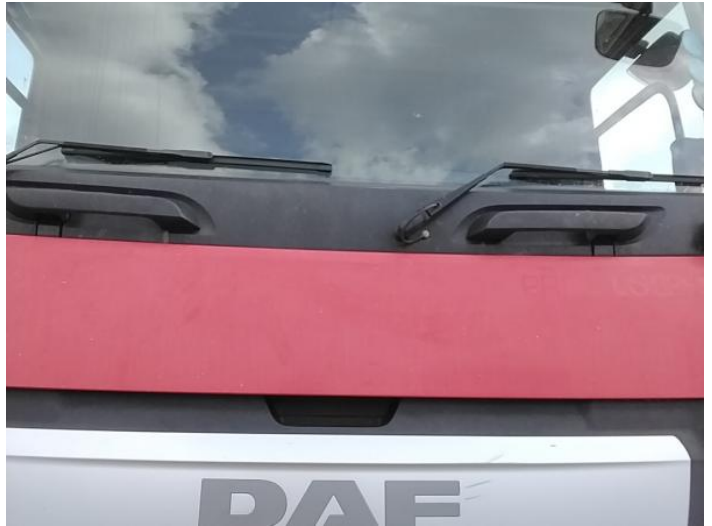
4: Bonnet
Chipped
Multiple Chips

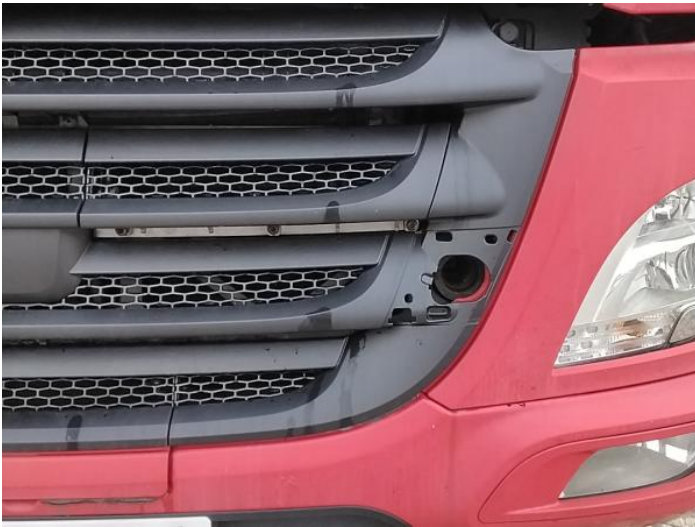
5: Front TowEye Cvr
Missing
Replace

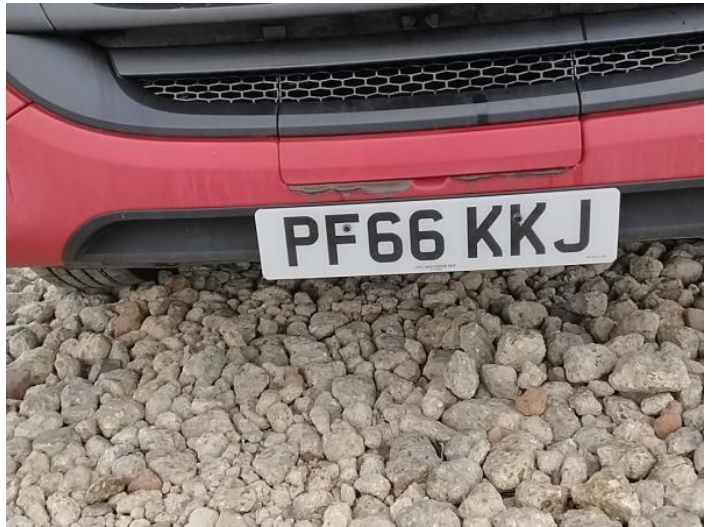
6: Bumper Front
Rusted
Over 5mm

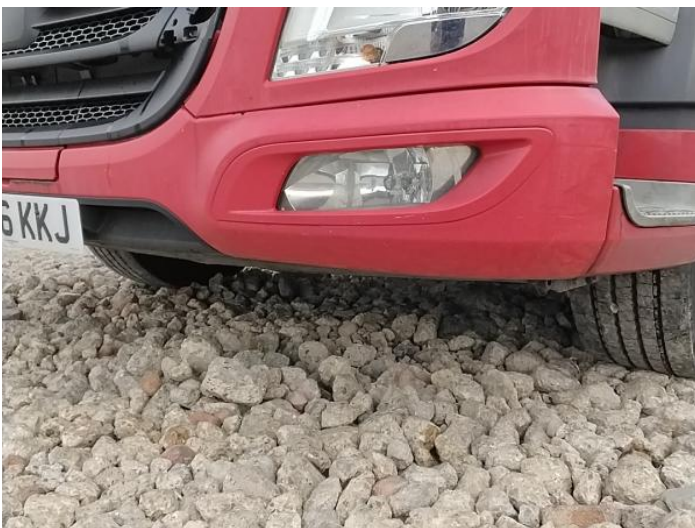
7: Bumper Front Moulding
Scratched (Painted)
UpTo 25mm Thru Paint

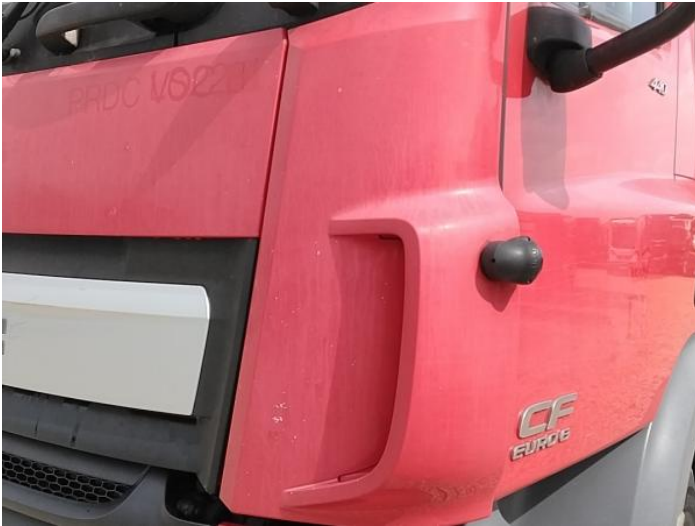
9: Wing nsf
Chipped
Multiple Chips

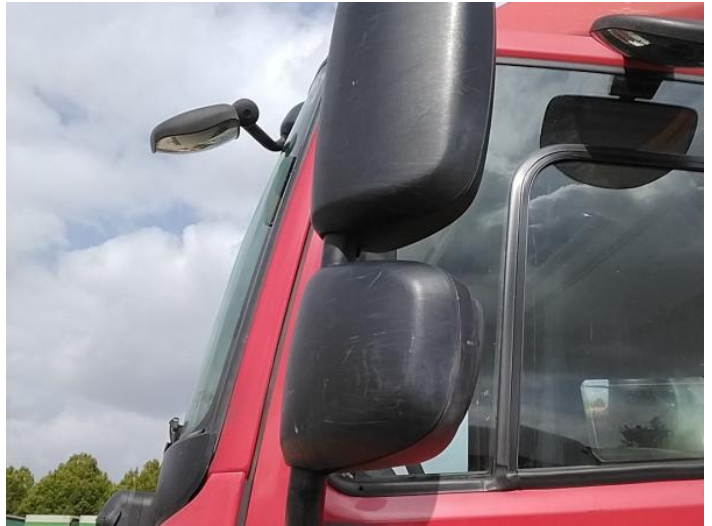
10: Door Mirror Assy nsf
Scuffed (Unpainted)
UpTo 100mm

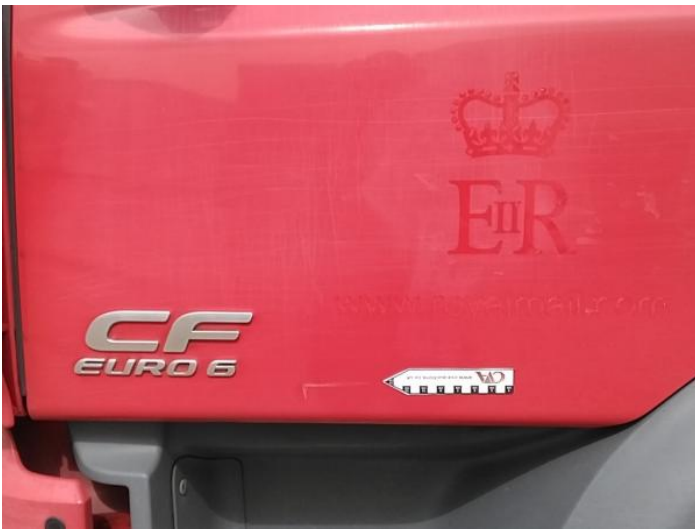
11: Door nsf
Scratched
UpTo 25mm Thru Paint

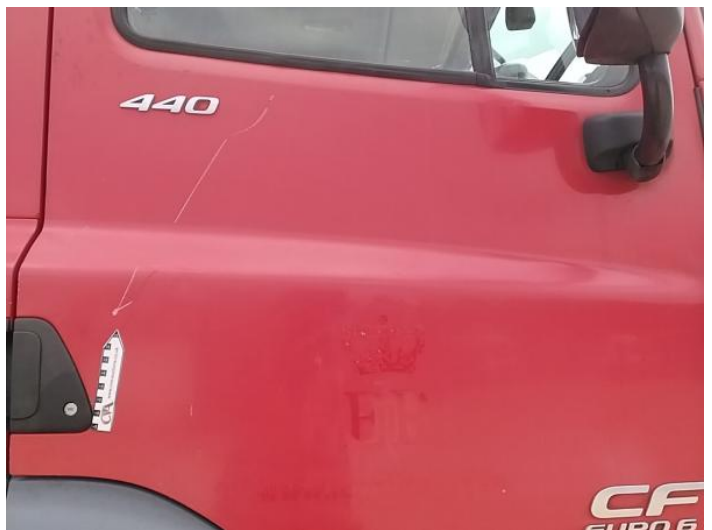
14: Door osf
Scratched
Over 25mm Thru Paint

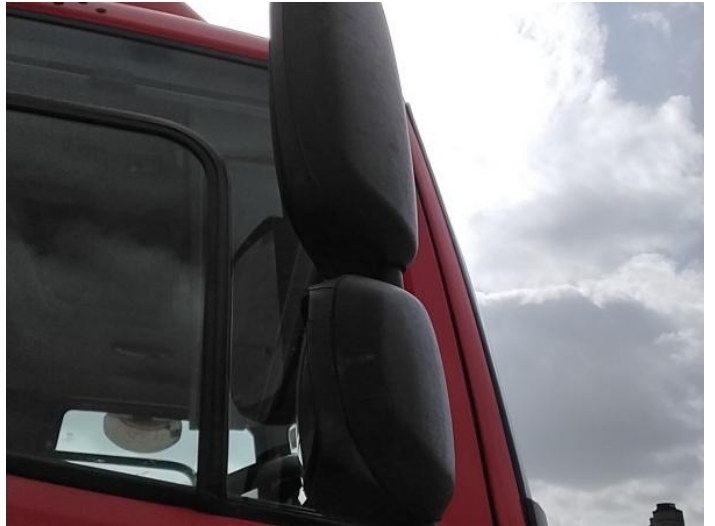
16: Door Mirror Assy osf
Broken
Replace
