# VEHICLE INSPECTION REPORT

**DV73PVF**

## Vauxhall Vivaro 3100 2.0 D 145PS

**Non Runner  
Inspection**

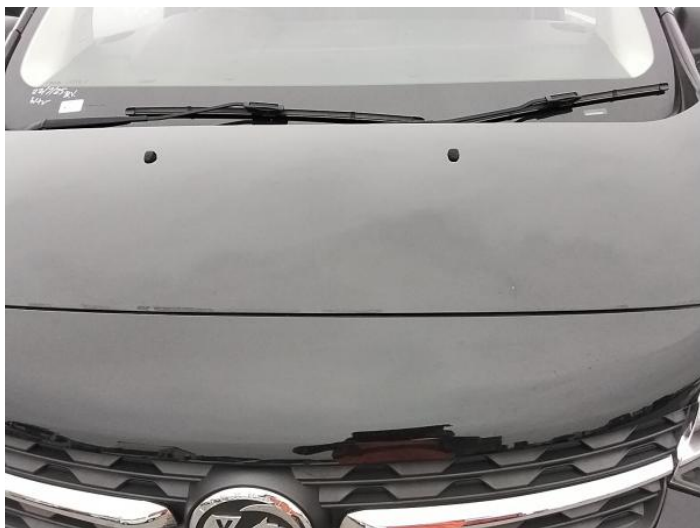
1: Bonnet  
Chipped  
Multiple Chips

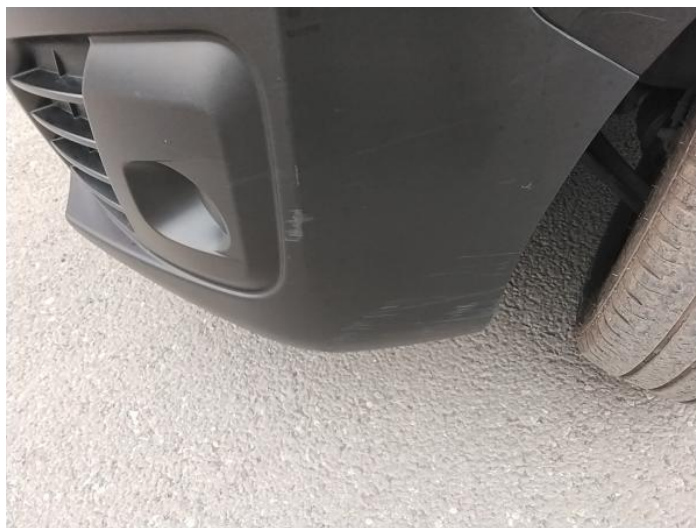
2: Bumper Front  
Scratched  
Over 100mm Thru Paint

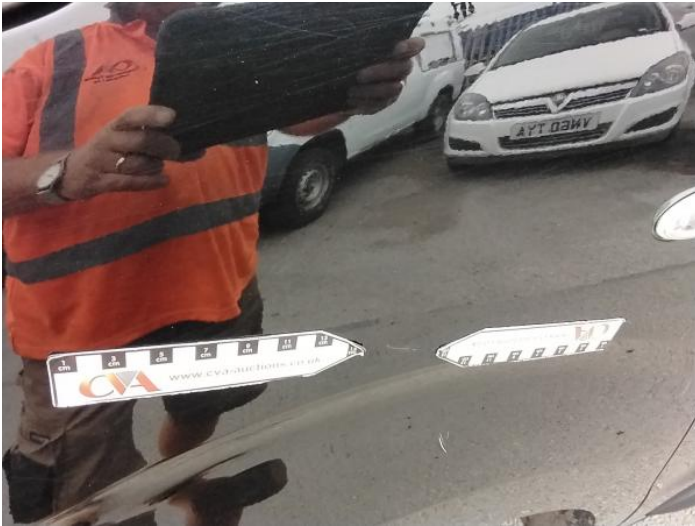
3: Wing nsf  
Dented  
With Paint Damage

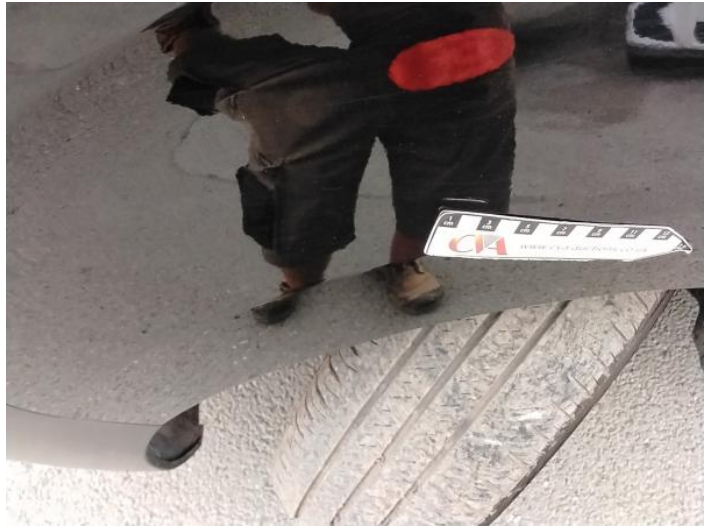
4: Wing nsf  
Scratched  
Over 25mm Thru Paint

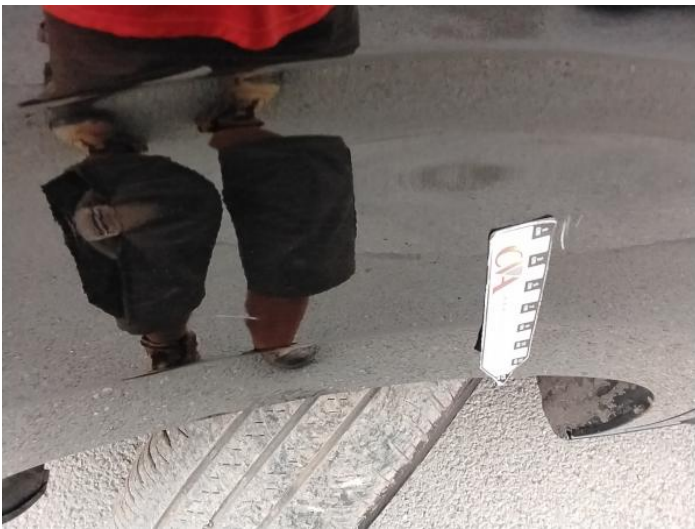
5: Wing nsf  
Scratched  
Over 25mm Thru Paint

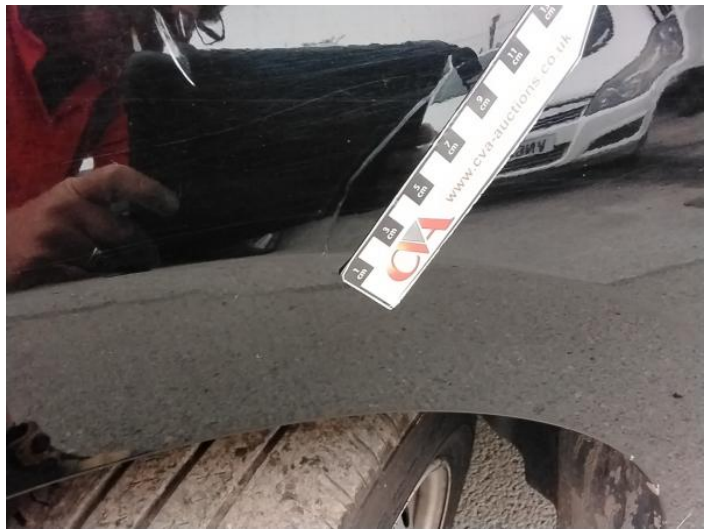
6: Wing nsf  
Scratched  
Over 25mm Not Thru Paint

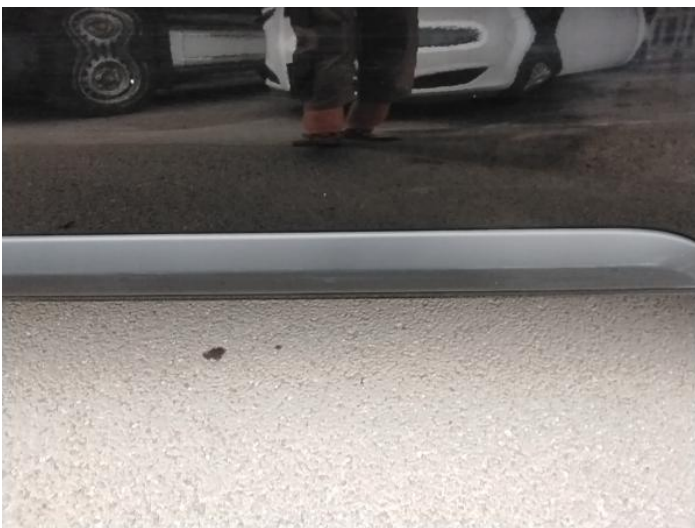
7: Qtr Panel Moulding ns  
Scuffed (Unpainted)  
Over 100mm

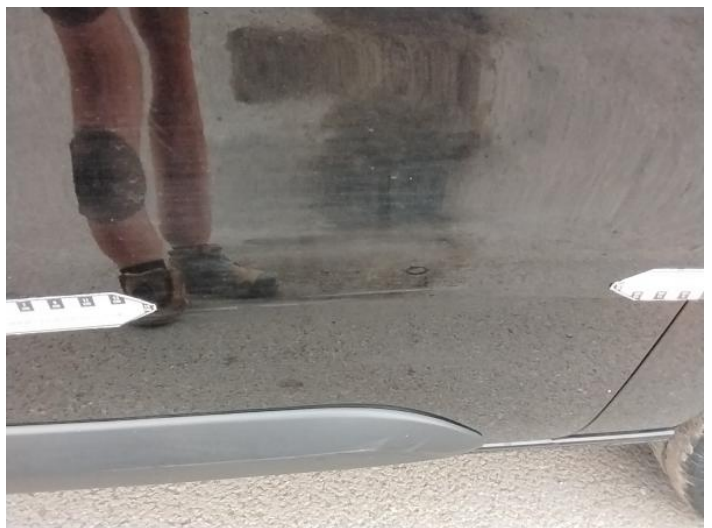
8: Qtr Panel nsr  
Dented  
With Paint Damage

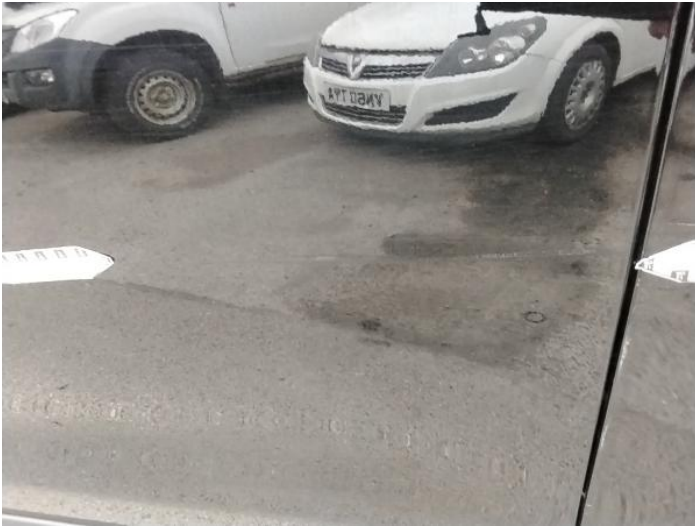
9: Qtr Panel nsr  
Dented  
With Paint Damage

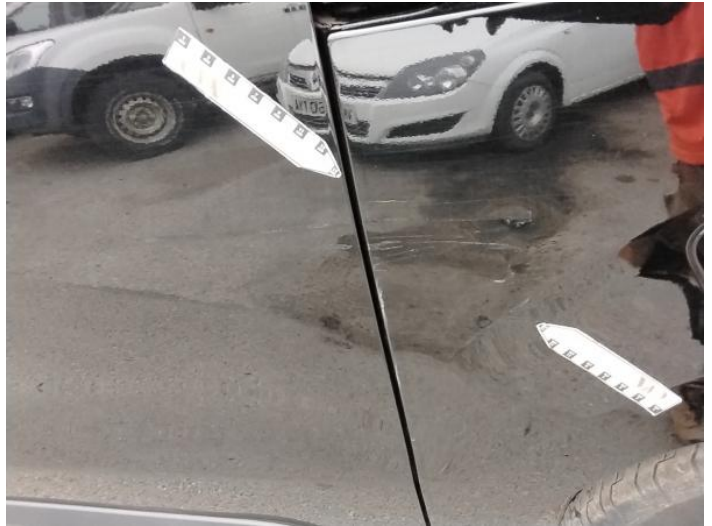
10: Qtr Panel nsr  
Dented  
With Paint Damage

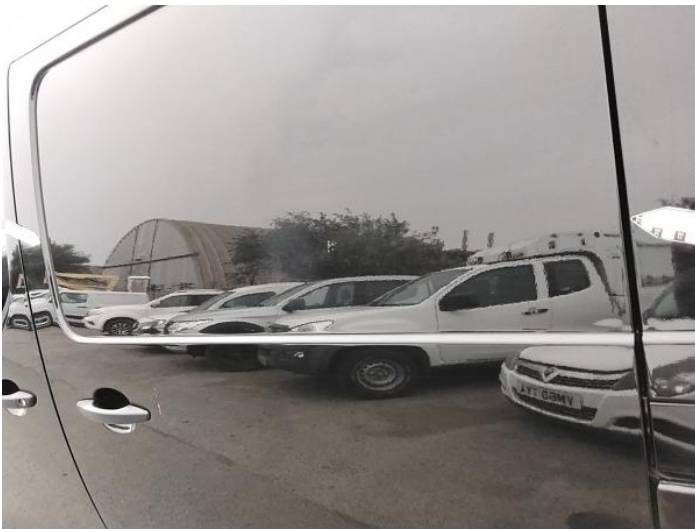
11: Qtr Panel nsr  
Scratched  
Over 25mm Not Thru Paint

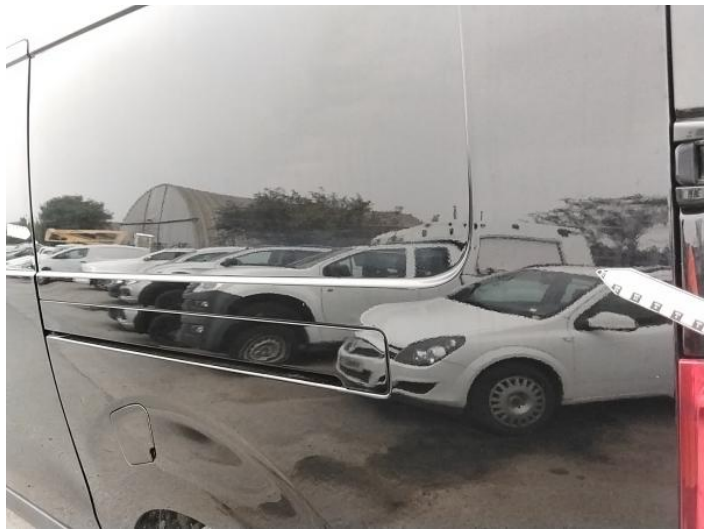
12: Qtr Panel nsr  
Scratched  
Over 25mm Not Thru Paint

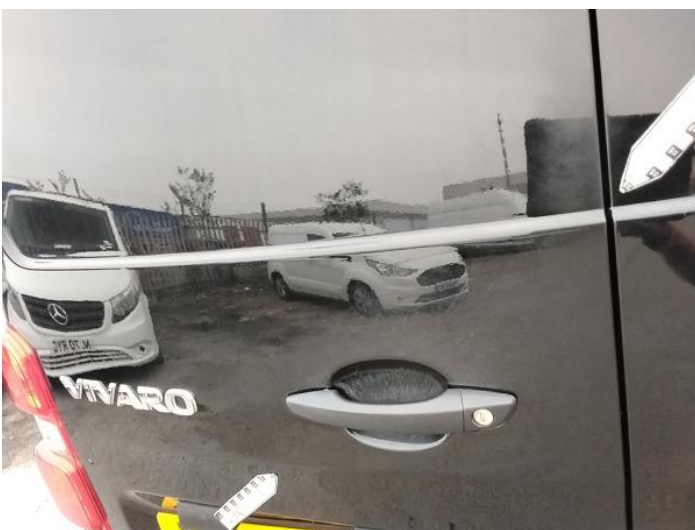
13: Door nsr  
Scratched  
Over 25mm Thru Paint

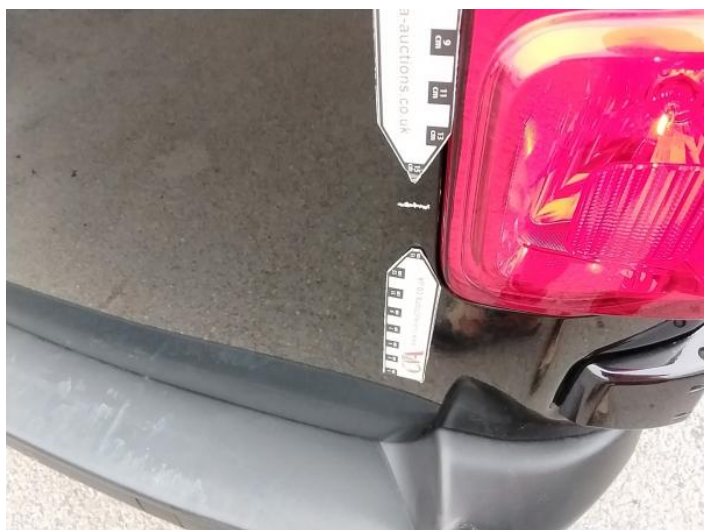
14: Door osr  
Dented  
With Paint Damage

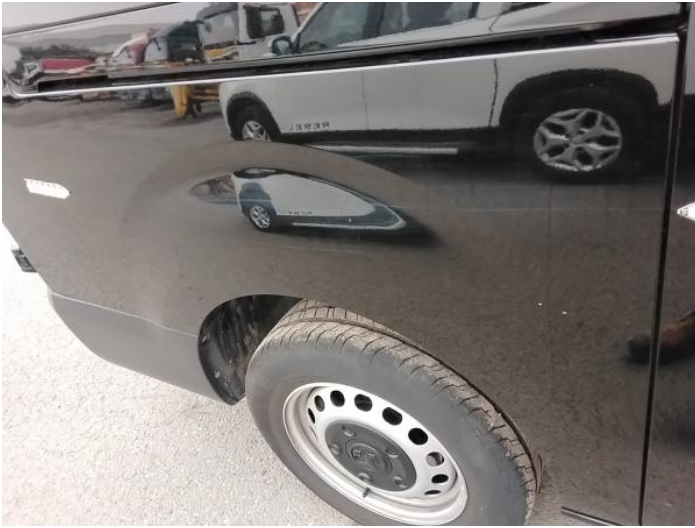
15: Qtr Panel osr  
Scratched  
Over 25mm Thru Paint

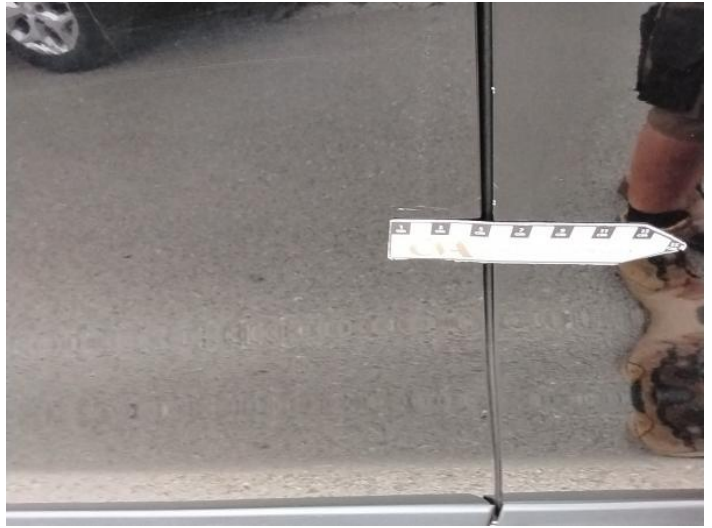
16: Qtr Panel osr  
Scratched  
Over 25mm Thru Paint

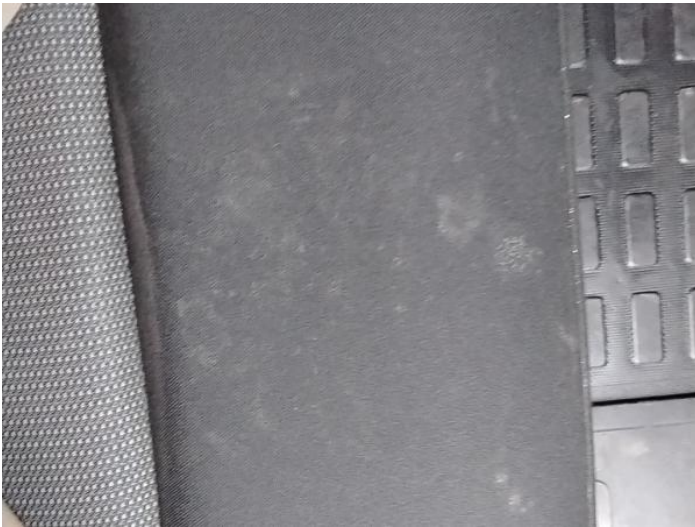
17: Seat Base Cover osf  
Soiled  
Light

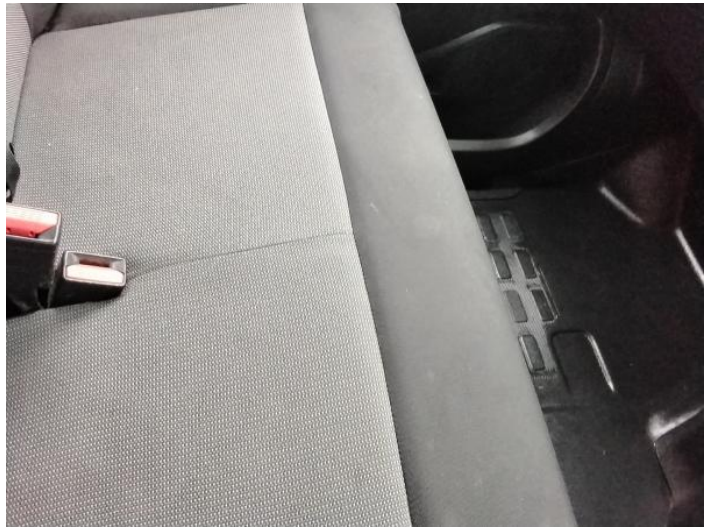
18: Seat Base Cover nsf  
Soiled  
Light

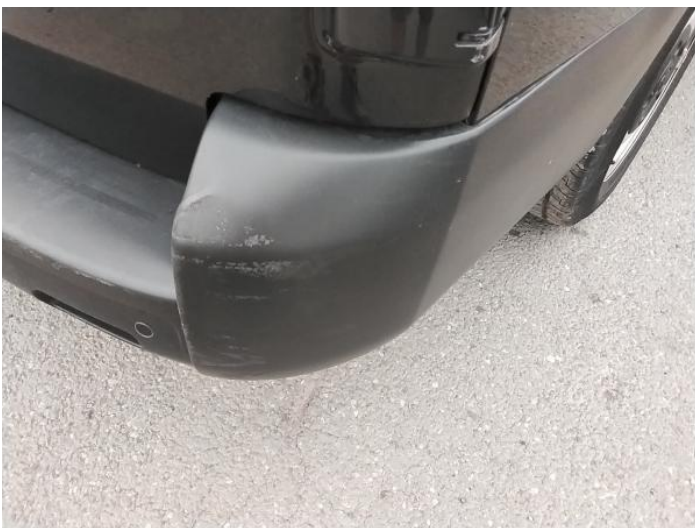
19: Qtr Panel Moulding os  
Scuffed (Unpainted)  
Over 100mm

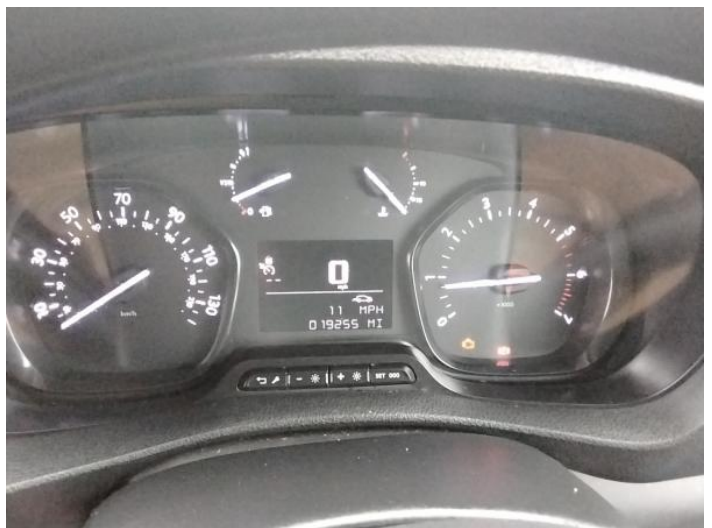
\*WARNING LIGHT ON DASH\* AD-BLUE, TWIN SIDE LOAD DOOR, E/ MIRRORS

20: Dash Warning Lights  
Displayed  
No Action

Carpet Condition	OK	Upholstery Condition	OK
Seat Condition	Average	Odour	-
Engine Runs	OK	No Excessive Smoking	OK
EML light illuminated	Fault	DPF light illuminated	OK
ABS light illuminated	OK
