VEHICLE INSPECTION REPORT

KX16FFD

Volvo FH 460

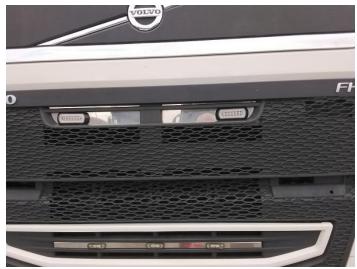
1: Bonnet Chipped Multiple Chips

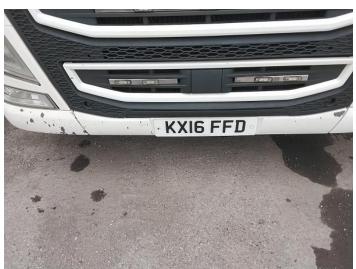
2: Bumper Front Chipped Multiple Chips

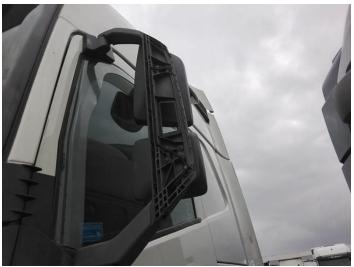
3: Door Moulding nsf Missing Replace

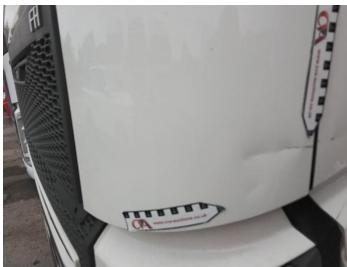
4: Bonnet Dented With Paint Damage

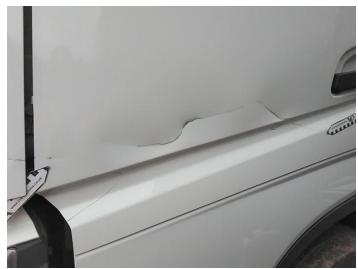
5: Door nsf Dented With Paint Damage

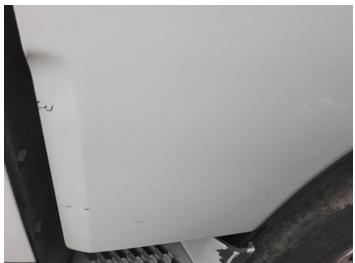
6: Door nsf Scratched Over 25mm Thru Paint

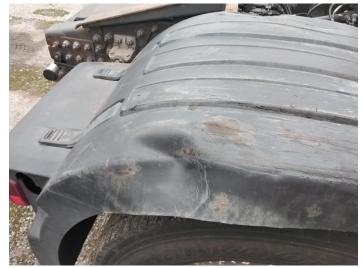
7: Qtr Panel Moulding os Scuffed (Unpainted) Over 100mm

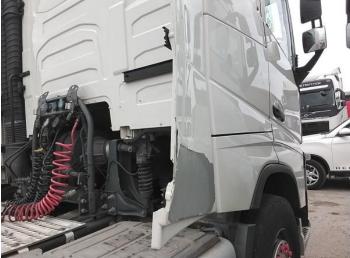
8: Qtr Panel Trim os Broken Replace

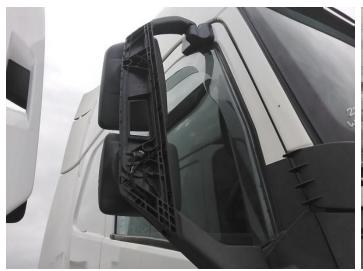
9: Door Moulding osf Missing Replace

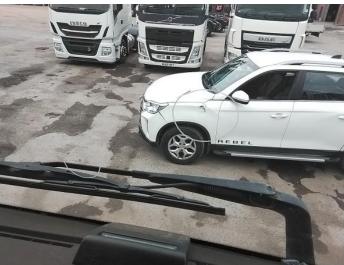
10: Screen Front Chipped Over 10mm

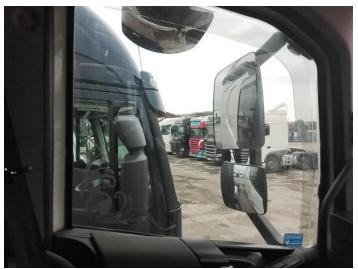
11: Door Window nsf Scratched Over 30mm

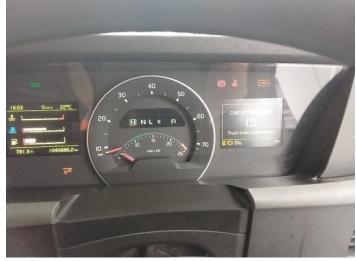
WARNING LIGHT ON DASH

13: Dash Warning Lights Displayed No Action
