VEHICLE INSPECTION REPORT

DK17LJL

Man TGM 18.250

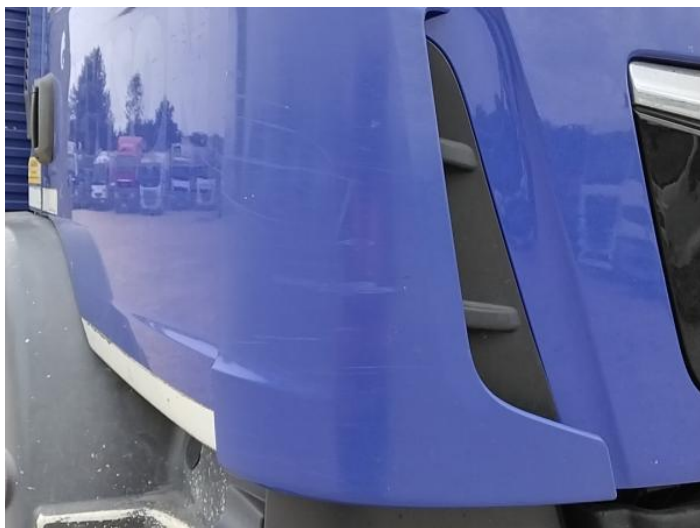
1: Wing osf
Scratched
Over 25mm Not Thru Paint

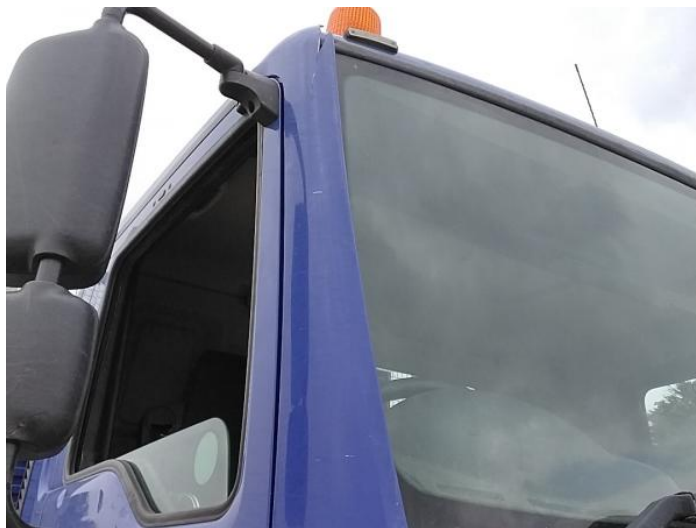
2: A Post os
Cracked
Replace

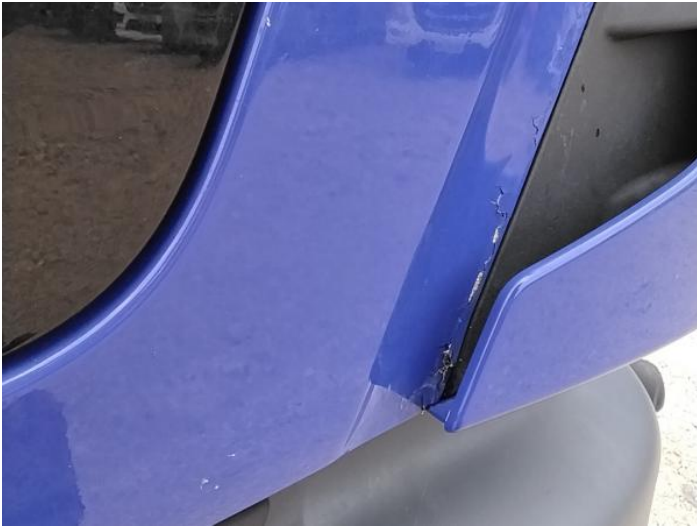
3: Bonnet
Cracked
Replace

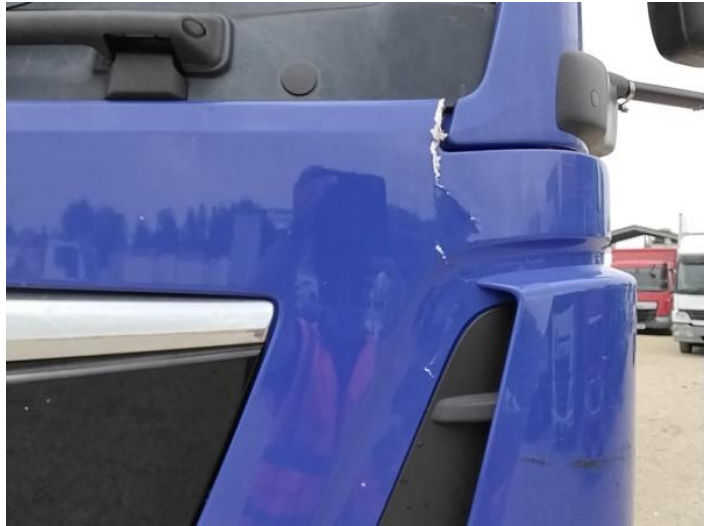
4: Bonnet
Cracked
Replace

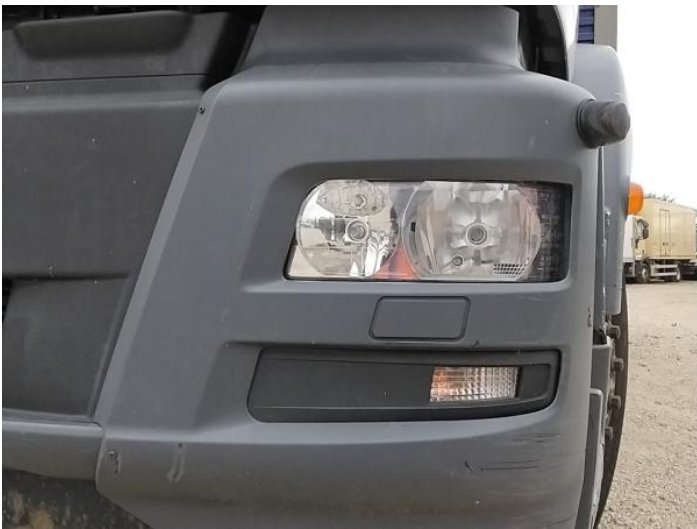
5: Fog Lamp Surround ns
Scuffed (Unpainted)
Over 100mm

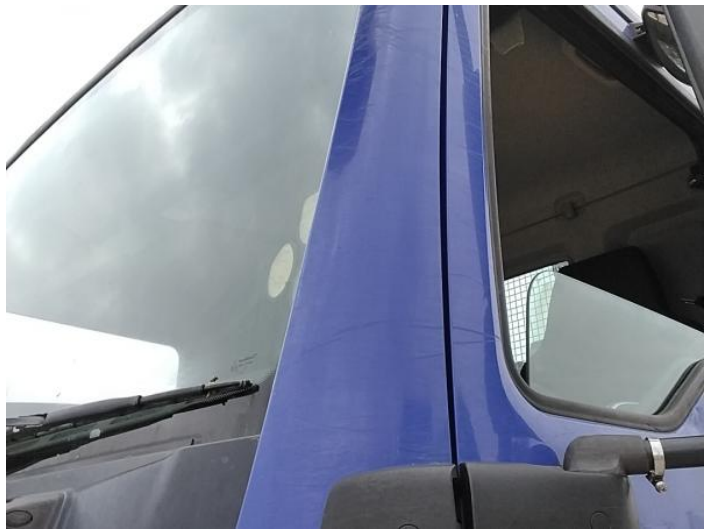
6: A Post ns
Scratched
Over 25mm Not Thru Paint

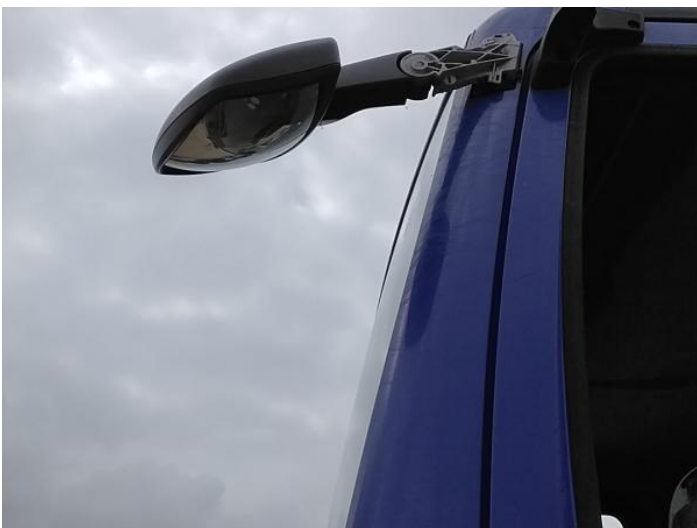
7: Door Mirror Assy nsf
Missing
Replace

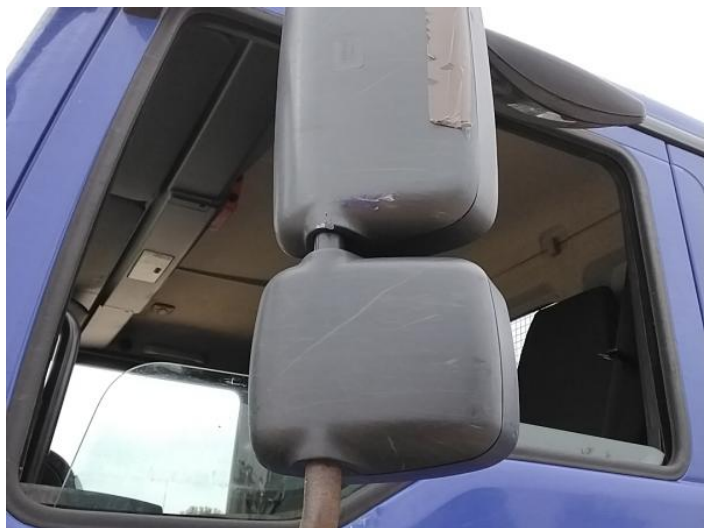
8: Door Mirror Assy nsf
Scuffed (Unpainted)
Over 100mm

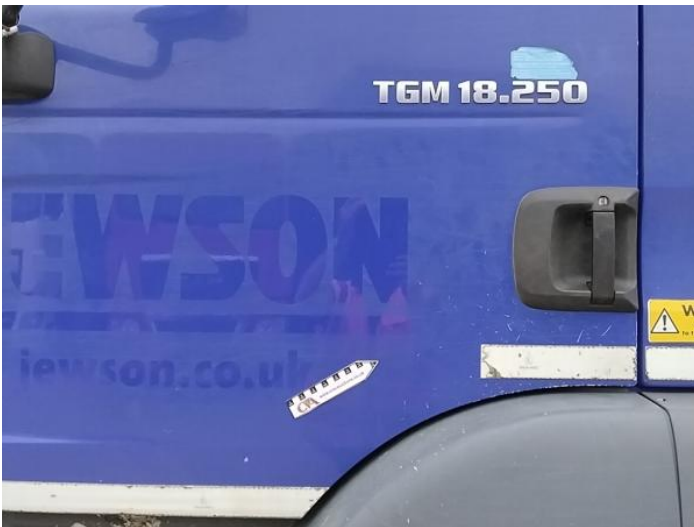
9: Door nsf
Scratched
Over 25mm Thru Paint

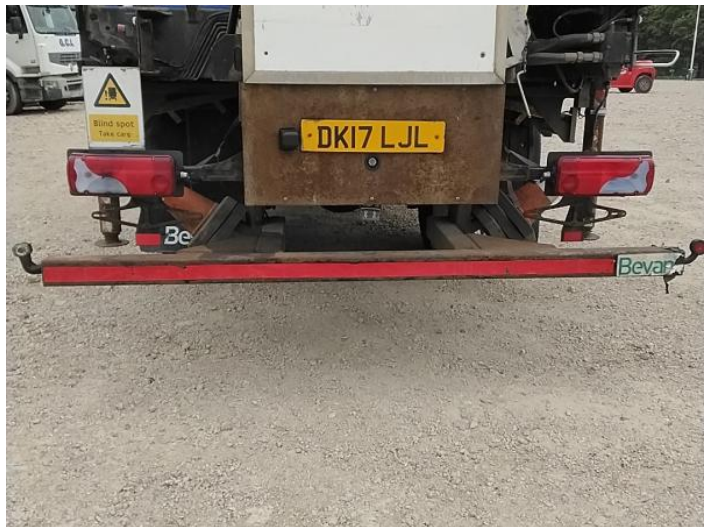
12: Bumper Rear
Rusted
Over 5mm

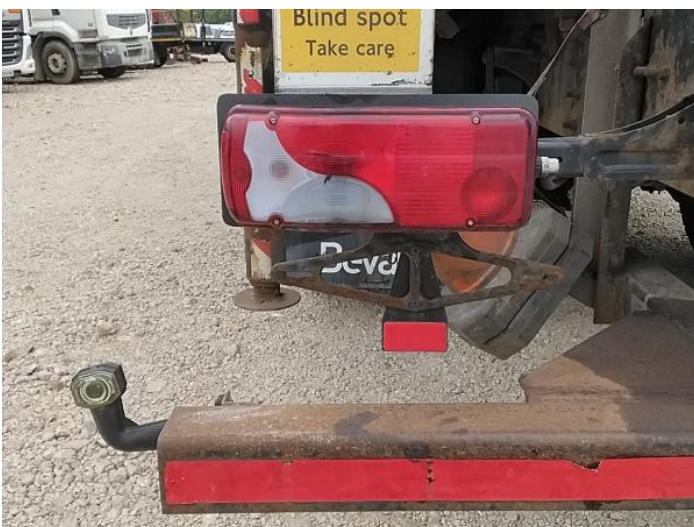
13: Lamp nsr
Broken
Replace

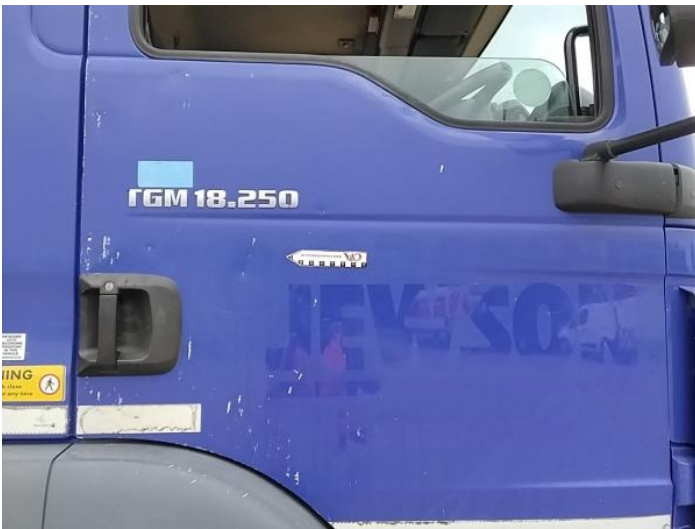
15: Door osf
Dented
Over 2 UpTo 10mm

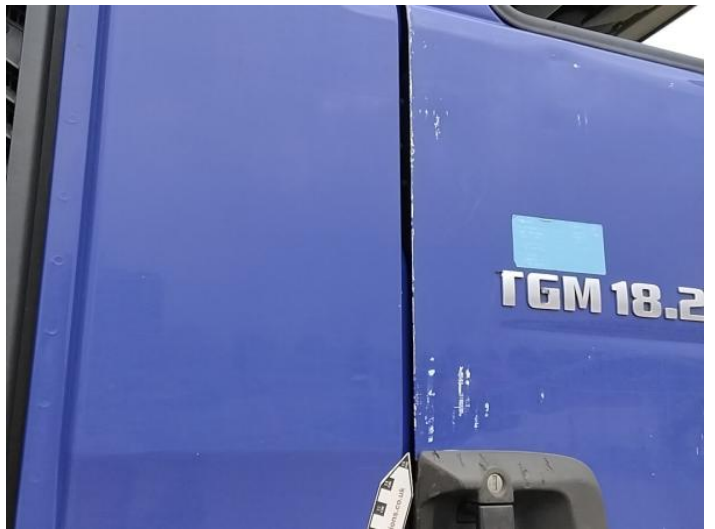
16: Door osf
Chipped
Edge Chip

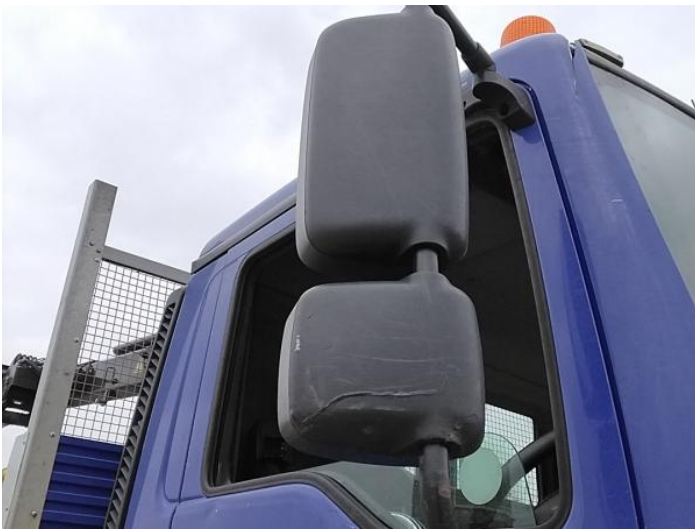
17: Door Mirror Assy osf
Scuffed (Unpainted)
UpTo 100mm

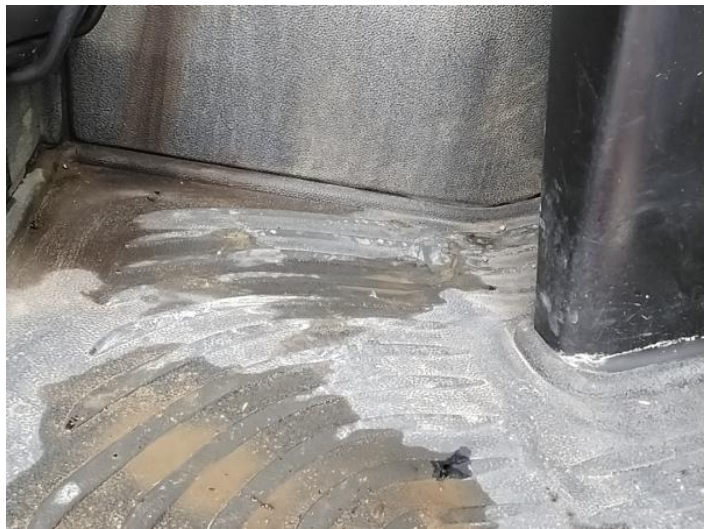
18: Carpets Front
Holed
Over 3mm

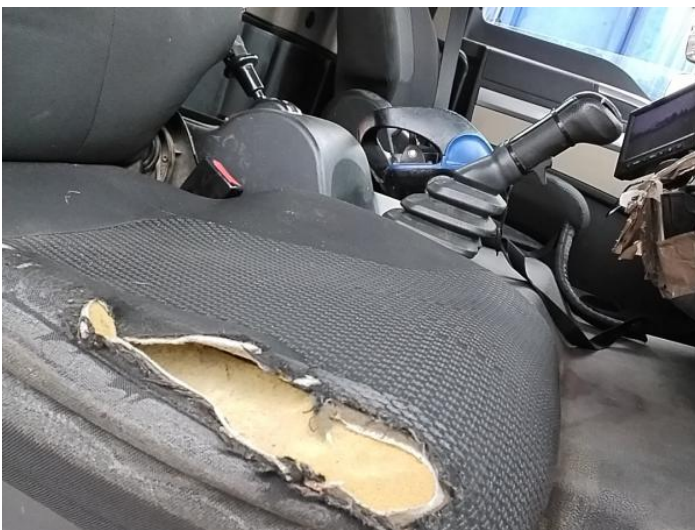
19: Seat Base Cover osf
Holed
Over 3mm

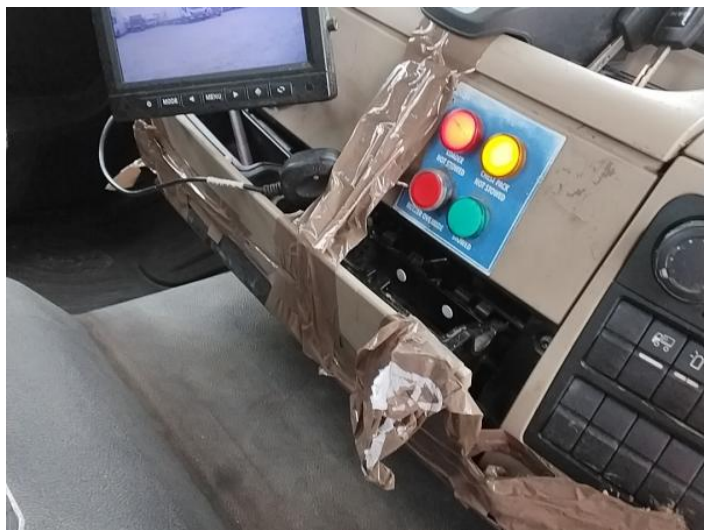
20: Centre Console Front
Broken
Replace

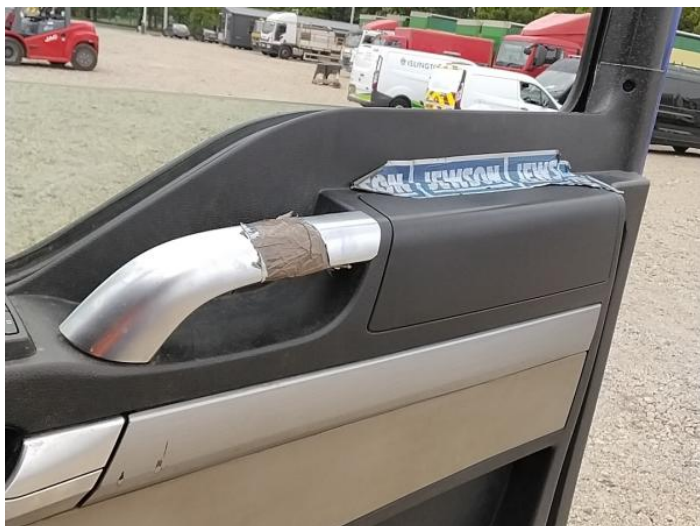
21: Door Pad osf
Broken
Replace

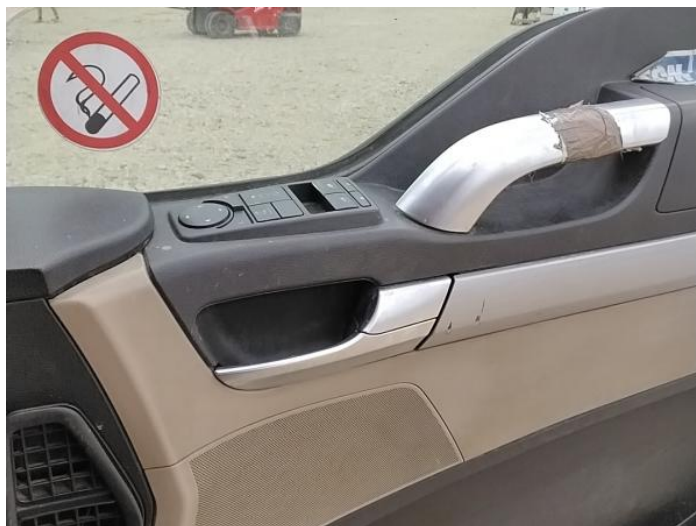
22: Handle Inner osf
Damaged
Replace
