VEHICLE INSPECTION REPORT

DK17LYH

Man TGM 18.250

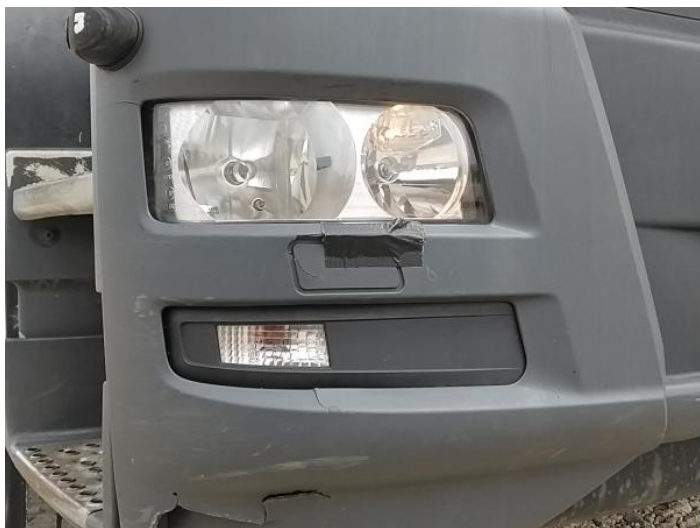
1: Fog Lamp Surround is
Broken
Replace

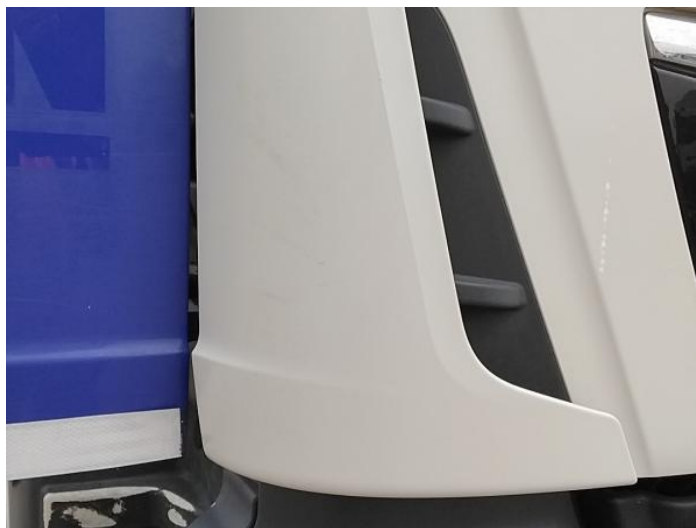
2: Wing is
Scratched
Up To 25mm Not Thru Paint

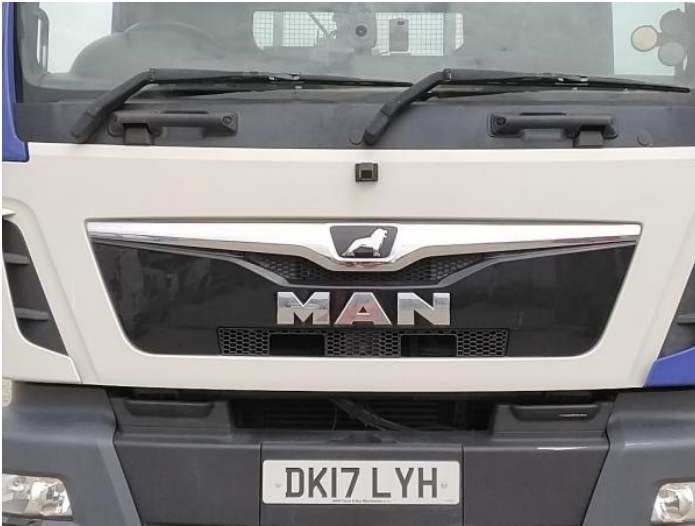
3: Bonnet
Scratched
UpTo 25mm Not Thru Paint

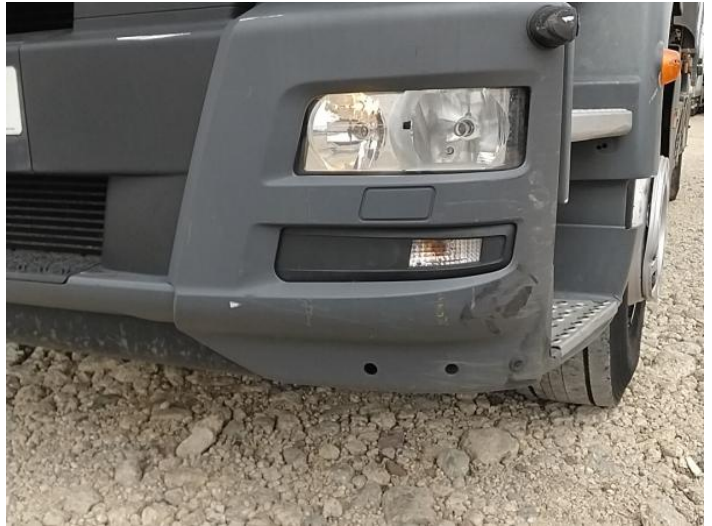
4: Fog Lamp Surround ns
Scuffed (Unpainted)
Over 100mm

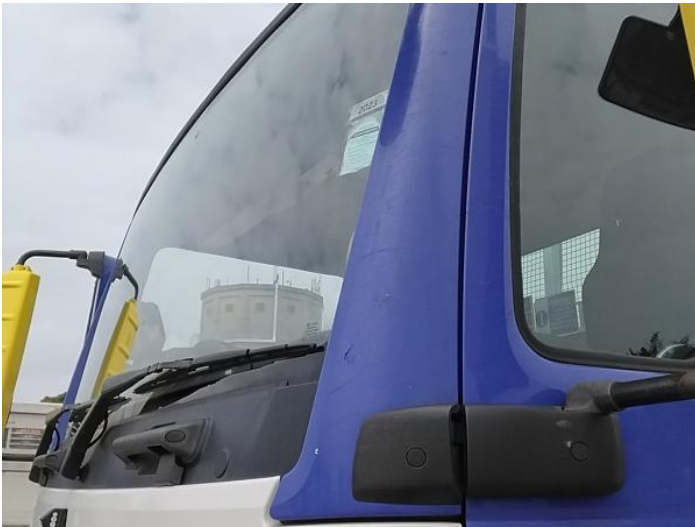
5: A Post ns
Cracked
Replace

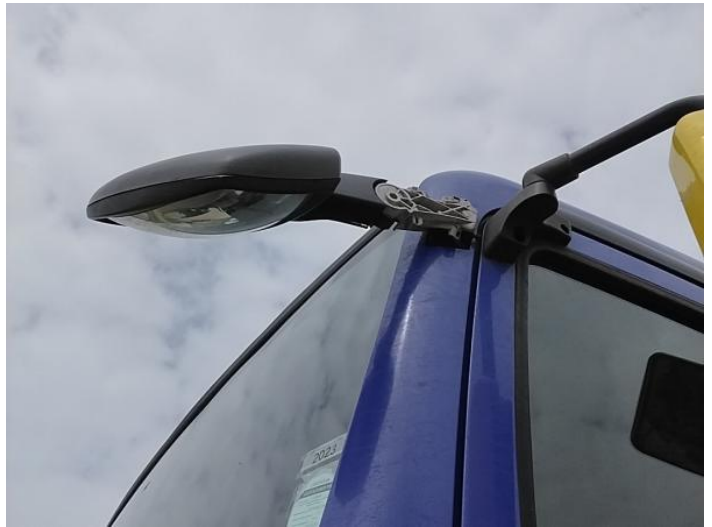
6: Door Mirror Assy nsf
Missing
Replace

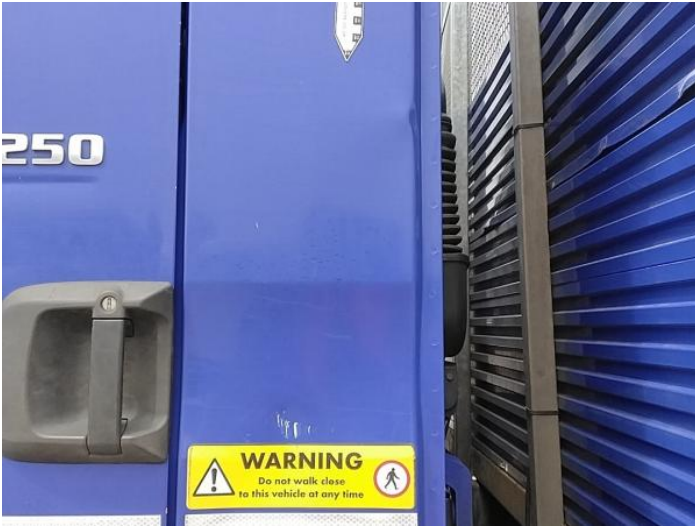
9: B Post ns
Dented
With Paint Damage

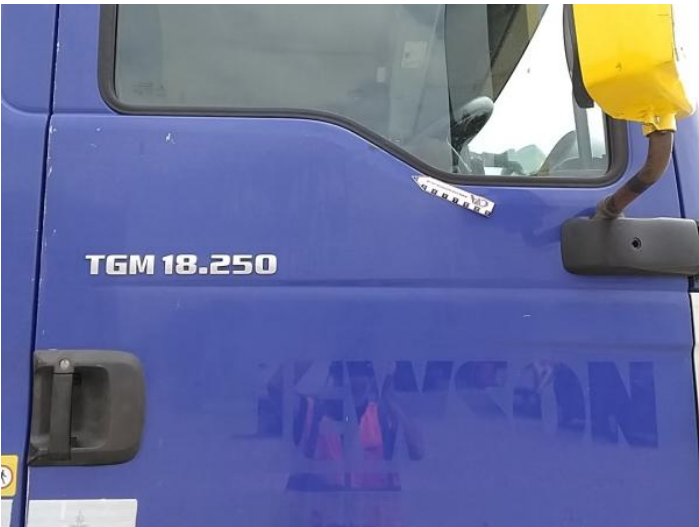
14: Door osf
Dented
2 Or Less UpTo 10mm

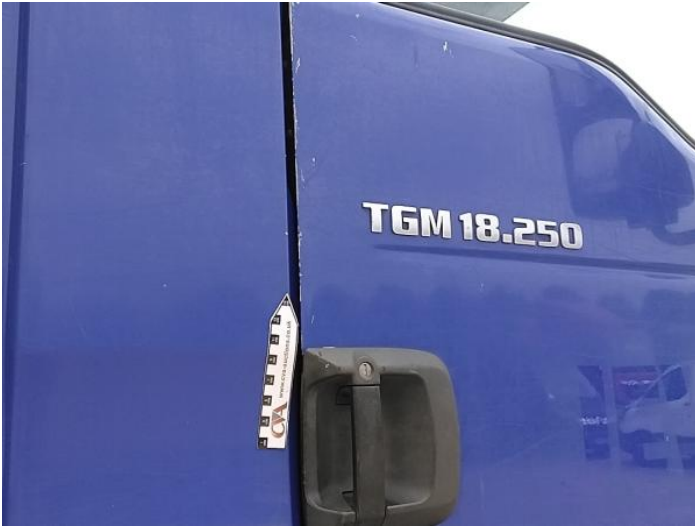
15: Door osf
Chipped
Edge Chip

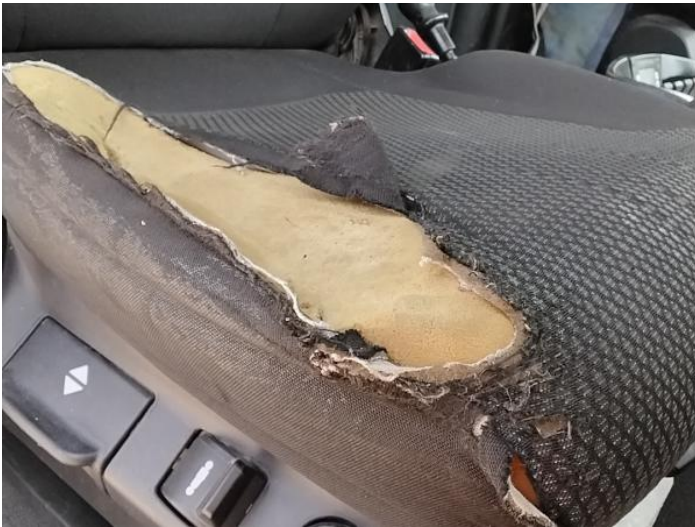
17: Seat Base Cover osf
Torn
Over 3mm

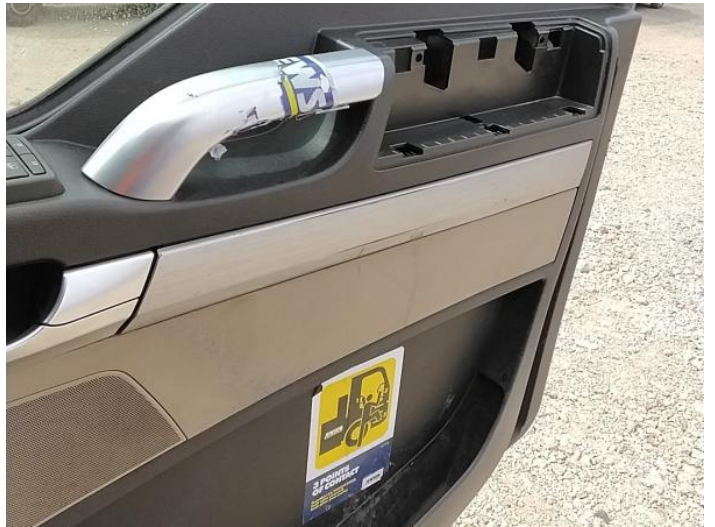
18: Door Pad osf
Missing
Replace

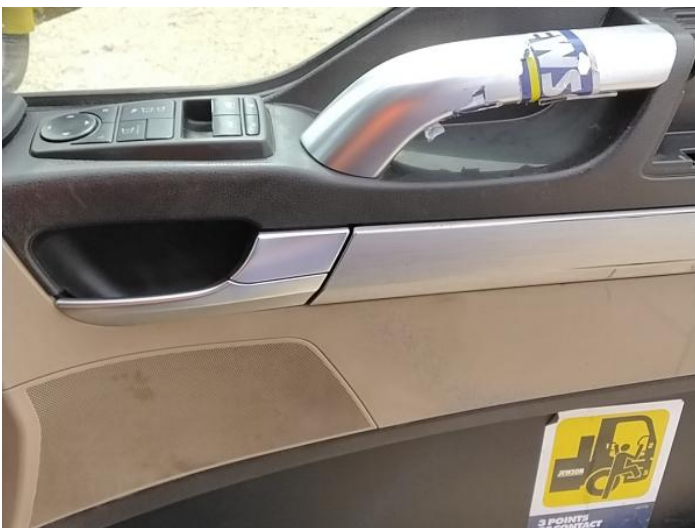
19: Handle Inner osf
Damaged
Replace
