# VEHICLE INSPECTION REPORT

**YA17SVC**

## Daf LF 150

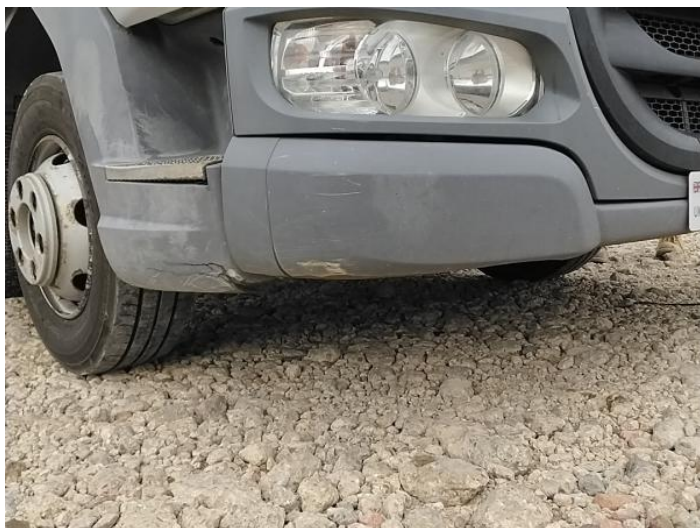
1: Bumper Front Moulding  
Scratched (Painted)  
Over 25mm Thru Paint

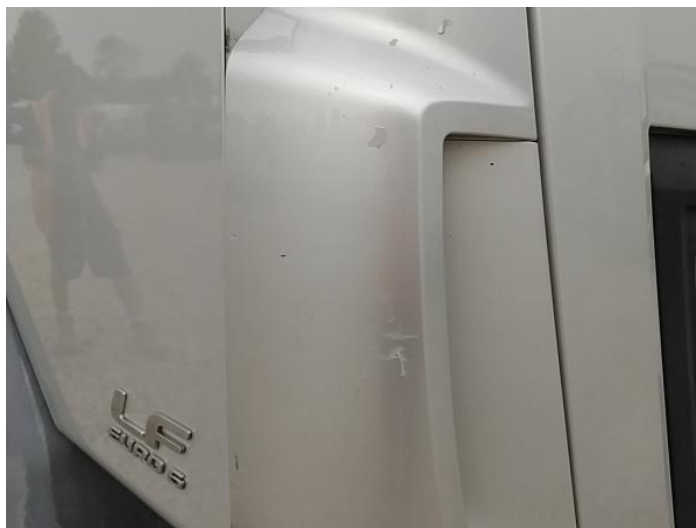
2: Wing osf  
Chipped  
Multiple Chips

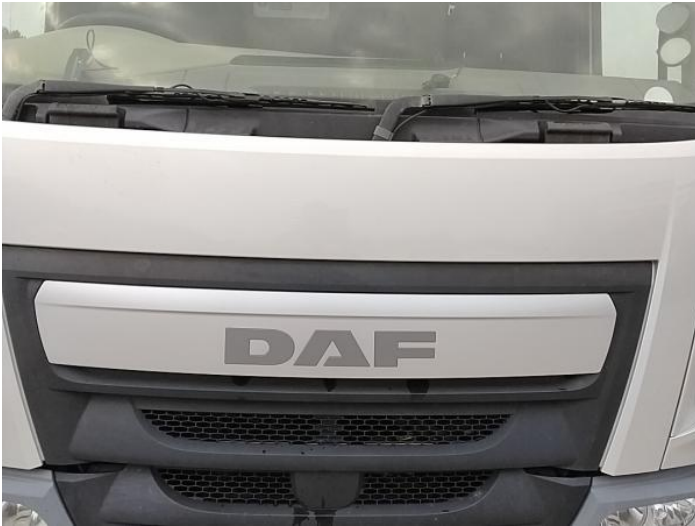
3: Bonnet  
Chipped  
Multiple Chips

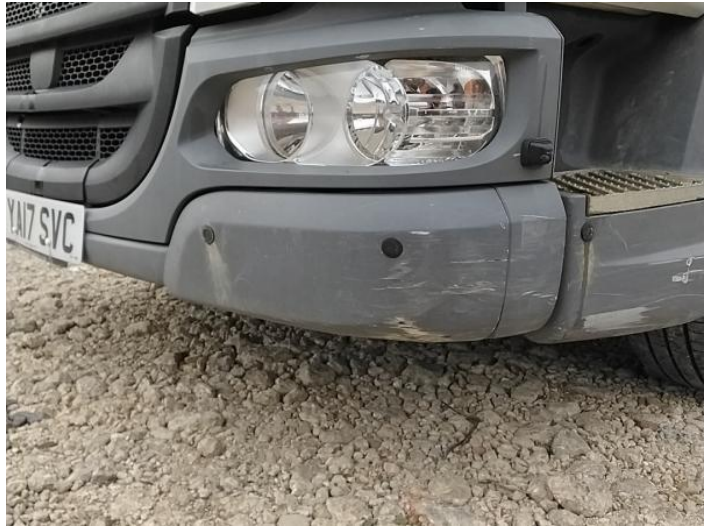
4: Bumper Front Moulding  
Scratched (Painted)  
Over 25mm Thru Paint

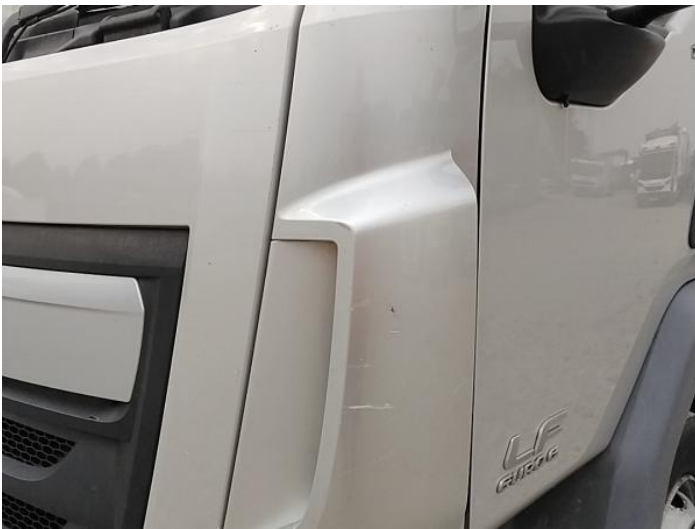
5: Wing nsf  
Scratched  
Over 25mm Thru Paint

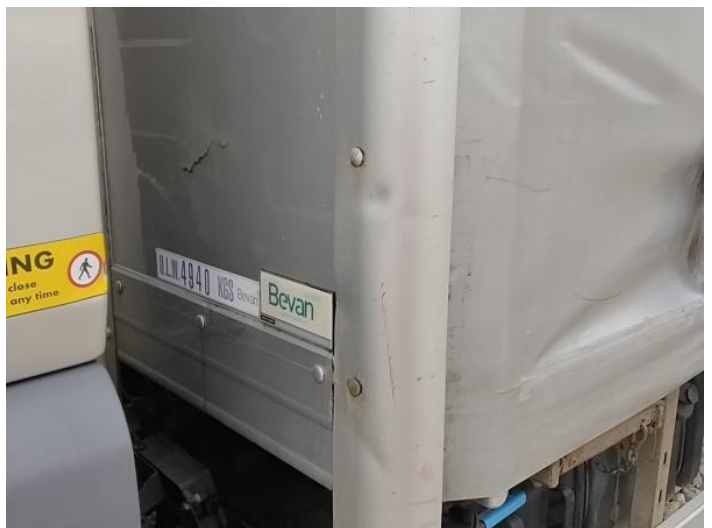
8: C Post ns  
Dented  
Between 10mm + 30mm

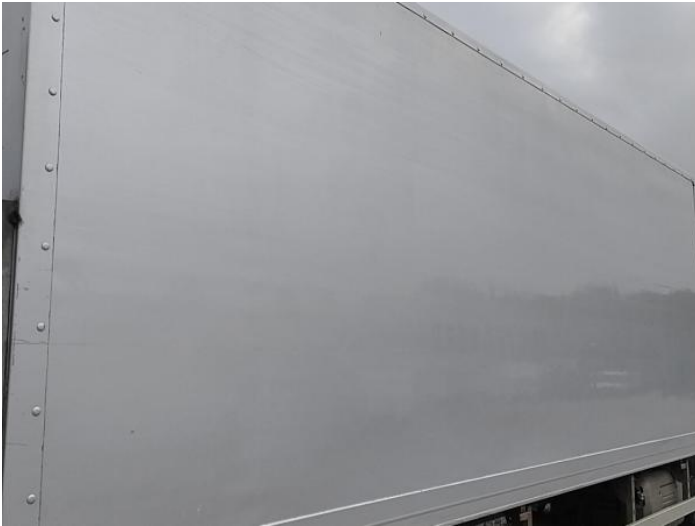
9: Qtr Panel osr  
Scratched  
Over 25mm Thru Paint

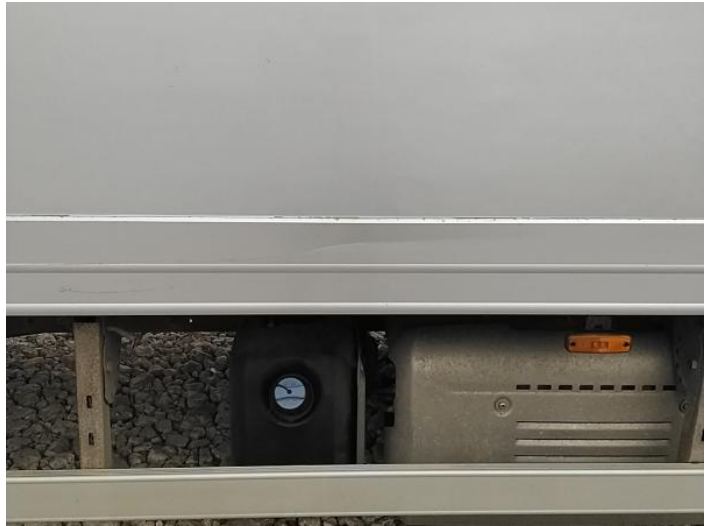
10: Qtr Panel osr  
Dented  
Between 10mm + 30mm

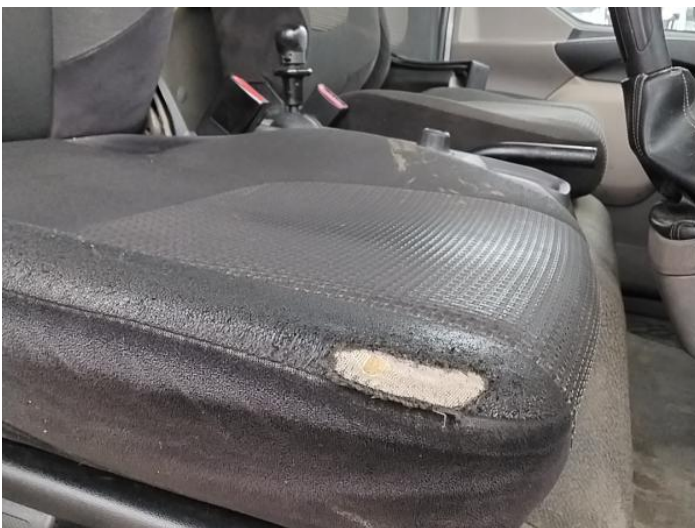
13: Seat Base Cover osf  
Holed  
Over 3mm
