# VEHICLE INSPECTION REPORT

**SN70YBV**

## Daf LF 290

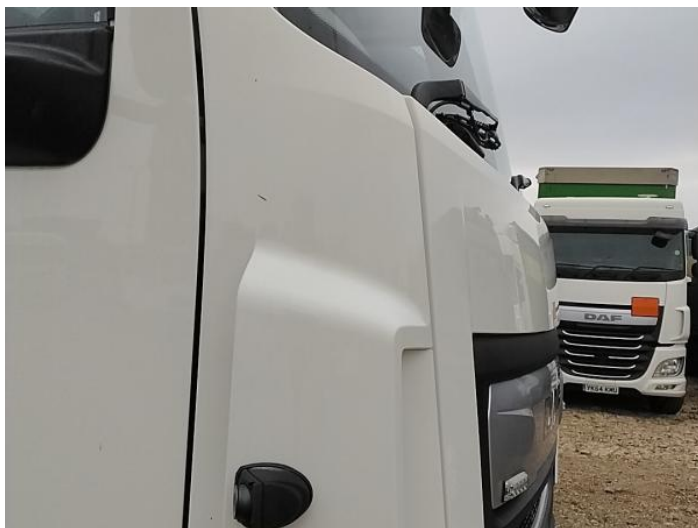
1: Wing osf  
Scratched  
UpTo 25mm Thru Paint

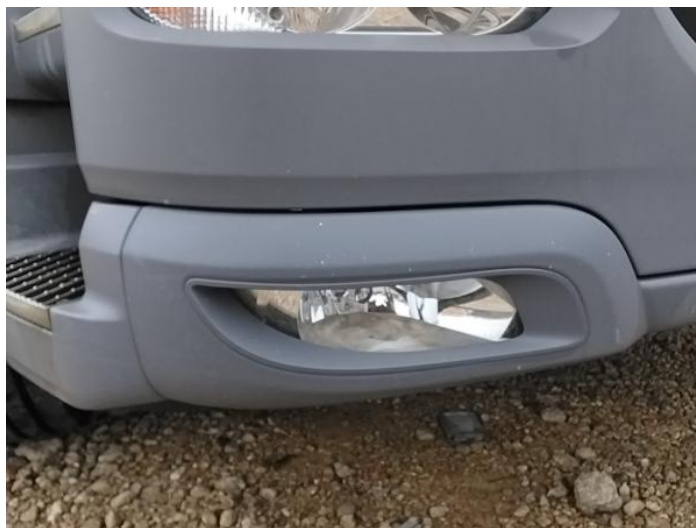
2: Bumper Front  
Chipped  
Multiple Chips

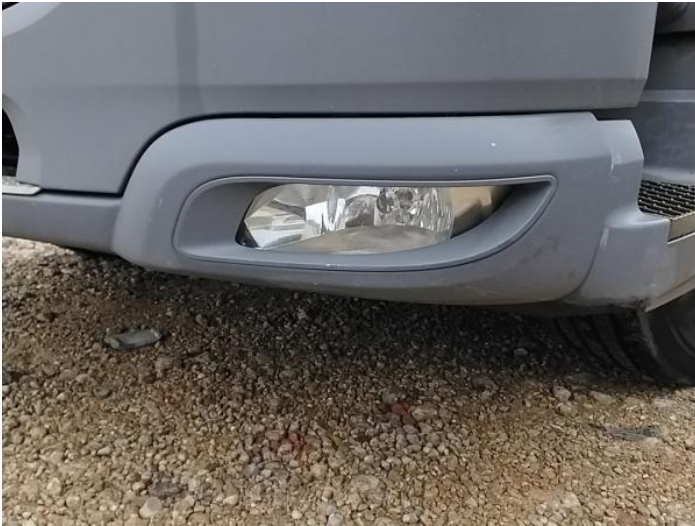
3: Bumper Front  
Chipped  
Multiple Chips

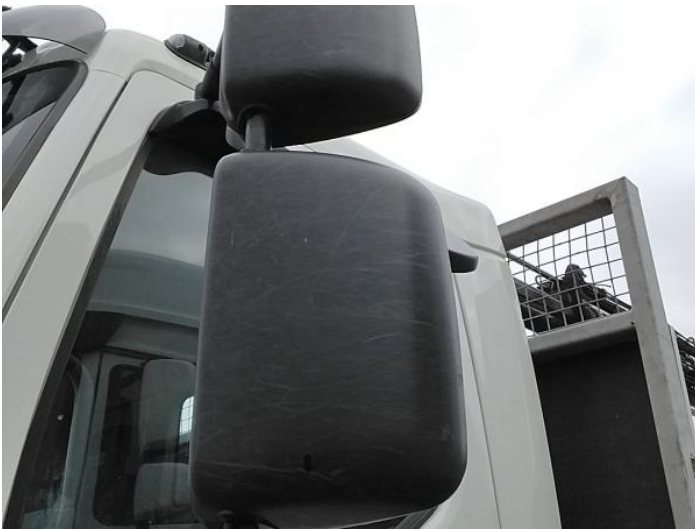
5: Door Mirror Assy nsf  
Scuffed (Unpainted)  
UpTo 100mm

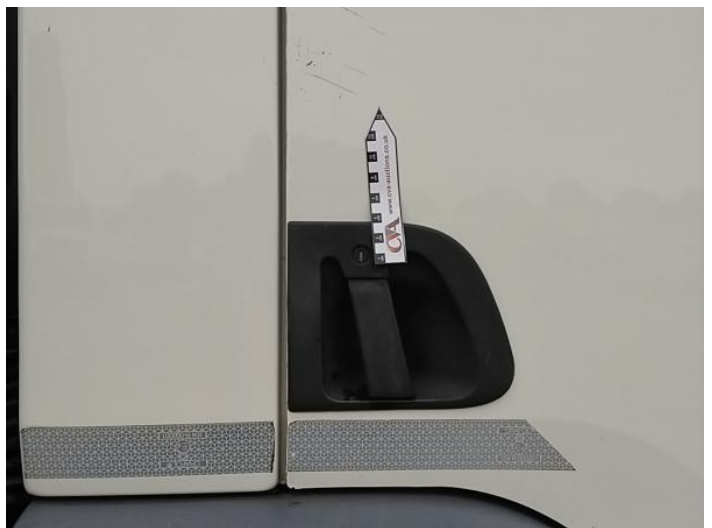
8: Door osf  
Scratched  
Over 25mm Thru Paint

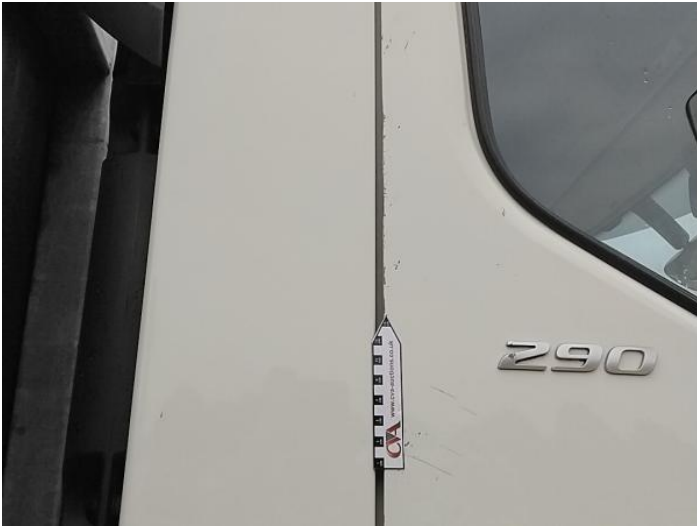
9: Door osf  
Chipped  
Edge Chip

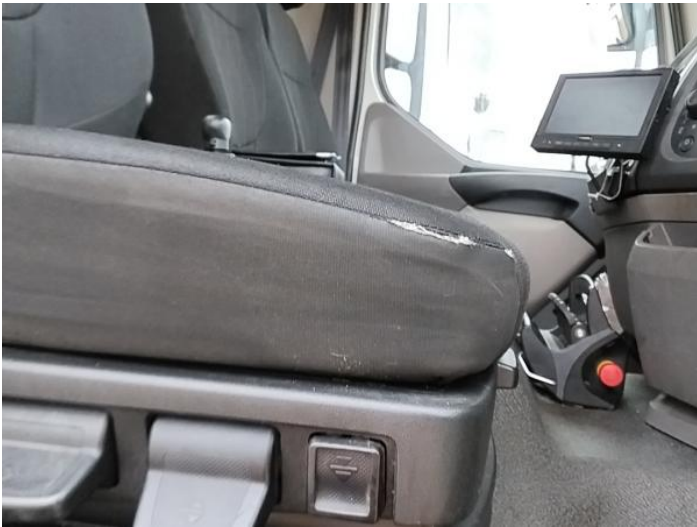
11: Seat Base Cover osf  
Holed  
Over 3mm
