## VEHICLE INSPECTION REPORT

**SL12FKE**

### Volkswagen Crafter CR35 Tdi 109ps LWB

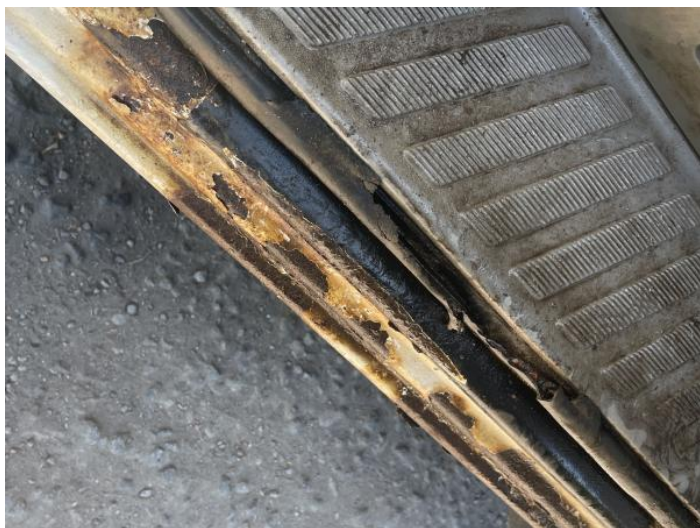
1: Sill os  
Rusted  
Over 5mm

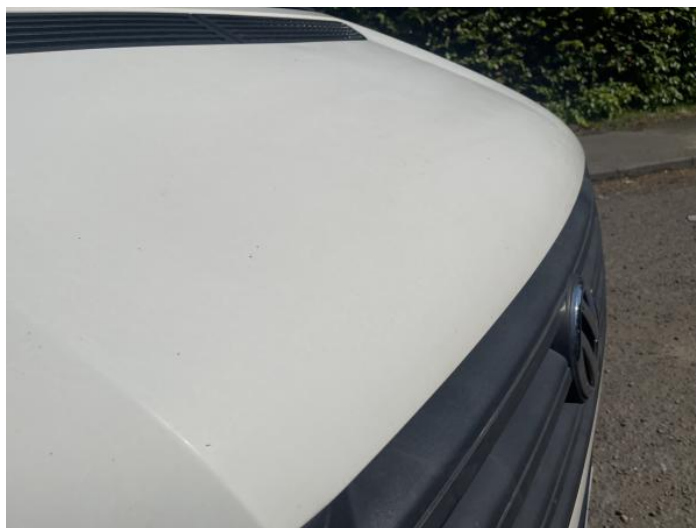
2: Bonnet  
Dented  
Over 30mm

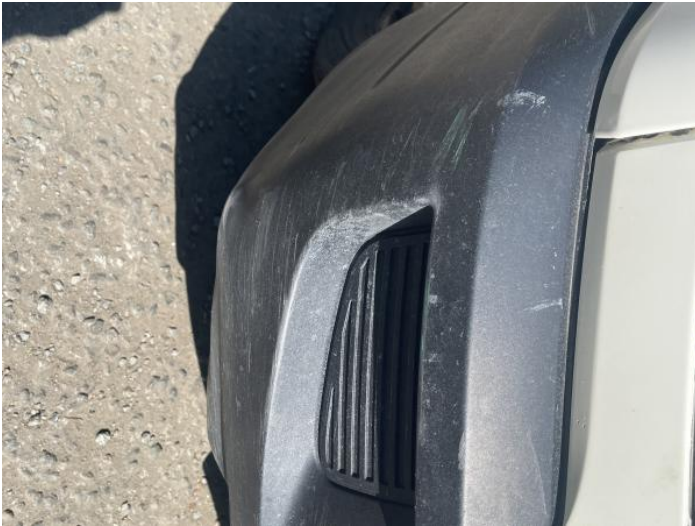
3: Bumper Front Moulding  
Scuffed (Unpainted)  
Over 100mm

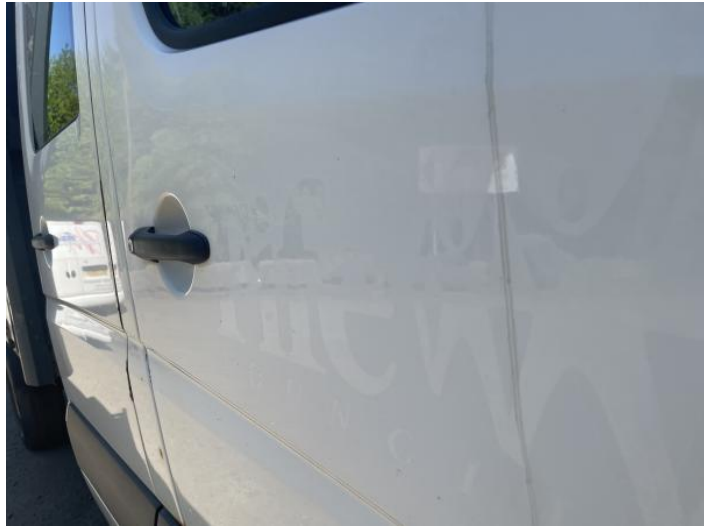
4: Door osf  
Dented  
With Paint Damage

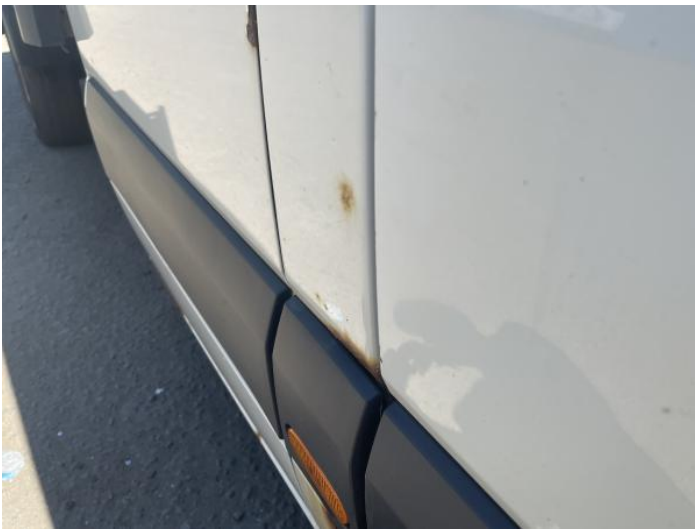
5: B Post os  
Rusted  
Over 5mm

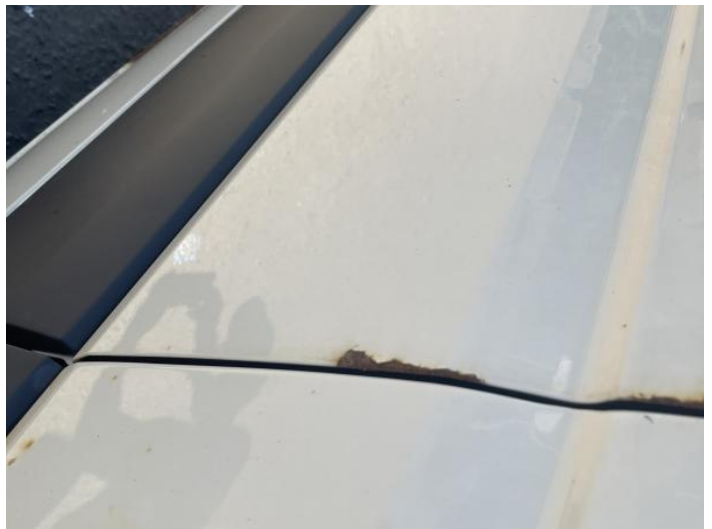
6: Door osr  
Rusted  
Over 5mm

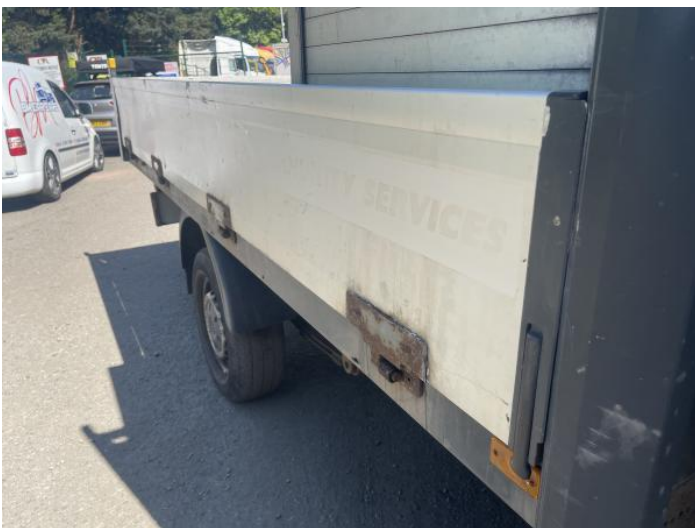
7: Qtr Panel osr  
Dented  
With Paint Damage

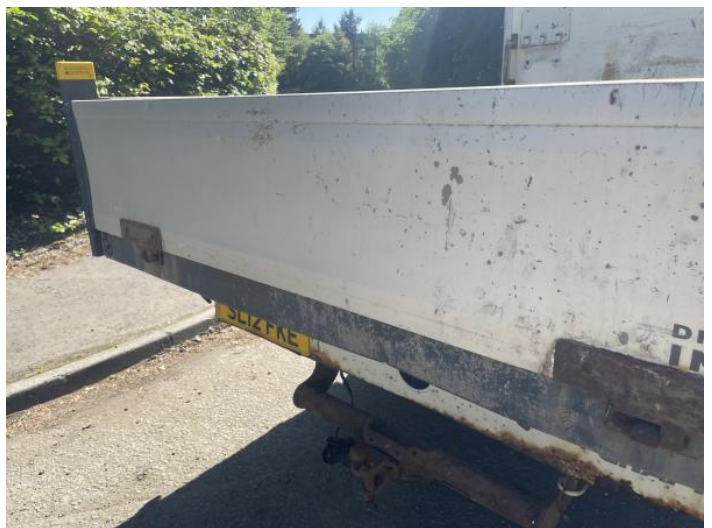
8: Tailgate  
Dented  
With Paint Damage

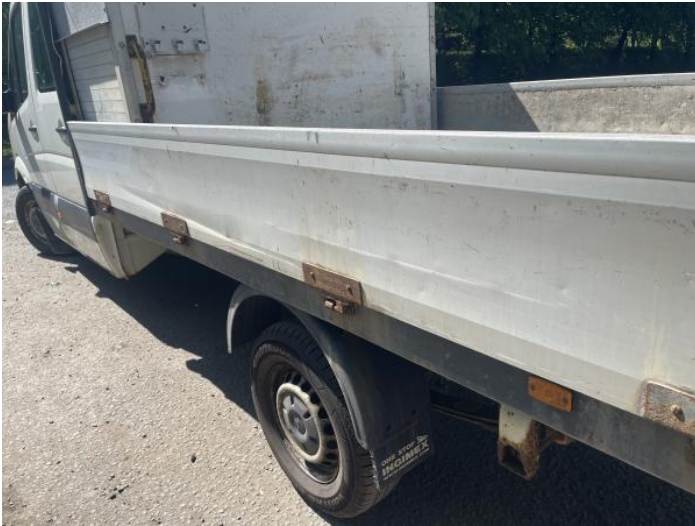
9: Qtr Panel nsr  
Dented  
With Paint Damage

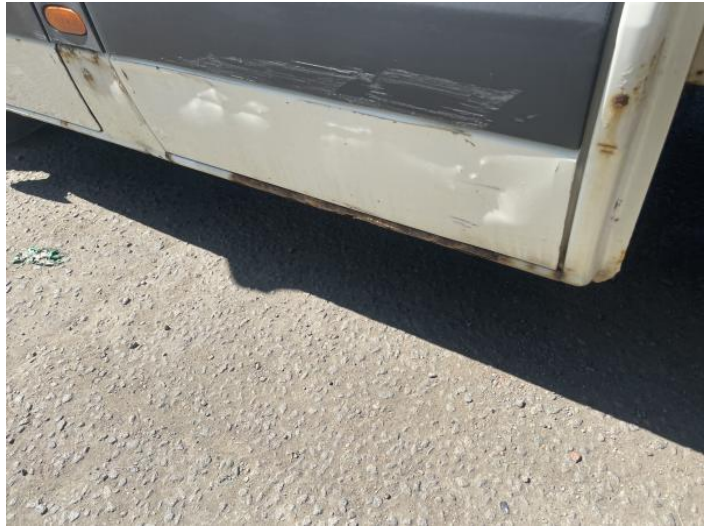
10: Door nsr  
Dented  
With Paint Damage

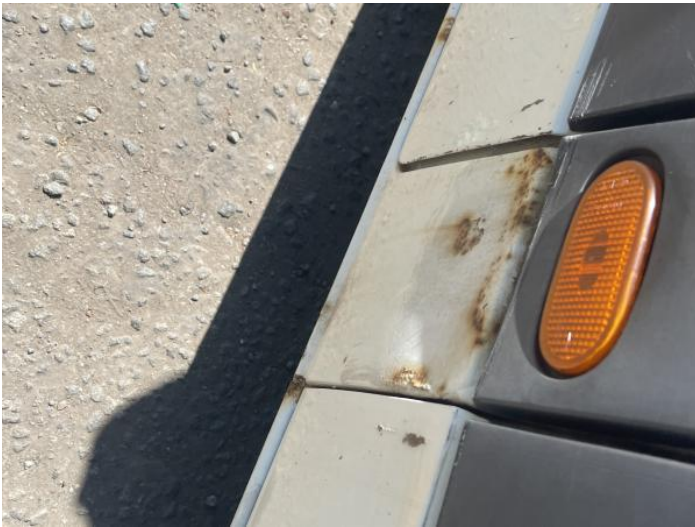
11: B Post ns  
Rusted  
Over 5mm

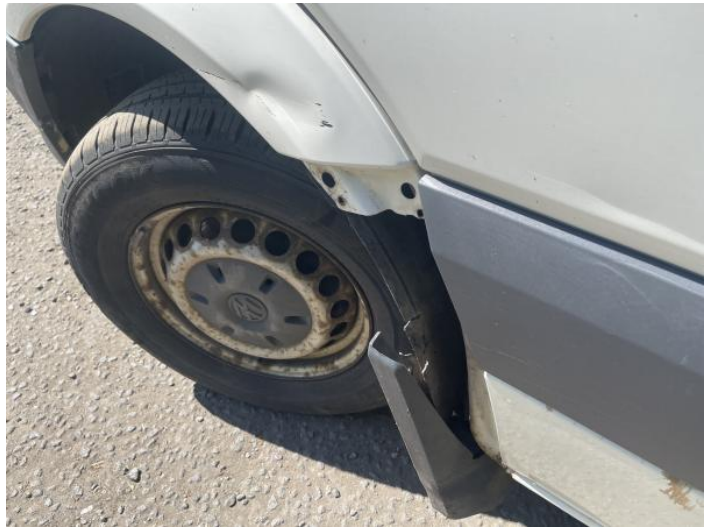
12: Door Moulding nsf  
Broken  
Replace

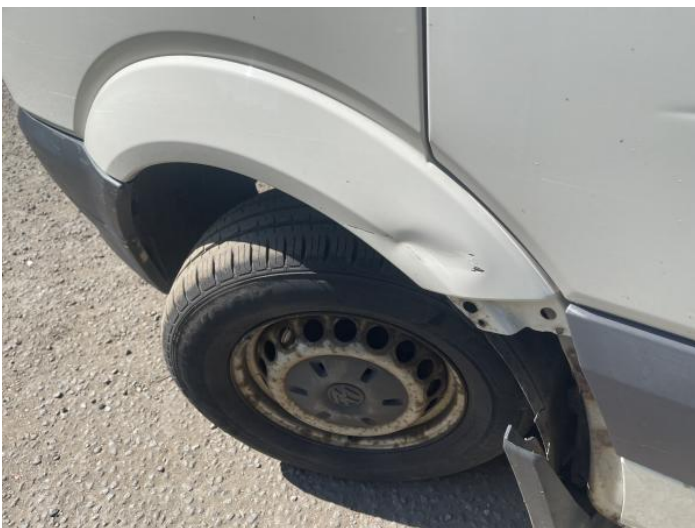
13: Wing nsf  
Dented  
With Paint Damage
