VEHICLE INSPECTION REPORT

MV68XWD

Ford Transit 350 2.0 TDCI 130PS

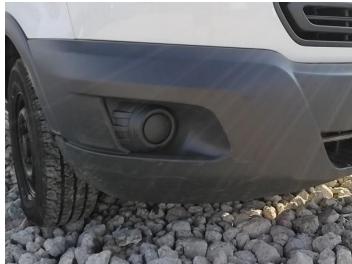
1: Bumper Front Moulding Scuffed (Unpainted) Over 100mm

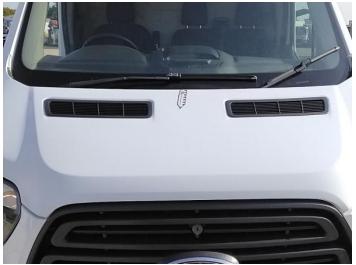
3: Bonnet Chipped Multiple Chips

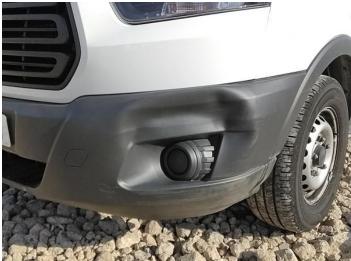
4: Bumper Front Dented Over 30mm

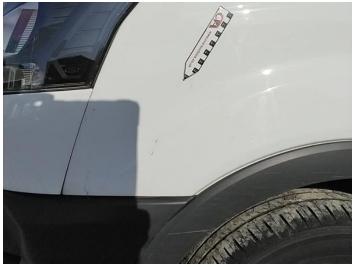
5: Wing nsf Scratched UpTo 25mm Thru Paint

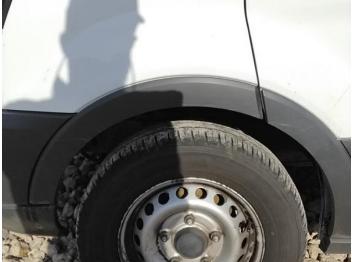
6: Moulding nsf Wing Scuffed (Unpainted) Over 100mm

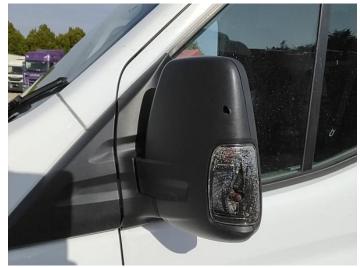
7: Door Mirror Assy nsf Broken Replace

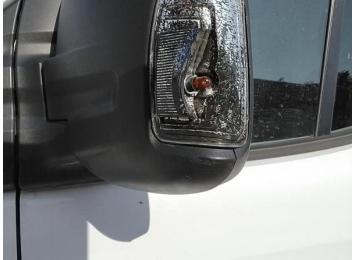
8: Flasher Side Repeater ns Broken Replace

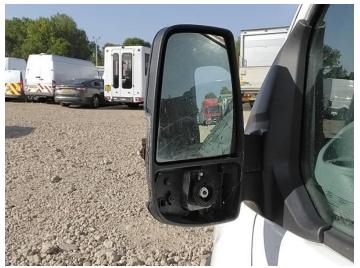
9: Door Mirror Glass ns Broken Replace

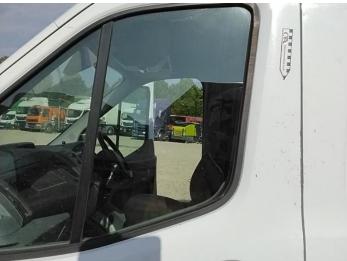
10: Door nsf Scratched Over 25mm Thru Paint

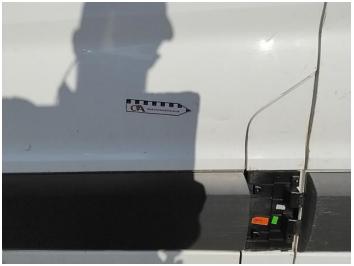
11: Door nsf Dented Between 10mm + 30mm

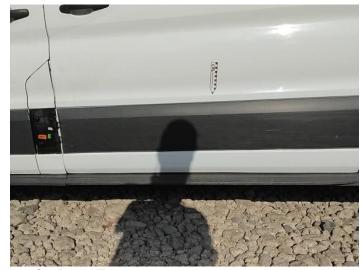
13: Qtr Panel Trim ns Scuffed Over 25mm

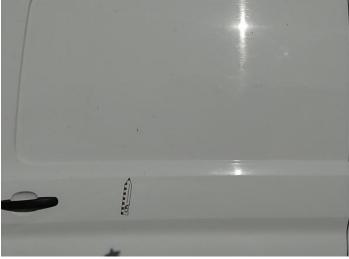
14: Door nsr Chipped Multiple Chips

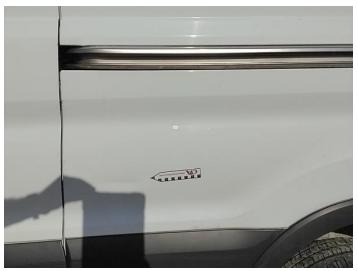
15: Qtr Panel nsr Dented Between 10mm + 30mm

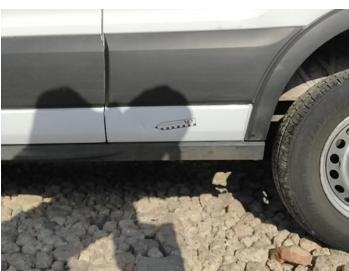
16: Qtr Panel nsr Dented With Paint Damage

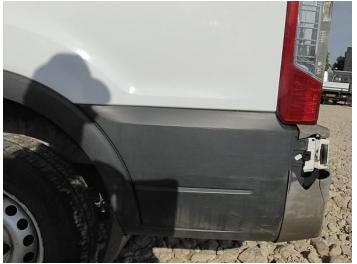
17: Qtr Panel Moulding ns Scuffed (Unpainted) Over 100mm

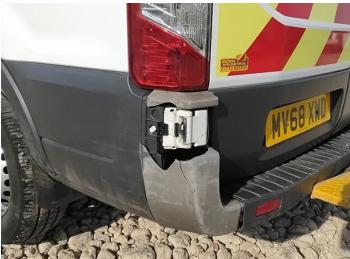
18: Bumper Rear Moulding Broken Replace

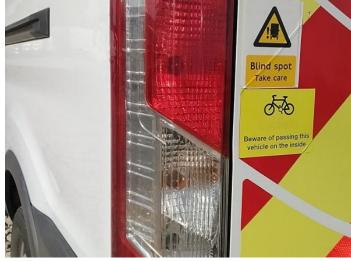
19: Lamp nsr Broken Replace

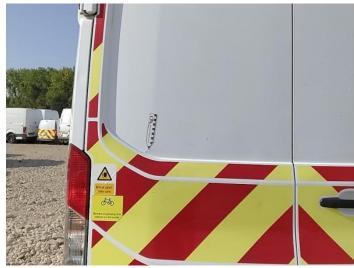
20: Door nsr Dented With Paint Damage

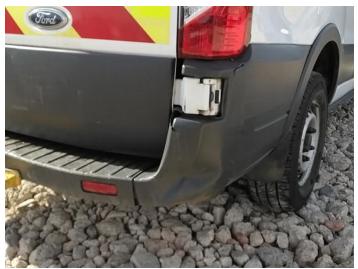
21: Bumper Rear Moulding Broken Replace

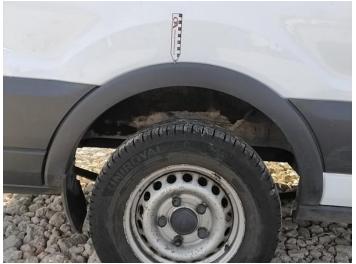
23: Qtr Panel Arch Extension os Scuffed (Unpainted) UpTo 100mm

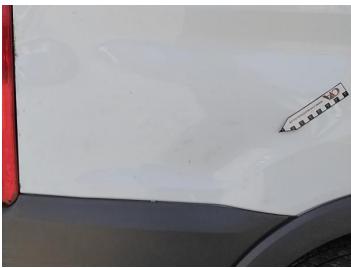
24: Qtr Panel osr Dented Between 10mm + 30mm

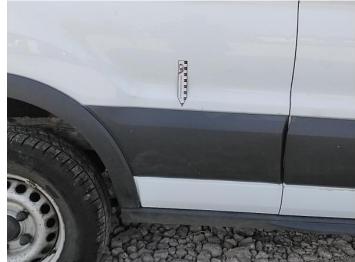
25: Qtr Panel Moulding os Scuffed (Unpainted) Over 100mm

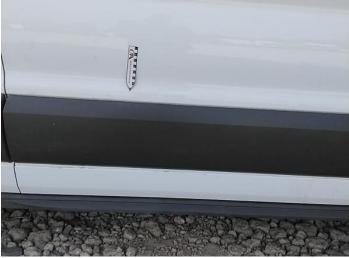
26: Qtr Panel Moulding os Scuffed (Unpainted) Over 100mm

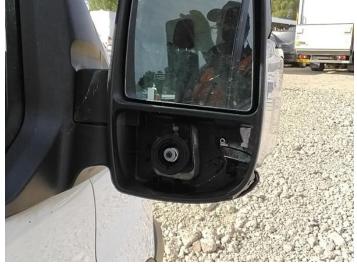
27: Door Mirror Glass os Missing Replace

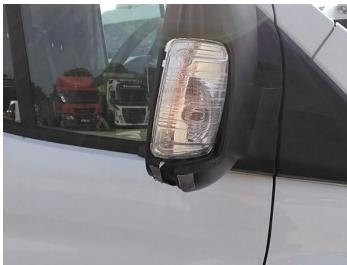
28: Door Mirror Assy osf Broken Replace

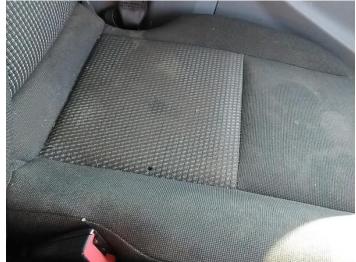
31: Seat Base Cover nsf Burn Over 3mm
