## VEHICLE INSPECTION REPORT

**LA21UUX**

### Citroen Relay 35 2.2 Bluehdi Enterprise

**Non Runner**  
Inspection

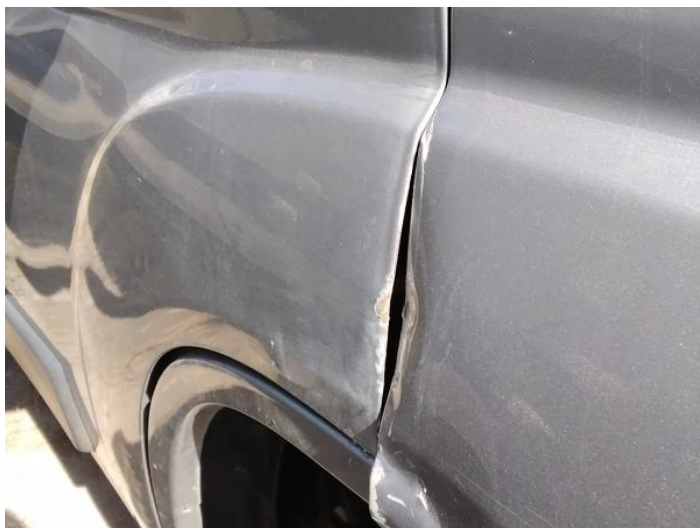
1: Wing nsf  
Dented  
With Paint Damage

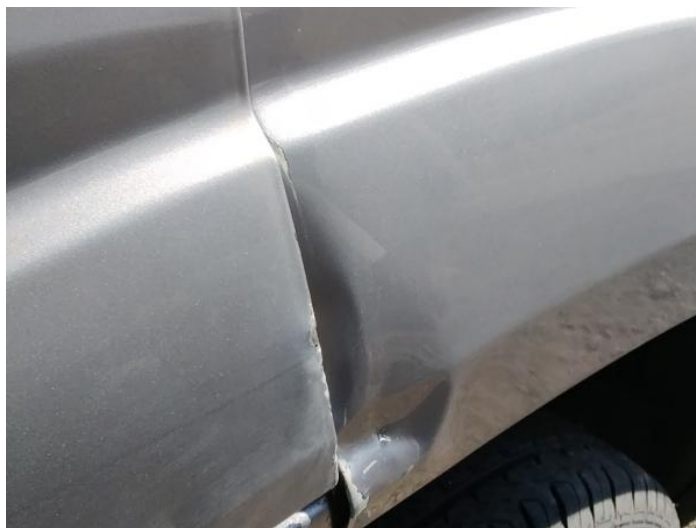
2: Door nsf  
Chipped  
Multiple Chips

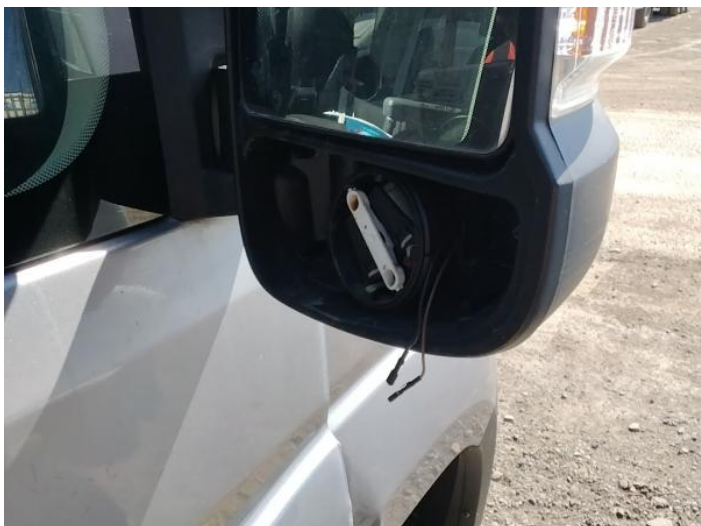
3: Door Mirror Glass ns  
Missing  
Replace

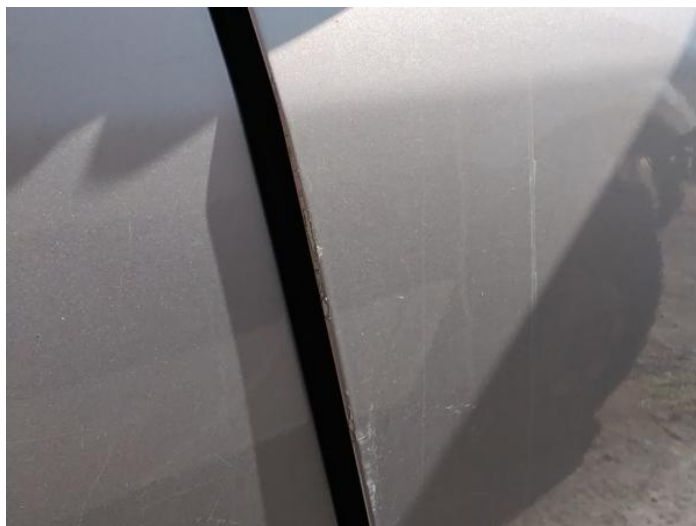
4: Door nsf  
Chipped  
Edge Chip

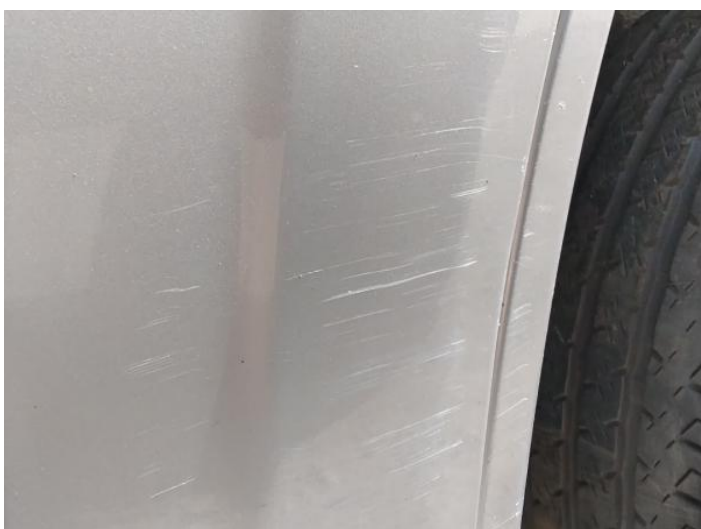
5: Door nsf  
Scratched  
Over 25mm Not Thru Paint

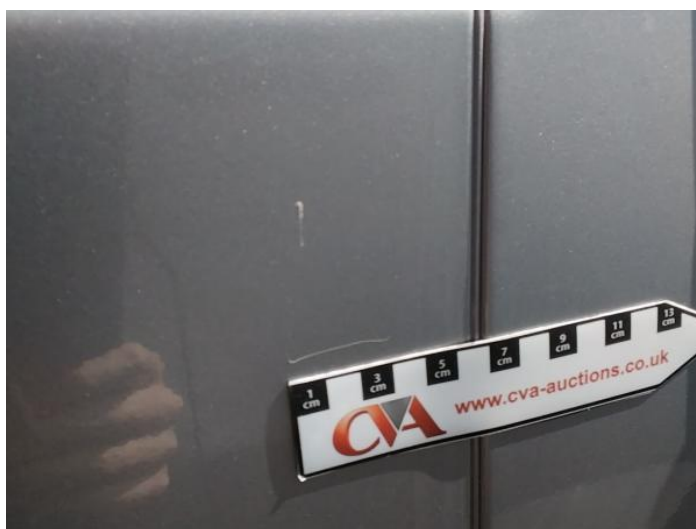
6: Panel Front  
Scratched  
Over 25mm Not Thru Paint

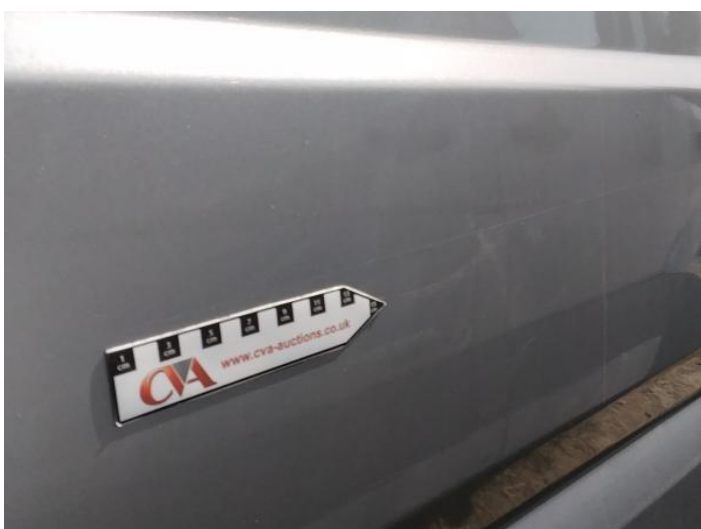
7: Panel Front  
Scratched  
Over 25mm Not Thru Paint

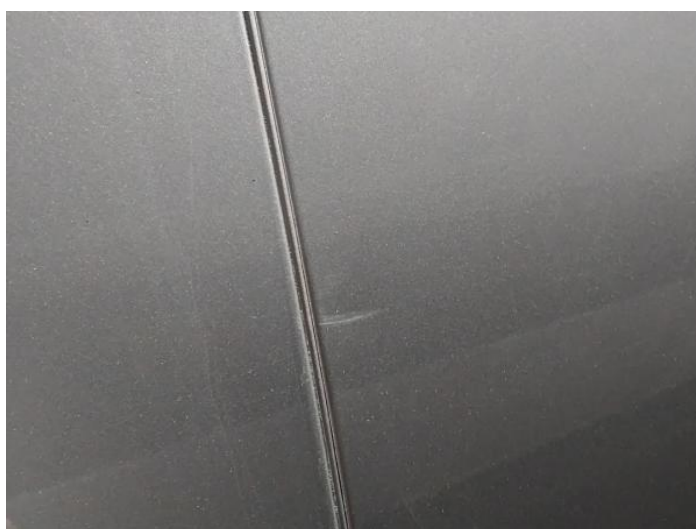
8: Panel Rear  
Scratched  
UpTo 25mm Not Thru Paint

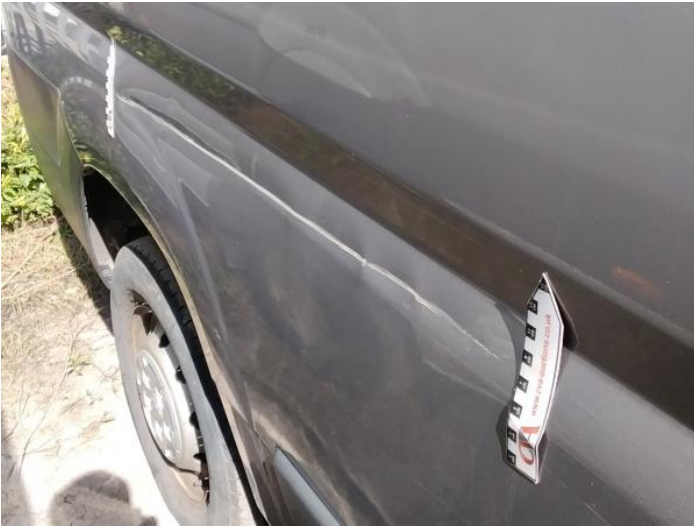
9: Panel Rear  
Dented  
With Paint Damage

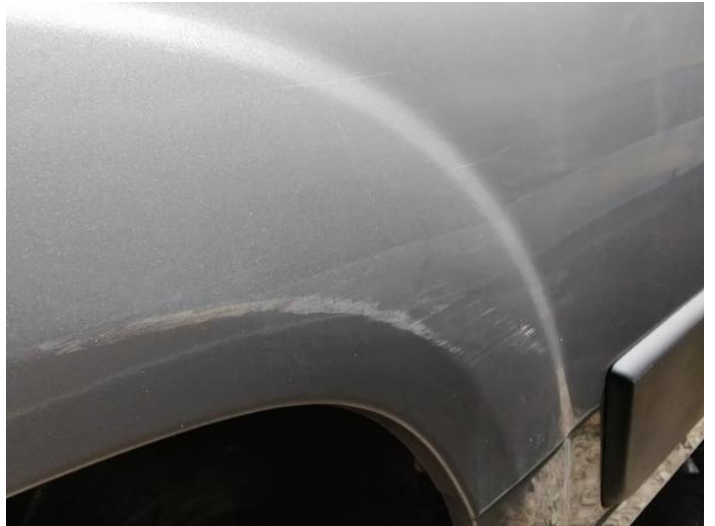
10: Panel Rear  
Scratched  
Over 25mm Not Thru Paint

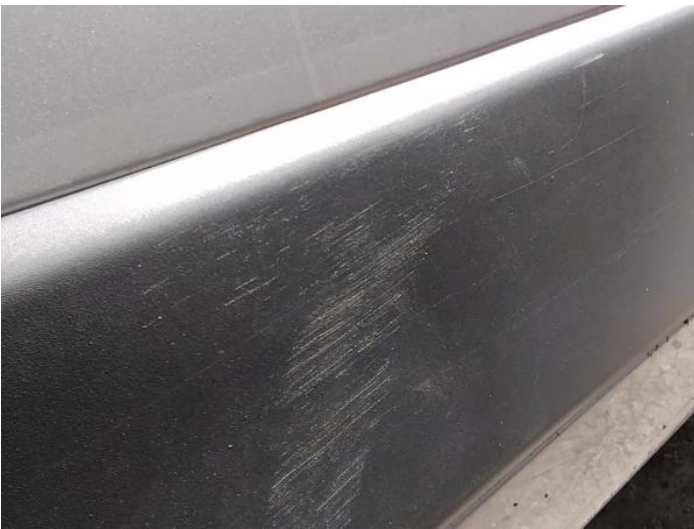
11: Panel Rear  
Scratched  
Over 25mm Not Thru Paint

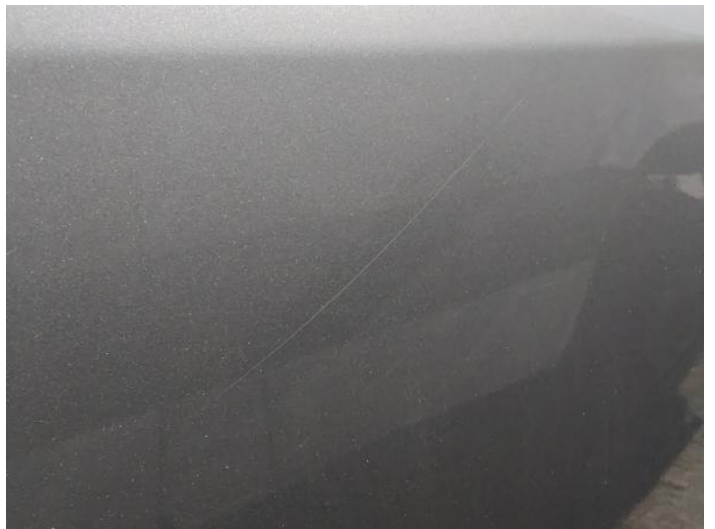
12: Panel Front  
Scratched  
Over 25mm Not Thru Paint

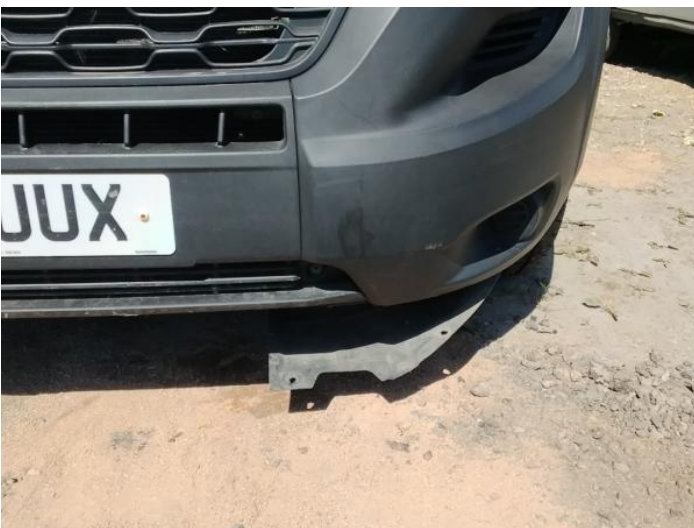
13: Bumper Front  
Insecure  
Action Required

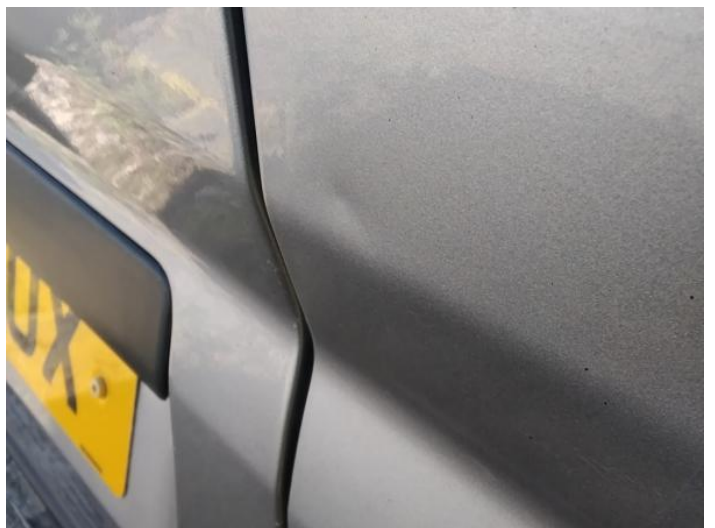
14: Panel Rear  
Dented  
Between 10mm + 30mm

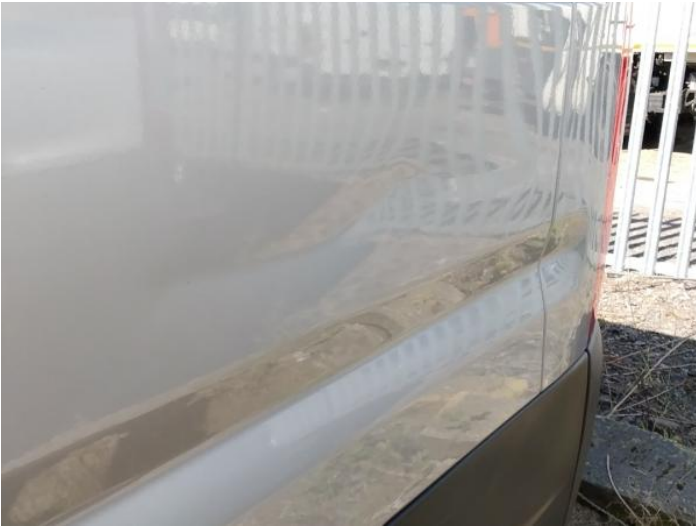
15: Panel Rear  
Dented  
Over 30mm

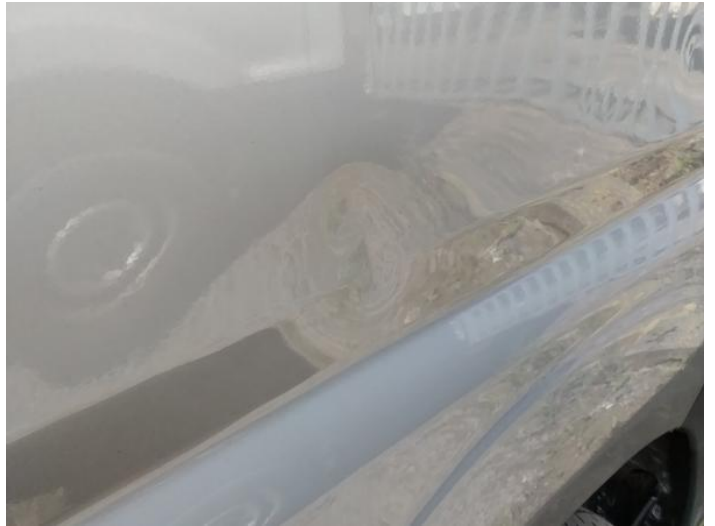
16: Panel Rear  
Dented  
Over 30mm

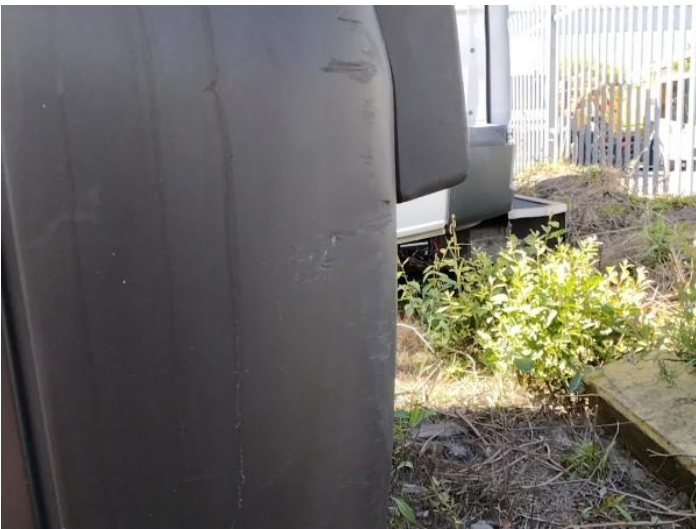
17: Bumper Rear  
Scratched  
Over 25mm Not Thru Paint

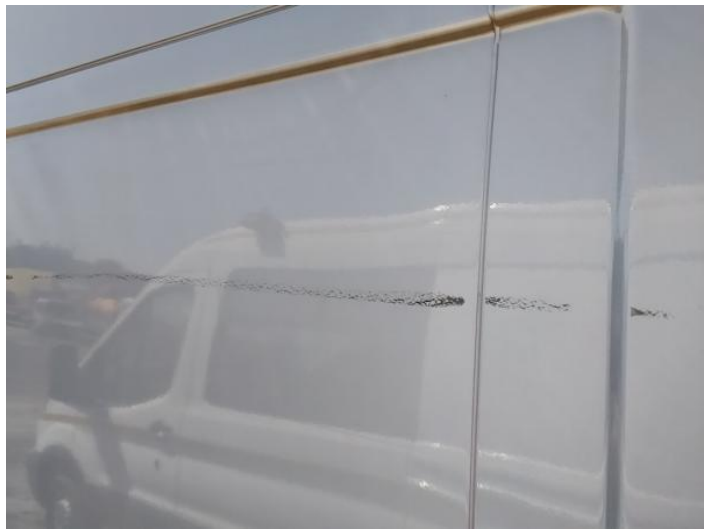
18: Panel Rear  
Scratched  
Over 25mm Not Thru Paint

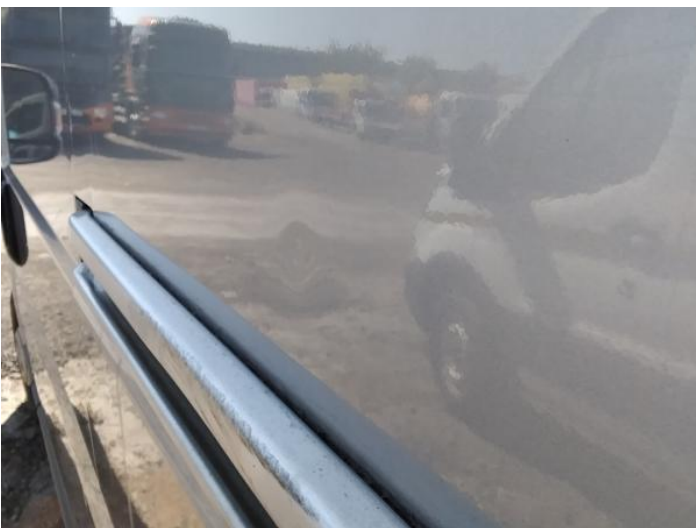
19: Panel Rear  
Dented  
Over 30mm

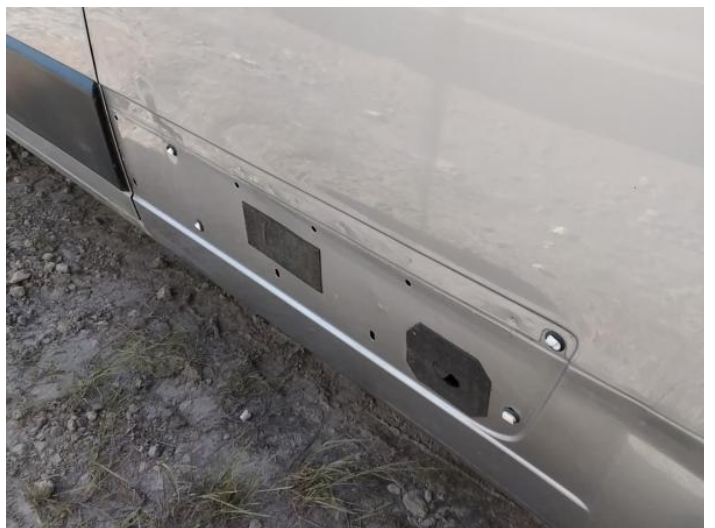
20: Qtr Panel Trim os  
Missing  
Replace

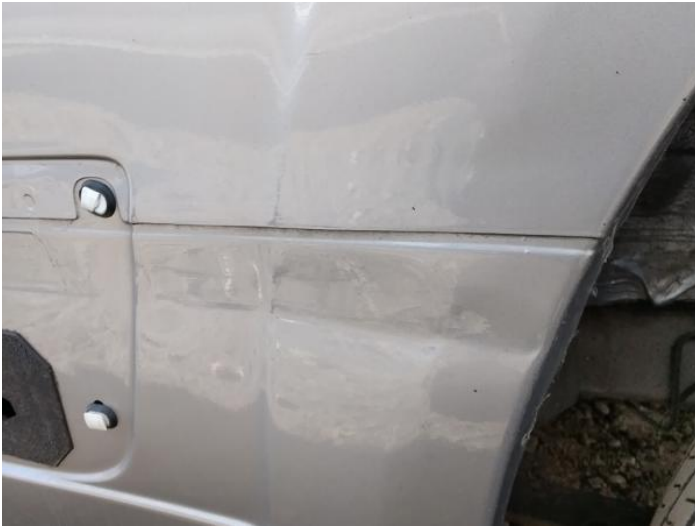
21: Panel Rear  
Dented  
Over 30mm

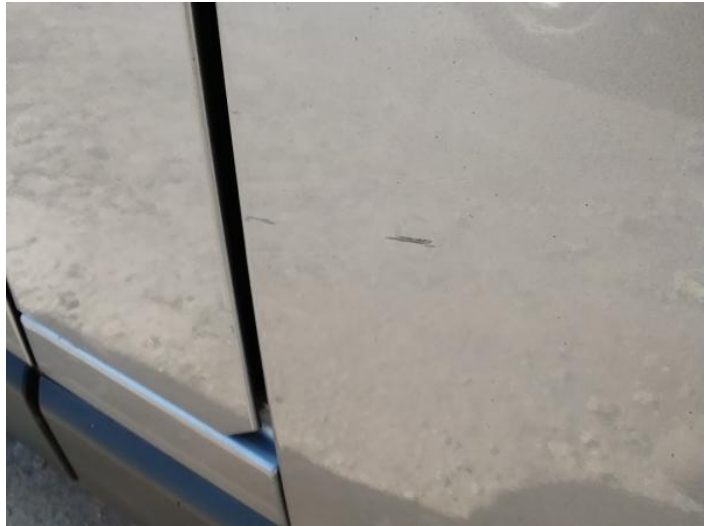
22: Panel Front  
Scratched  
Over 25mm Not Thru Paint

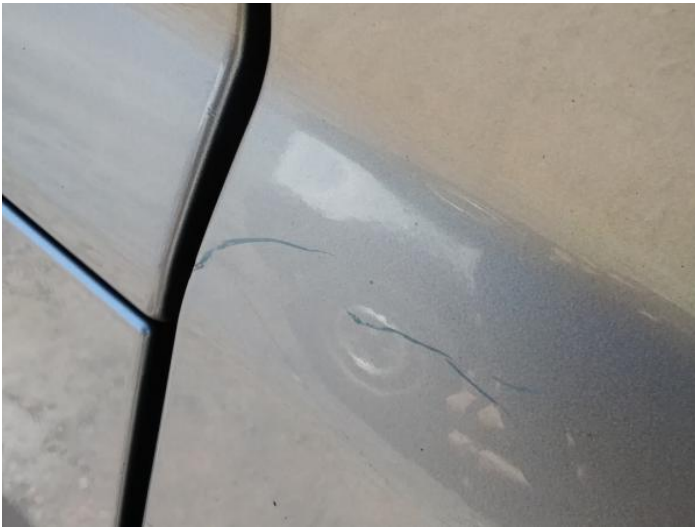
23: Panel Front  
Scratched  
Over 25mm Not Thru Paint

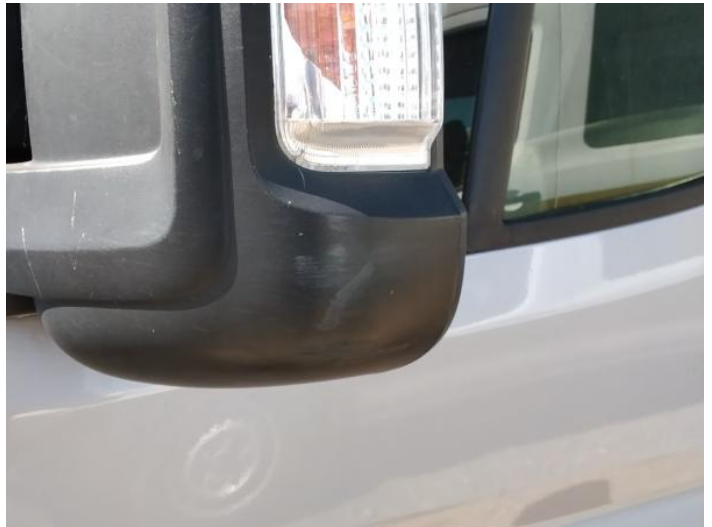
24: Door Mirror Assy osf  
Scuffed (Unpainted)  
Over 100mm

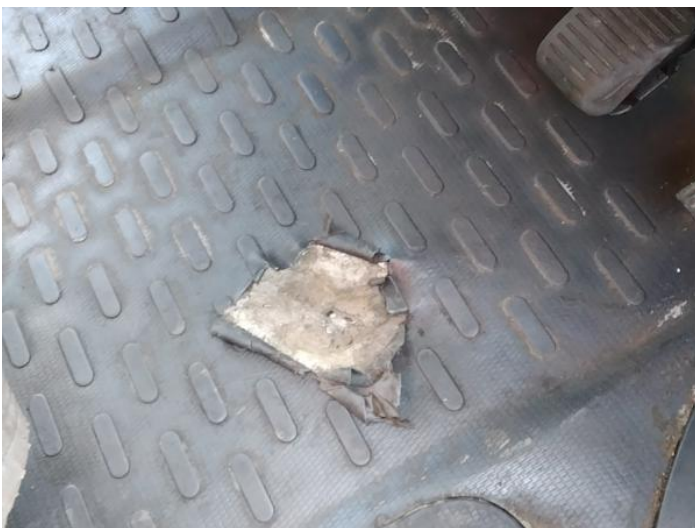
25: Carpets Front  
Holed  
Over 3mm

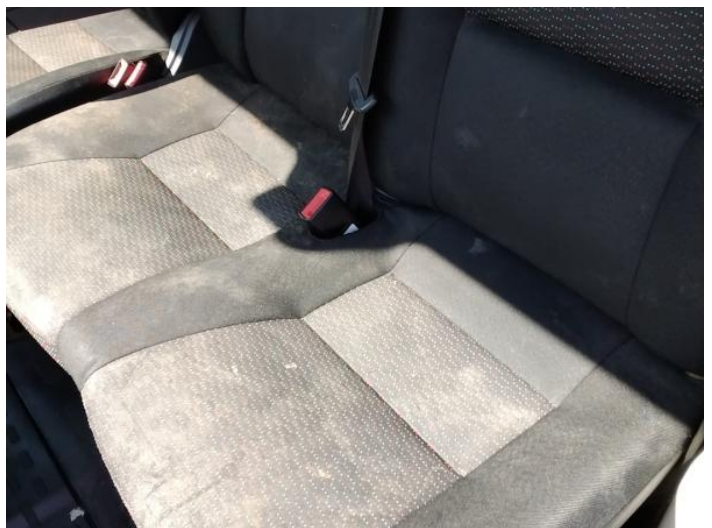
26: Seat Base Cover osf  
Soiled  
Light

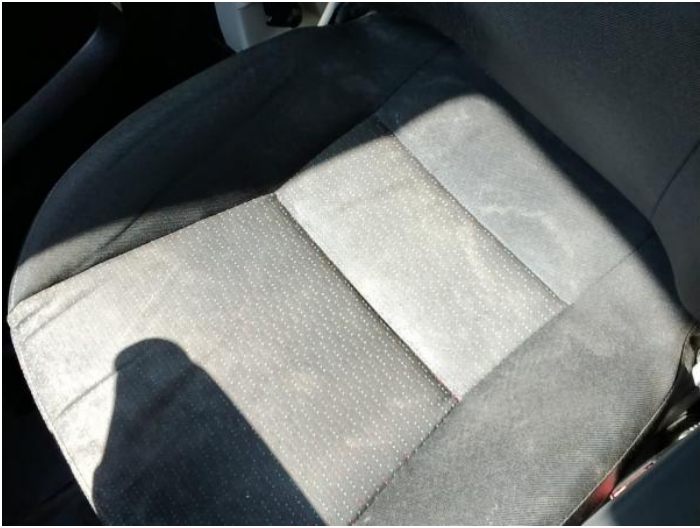
27: Seat Base Cover nsf  
Soiled  
Light
