VEHICLE INSPECTION REPORT

FN17BOH

Daf LF 180

Non Runner
Inspection

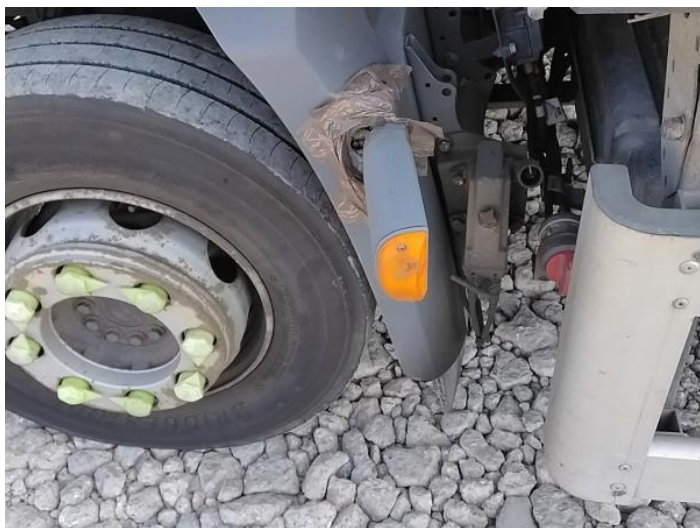
1: Sill Panel Trim ns
Broken
Replace

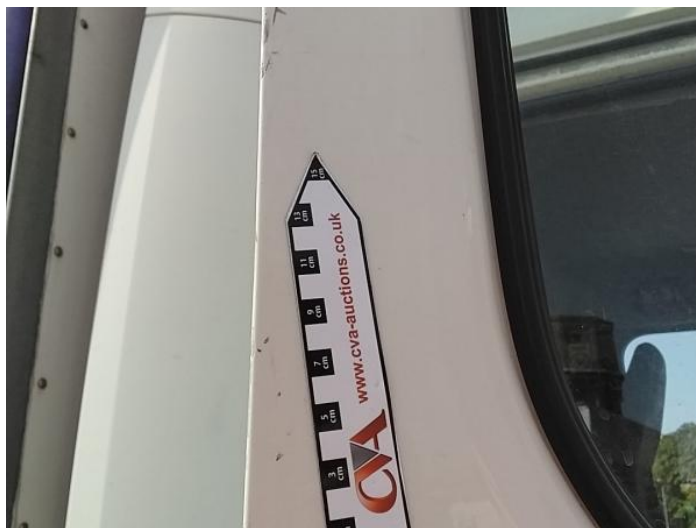
2: Door osf
Chipped
Multiple Chips

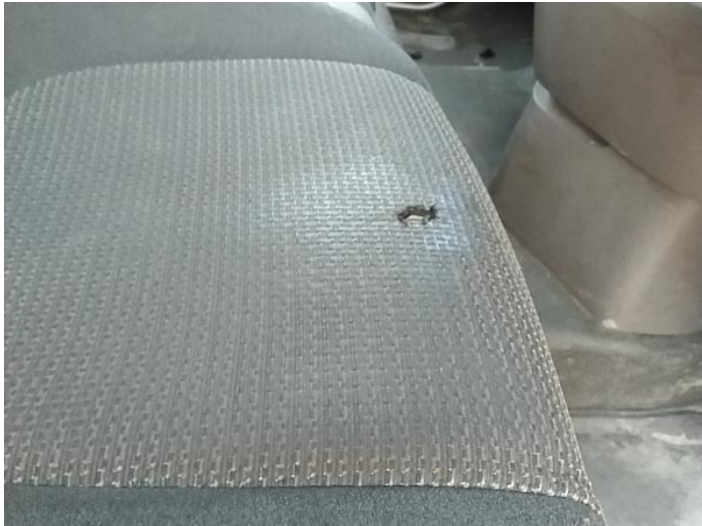
3: Seat Back Cover osf
Holed
Over 3mm
