# VEHICLE INSPECTION REPORT

**C291659**

## Iveco Stralis 460

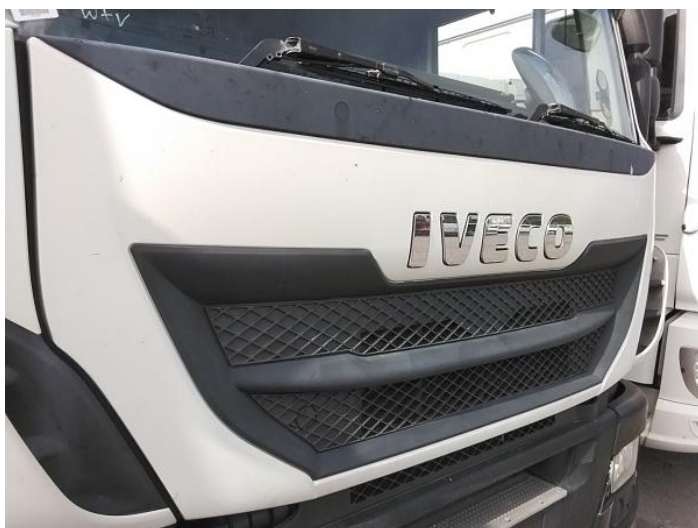
1: Bonnet  
Chipped  
Multiple Chips

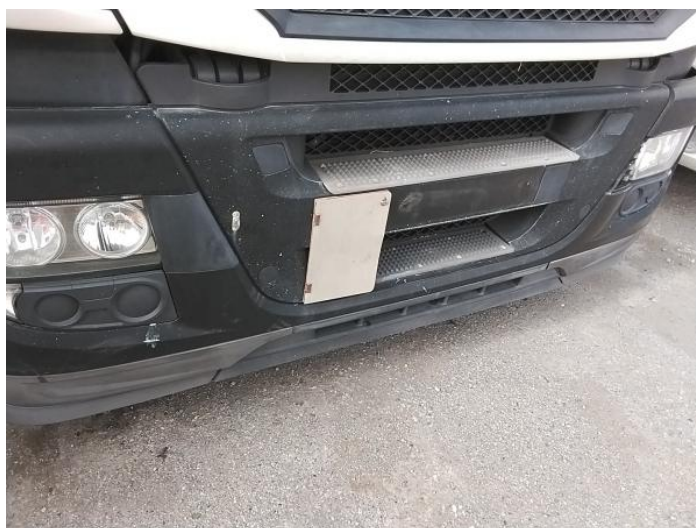
2: Bumper Front  
Chipped  
Multiple Chips

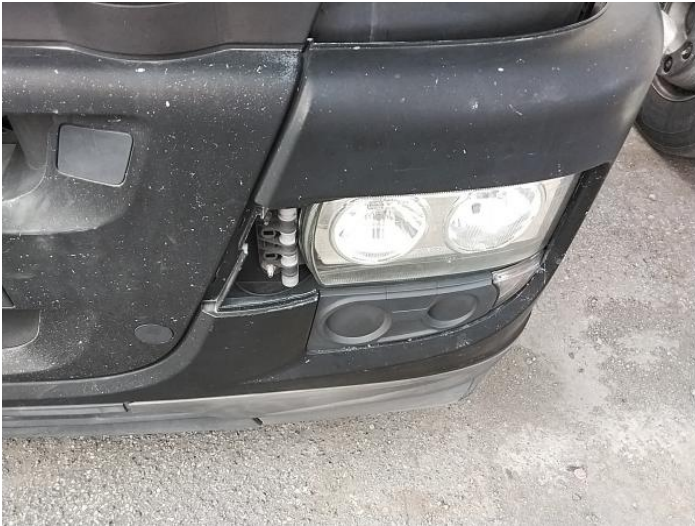
3: Bumper Front Moulding  
Missing  
Replace

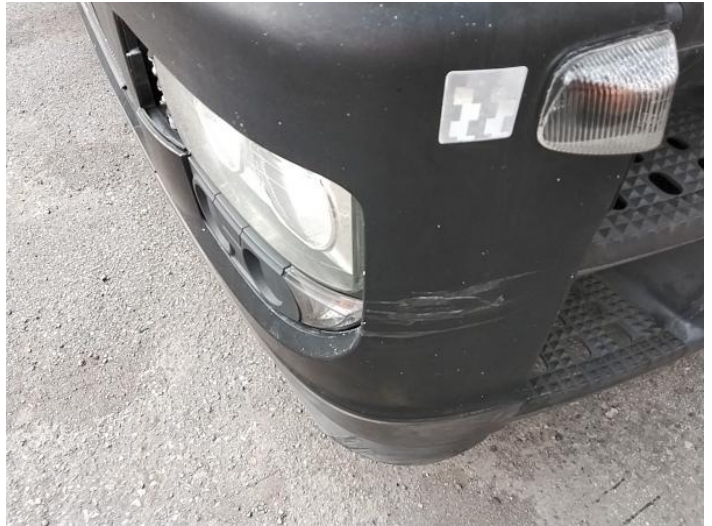
4: Bumper Front  
Scratched  
Over 100mm Thru Paint

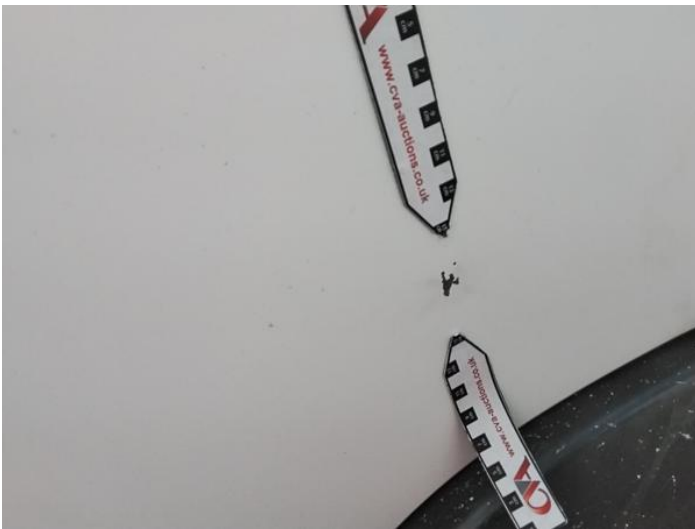
5: Door nsf  
Scratched  
Over 25mm Thru Paint

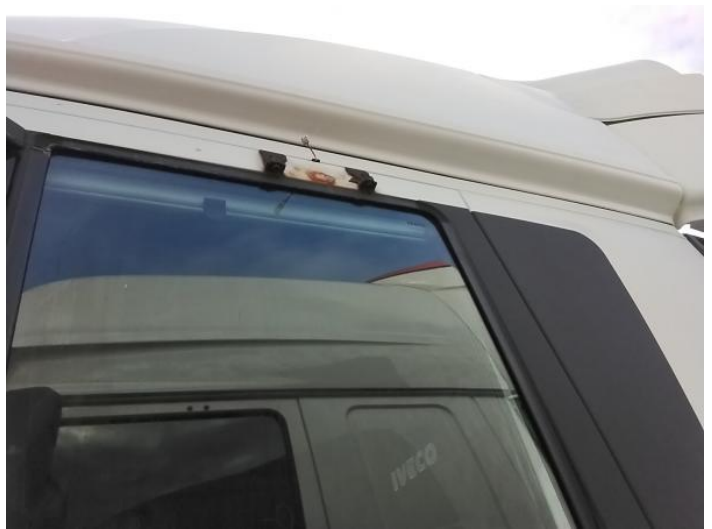
6: Door Mirror Assy nsf  
Missing  
Replace

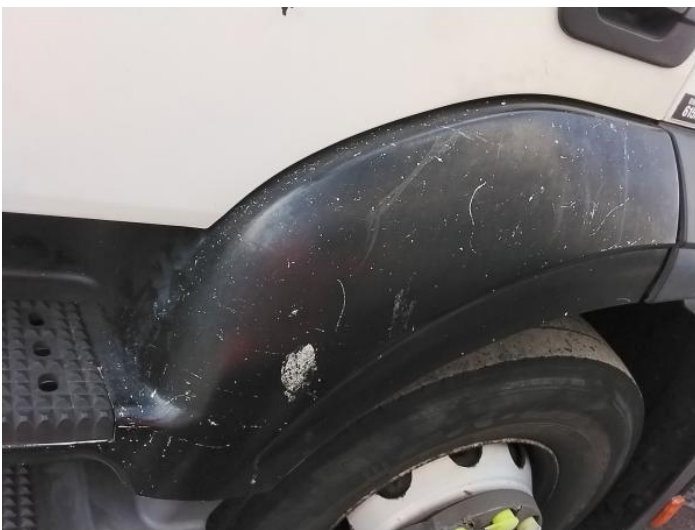
7: Wing nsf  
Scratched  
Over 25mm Thru Paint

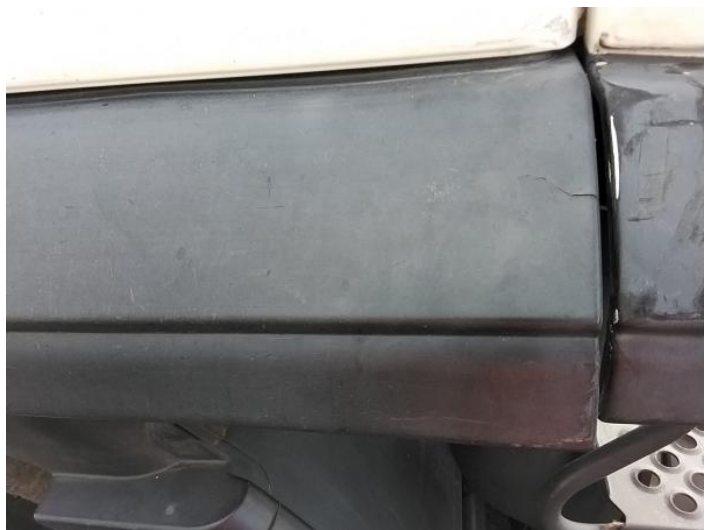
8: Qtr Panel Moulding ns  
Broken  
Replace

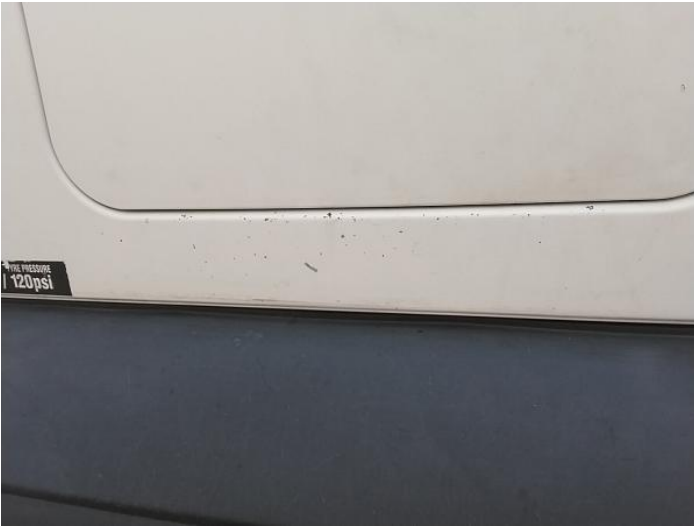
9: Qtr Panel nsr  
Chipped  
Multiple Chips

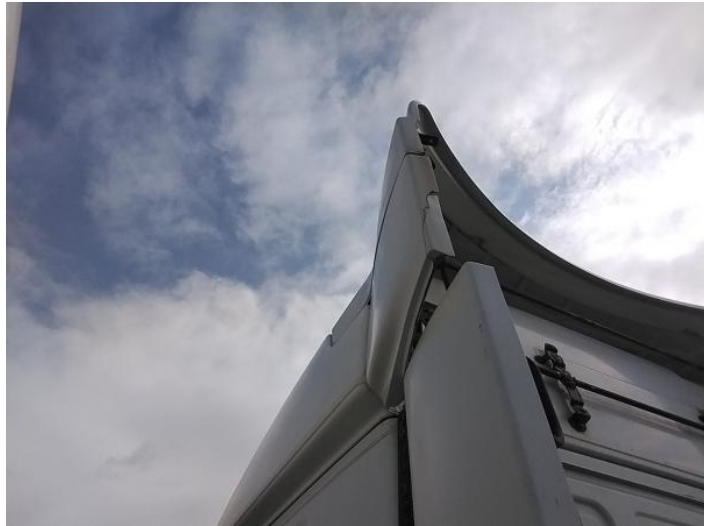
10: Qtr Panel Trim ns  
Broken  
Replace

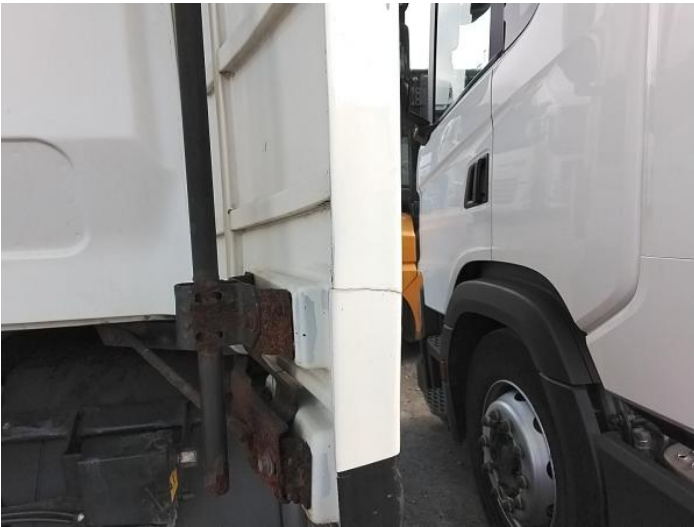
11: Qtr Panel Trim os  
Broken  
Replace

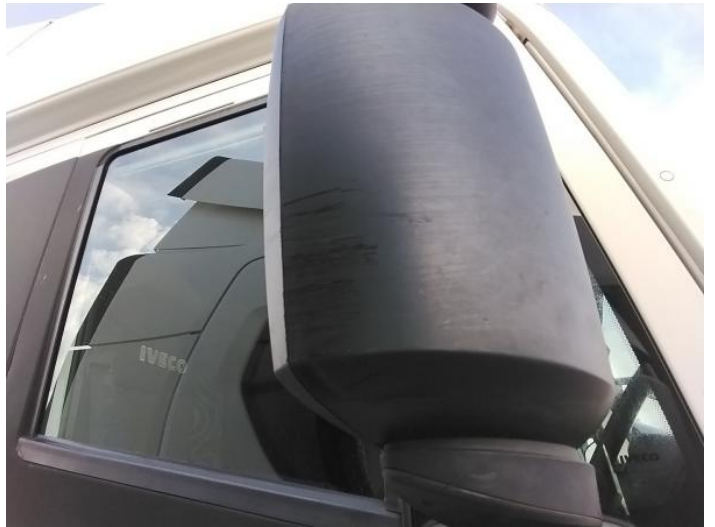
12: Door Mirror Assy osf  
Scuffed (Unpainted)  
Over 100mm

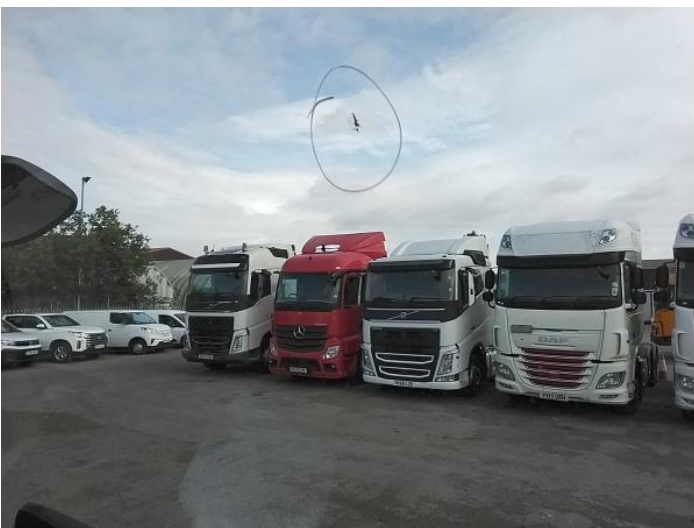
13: Screen Front  
Chipped  
Over 10mm

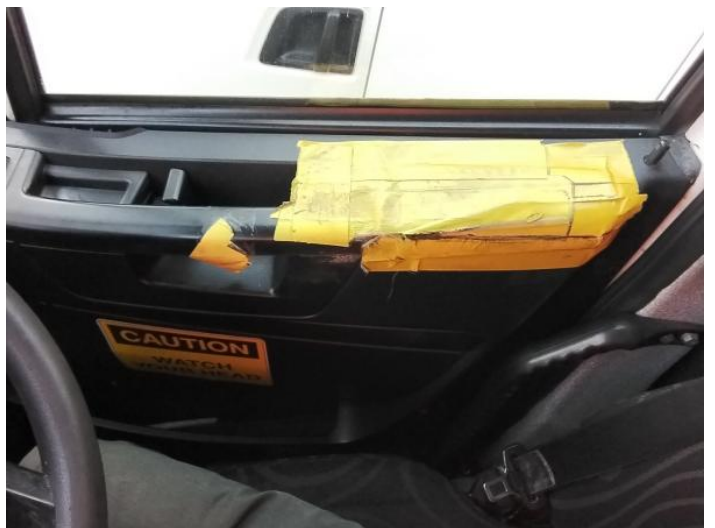
14: Door Pad osf  
Broken  
Replace

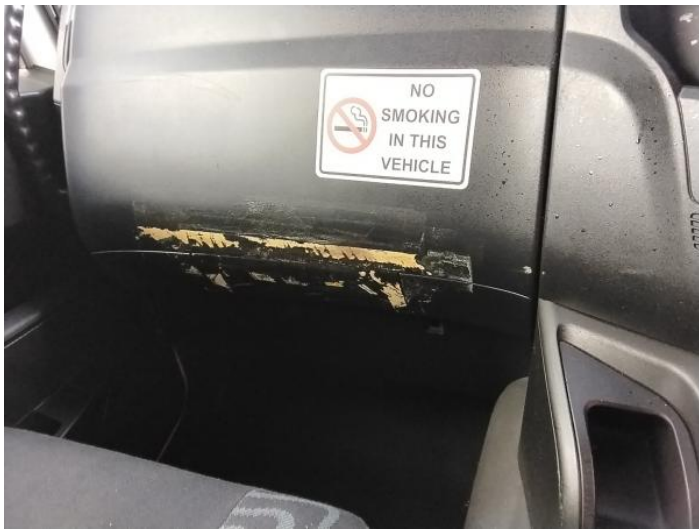
15: Fascia Panel  
Scuffed  
Over 25mm
