VEHICLE INSPECTION REPORT

YB64AEK

Renault Kangoo ML19dCi 90 eco2

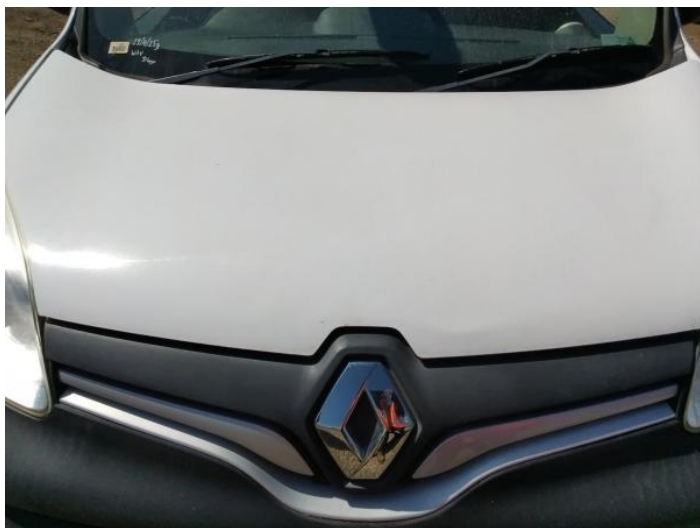
1: Bonnet
Chipped
Multiple Chips

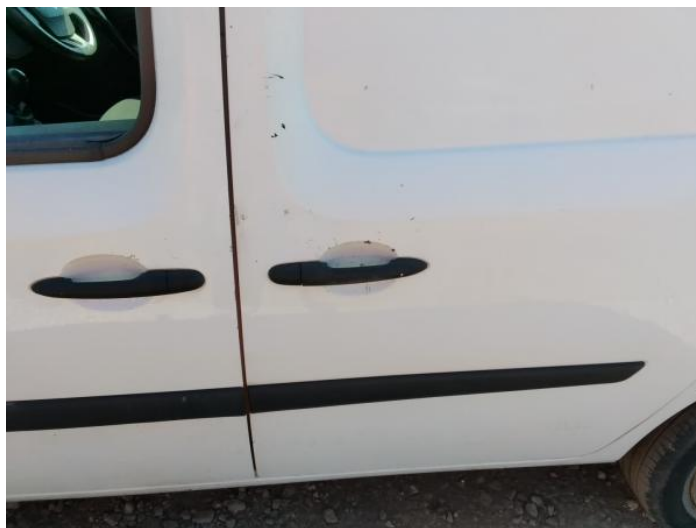
2: Qtr Panel nsr
Chipped
Multiple Chips

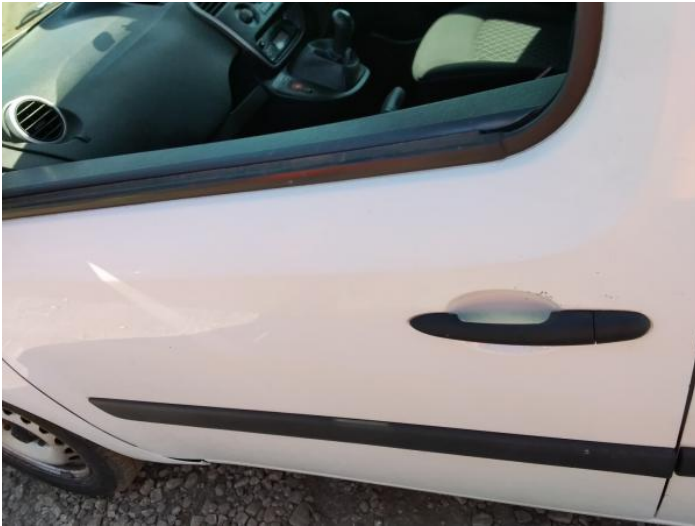
3: B Post ns
Chipped
Multiple Chips

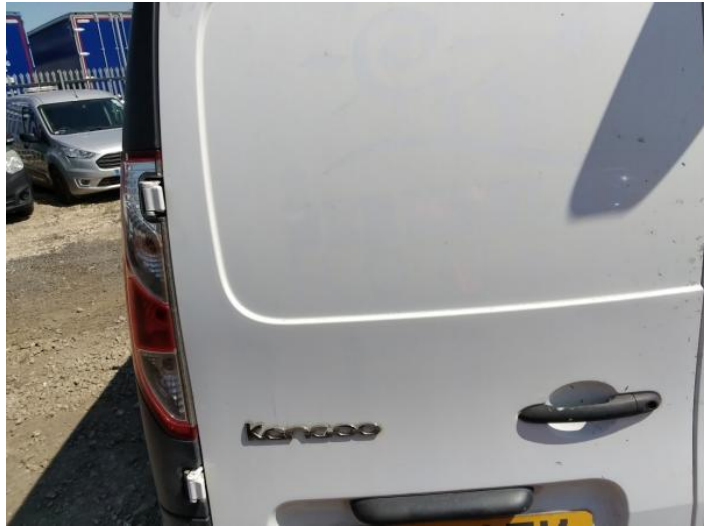
4: D Post os
Chipped
Multiple Chips

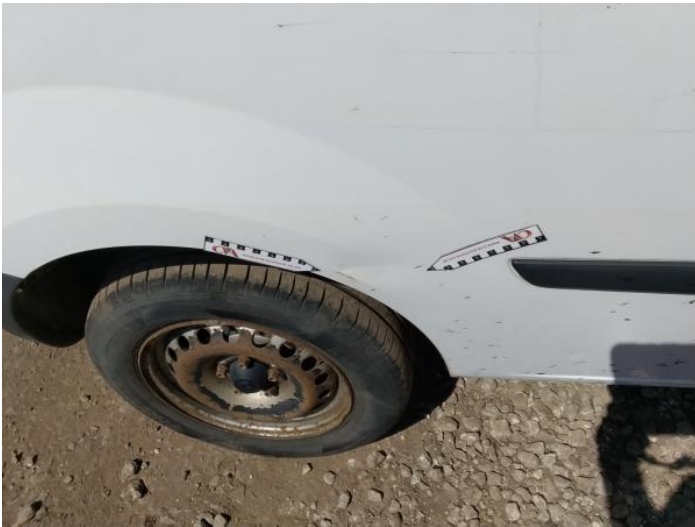
5: Qtr Panel osr
Dented
Over 30mm

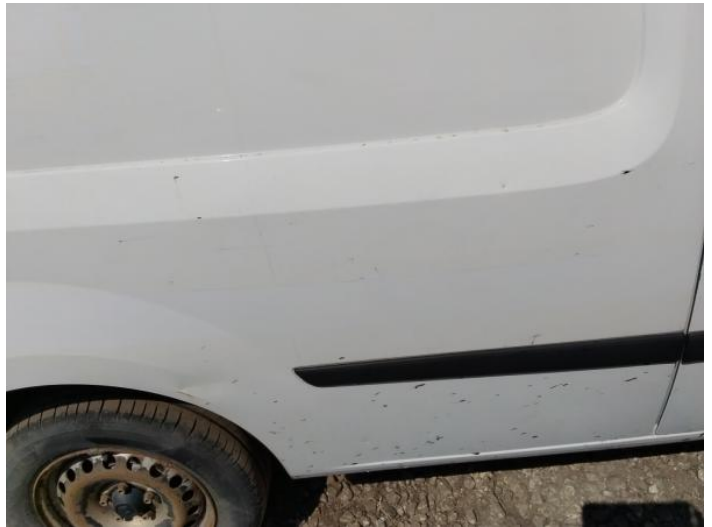
6: Qtr Panel osr
Chipped
Multiple Chips

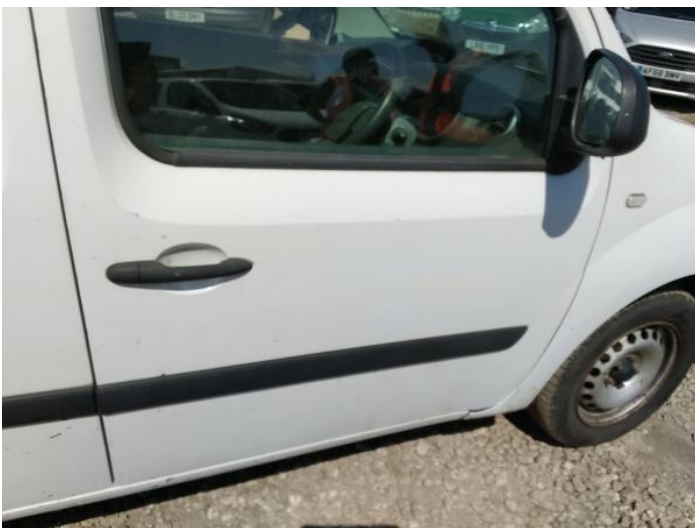
7: B Post os
Chipped
Multiple Chips

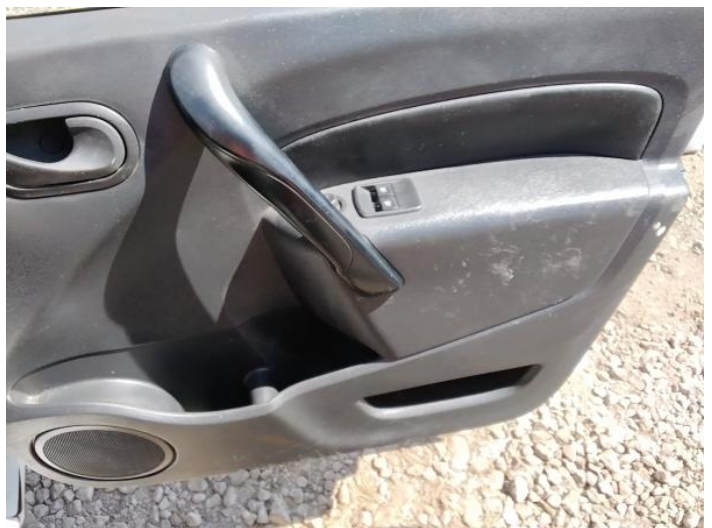
8: Door Pad osf
Scuffed
Over 25mm

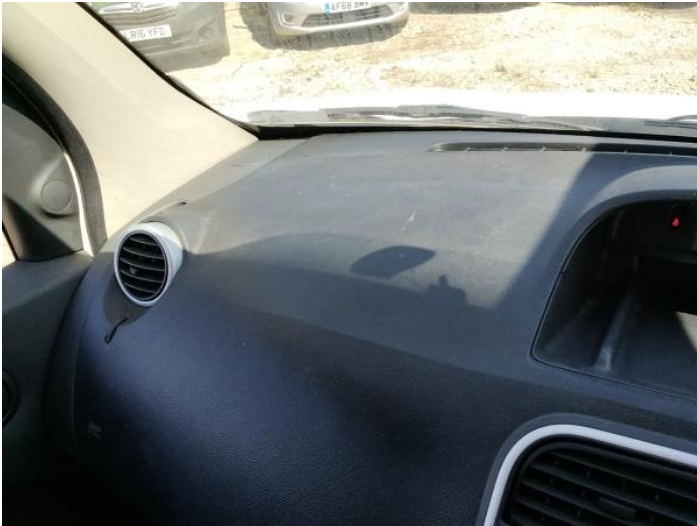
9: Fascia Panel
Soiled
Heavy

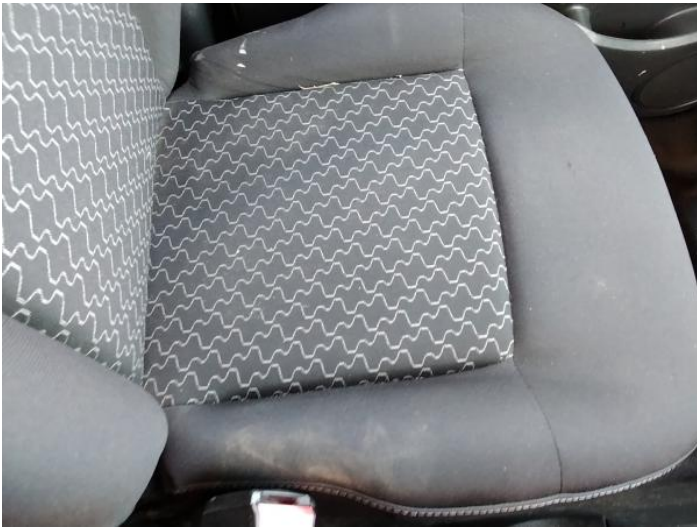
11: Seat Base Cover nsf
Soiled
Heavy

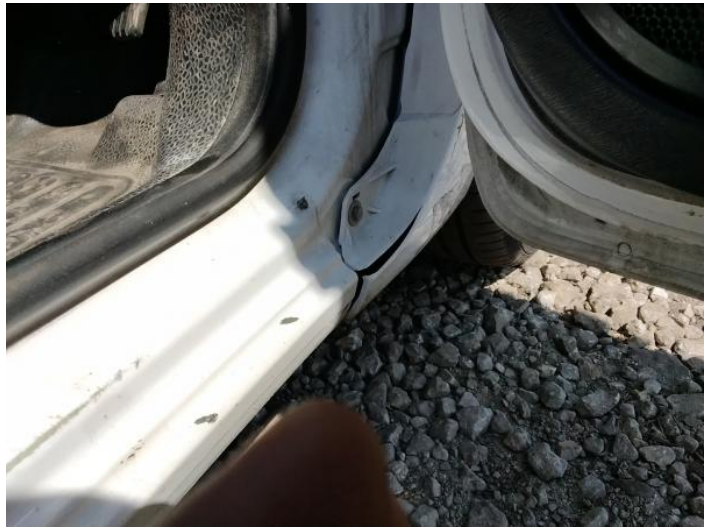
12: Wing osf
Cracked
Replace

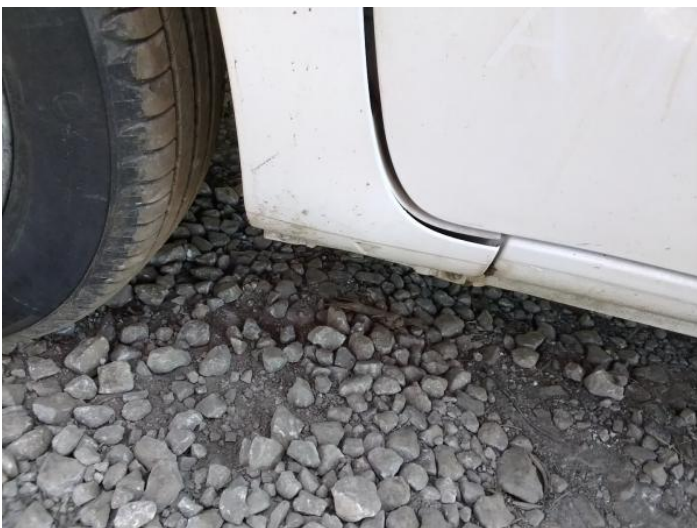
13: Wing nsf
Cracked
Replace
