VEHICLE INSPECTION REPORT

SJ15TWK

Vauxhall Vivaro 2900 1.6CDTI 115PS

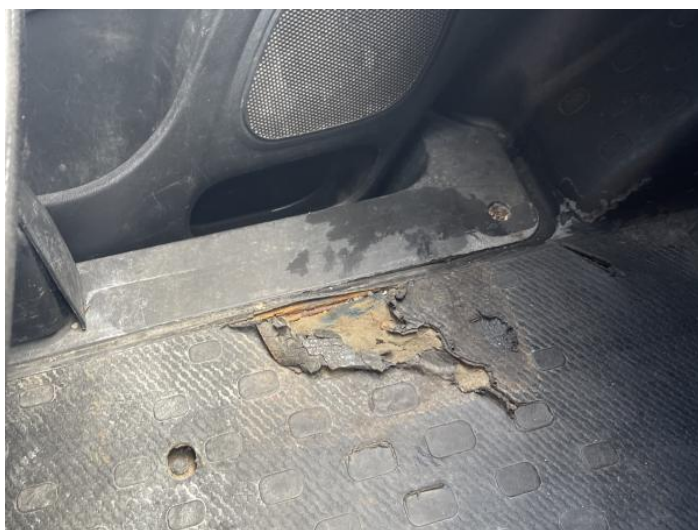
1: Carpets Front
Torn
Over 10mm

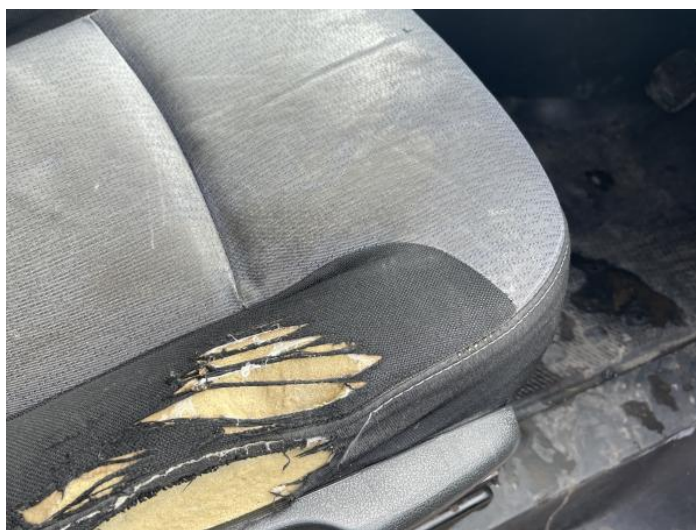
2: Seat Base Cover osf
Torn
Over 3mm

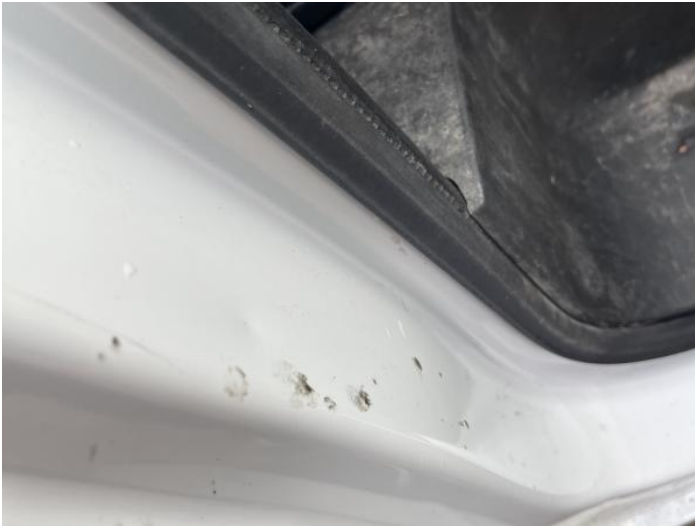
3: Sill os
Dented
Over 30mm

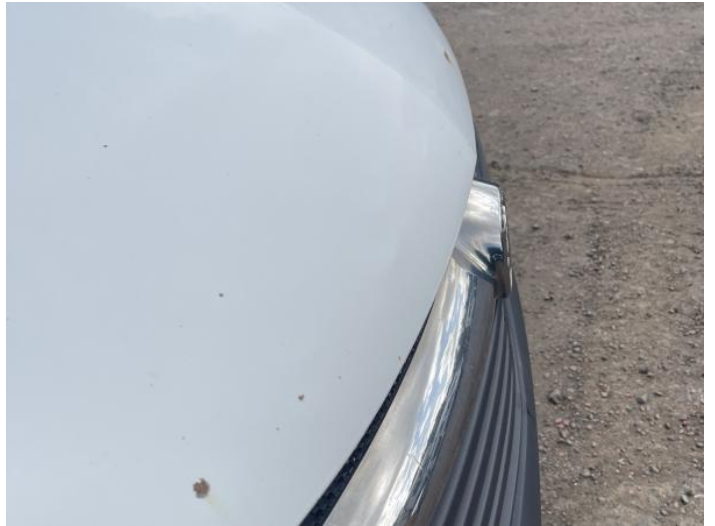
4: Bonnet
Dented
With Paint Damage

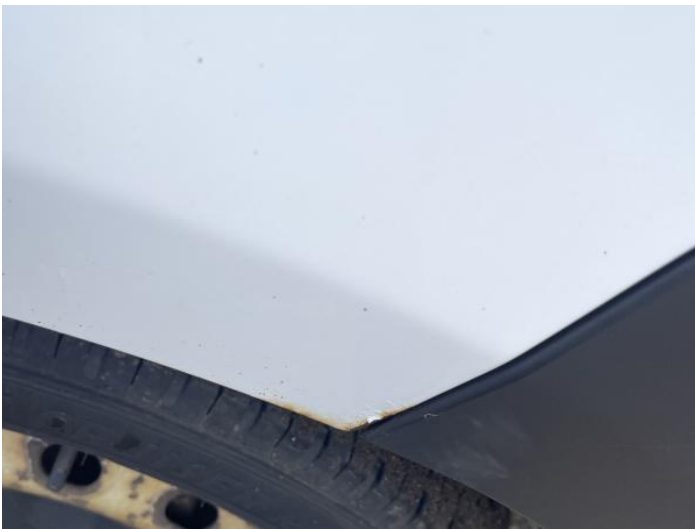
5: Wing osf
Rusted
Over 5mm

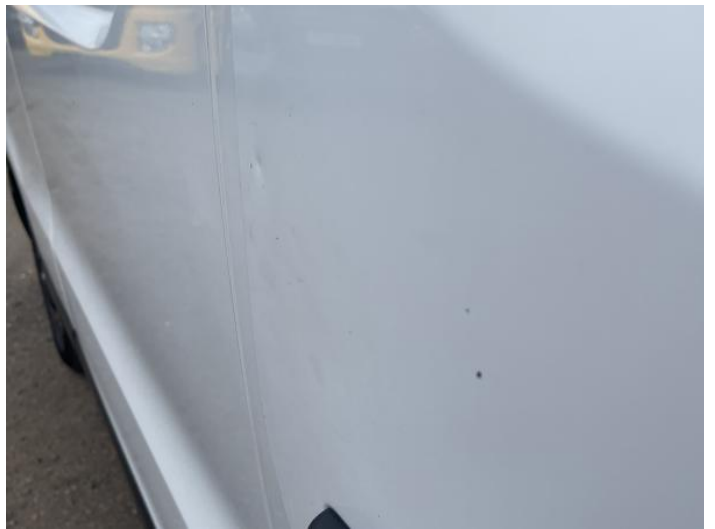
6: Door osf
Dented
Over 2 UpTo 10mm

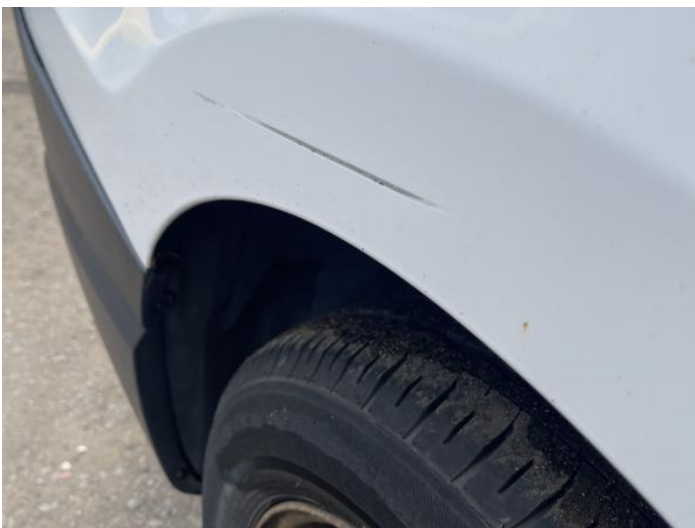
7: Qtr Panel osr
Dented
With Paint Damage

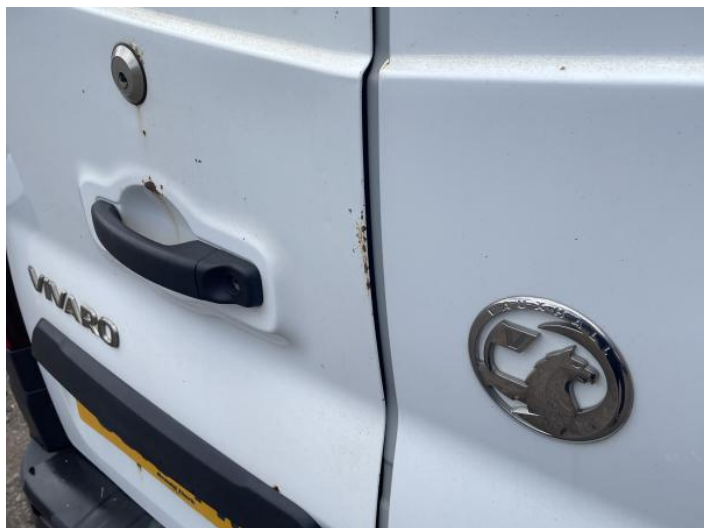
8: Tailgate
Dented
With Paint Damage

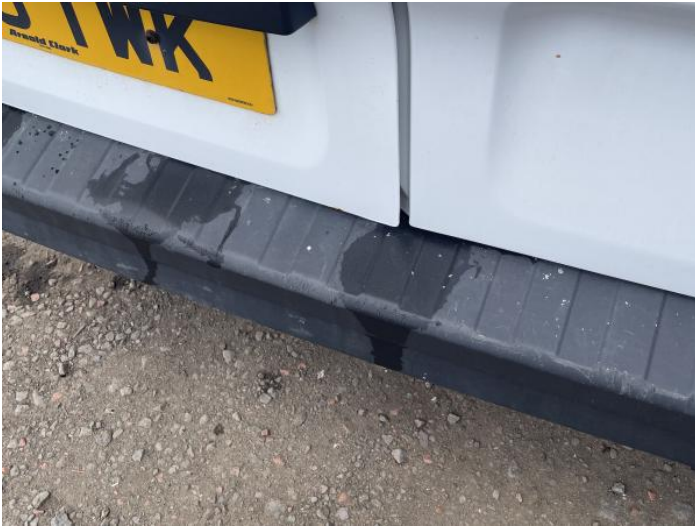
9: Bumper Rear Moulding
Scuffed (Unpainted)
Over 100mm

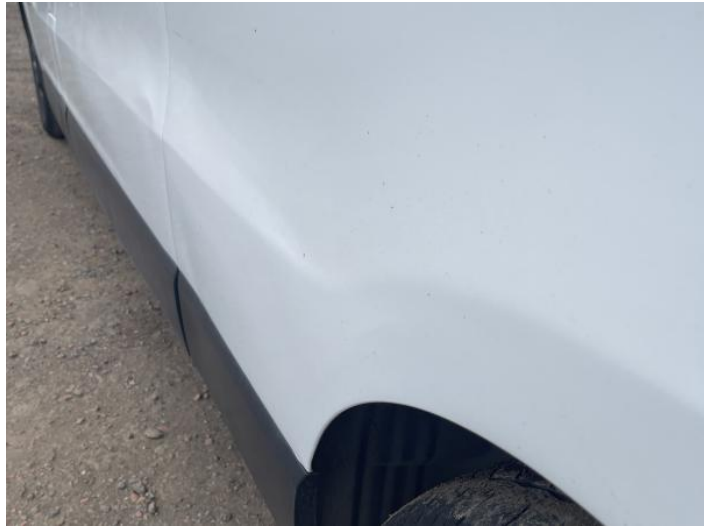
10: Qtr Panel nsr
Dented
With Paint Damage

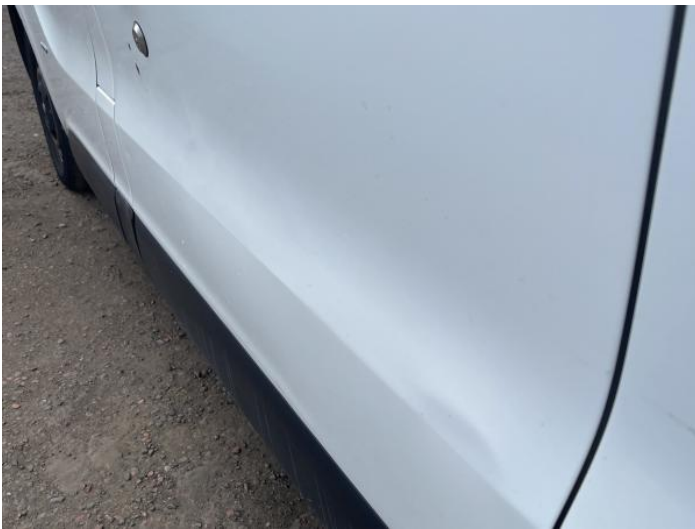
11: Door nsr
Dented
Over 30mm

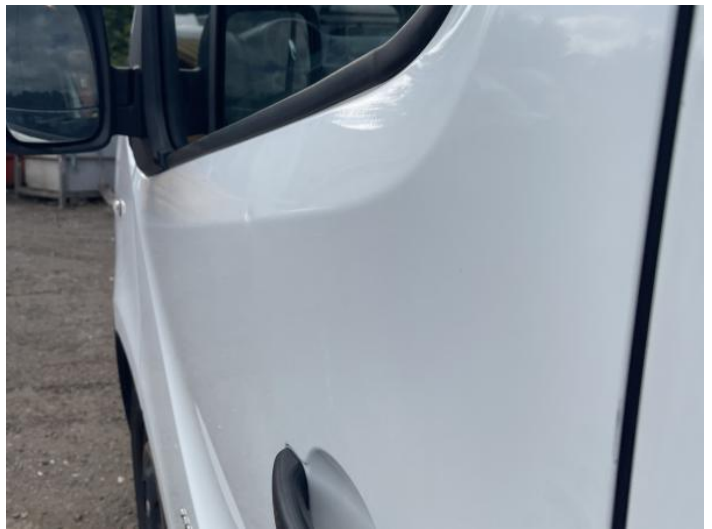
12: Door nsf
Dented
With Paint Damage

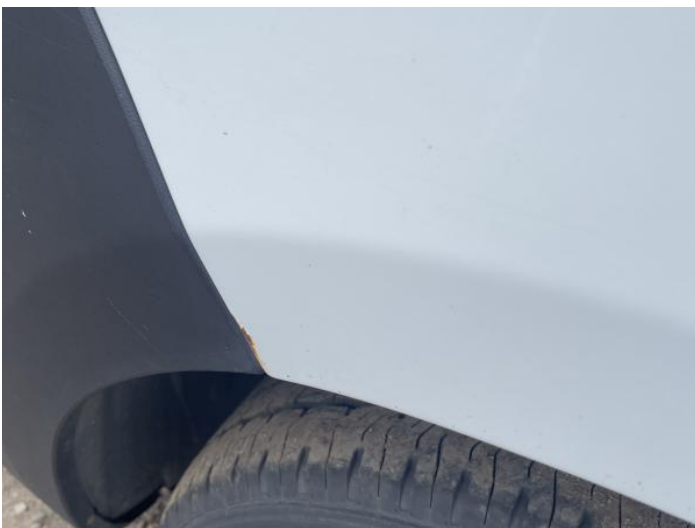
13: Wing nsf
Rusted
Over 5mm

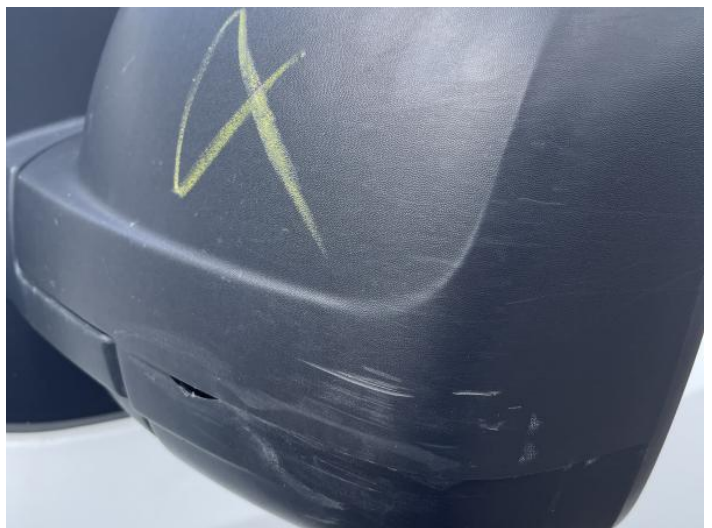
14: Door Mirror Assy nsf
Broken
Replace
