# VEHICLE INSPECTION REPORT

**SJ15TZL**

## Vauxhall Vivaro 2900 1.6CDTI 115PS

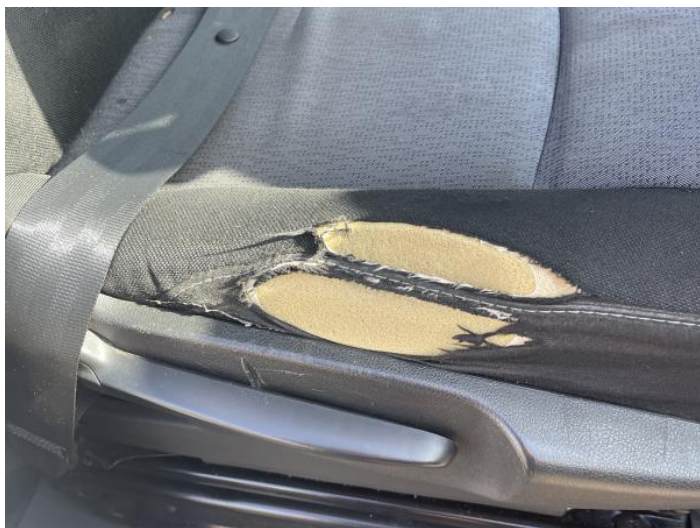
1: Seat Base Cover osf  
Torn  
Over 3mm

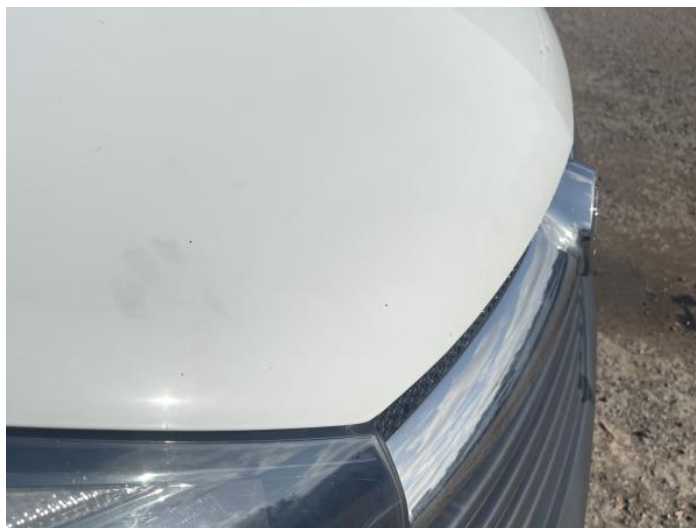
2: Bonnet  
Dented  
With Paint Damage

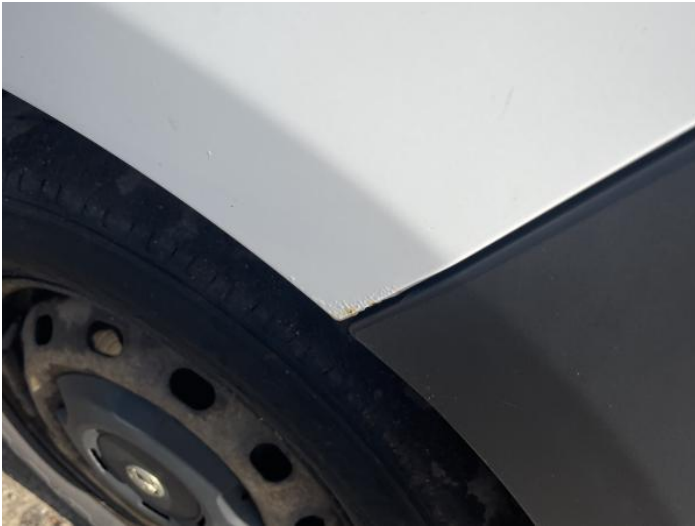
3: Wing osf  
Rusted  
Over 5mm

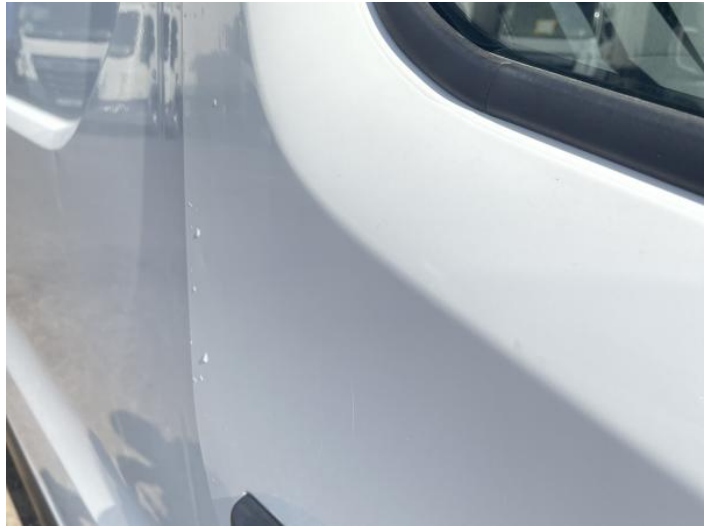
4: Door osf  
Dented  
With Paint Damage

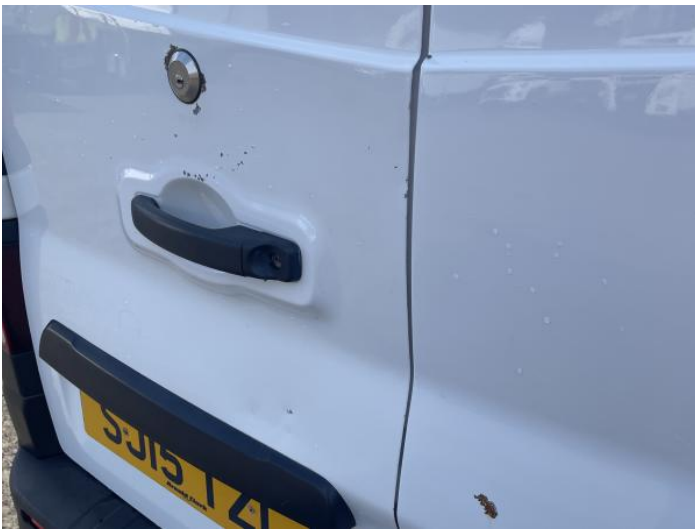
5: Tailgate  
Dented  
With Paint Damage

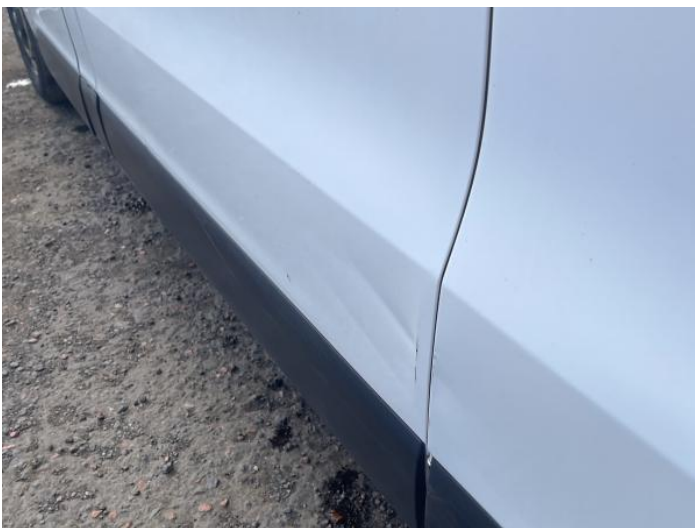
7: Door nsr  
Dented  
With Paint Damage
