VEHICLE INSPECTION REPORT

G120AK

Man TGM 18.240

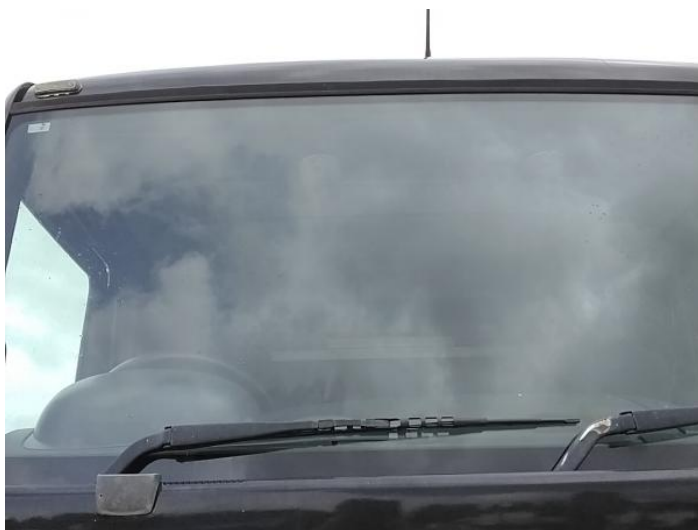
1: Screen Front
Chipped
UpTo 10mm

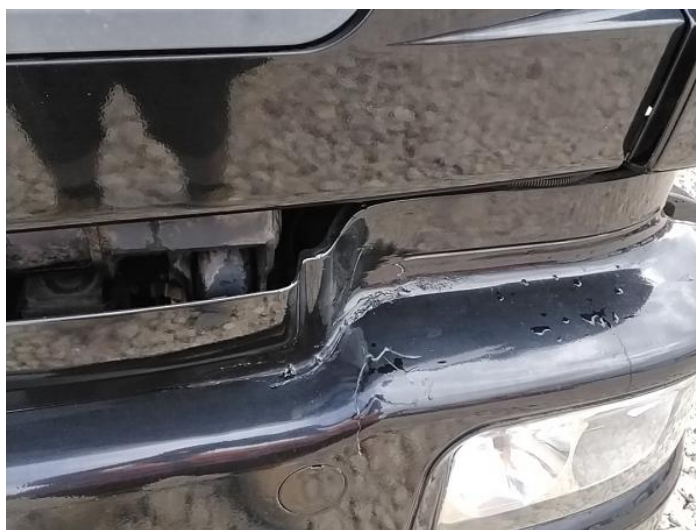
2: Bumper Front
Cracked
UpTo 25mm

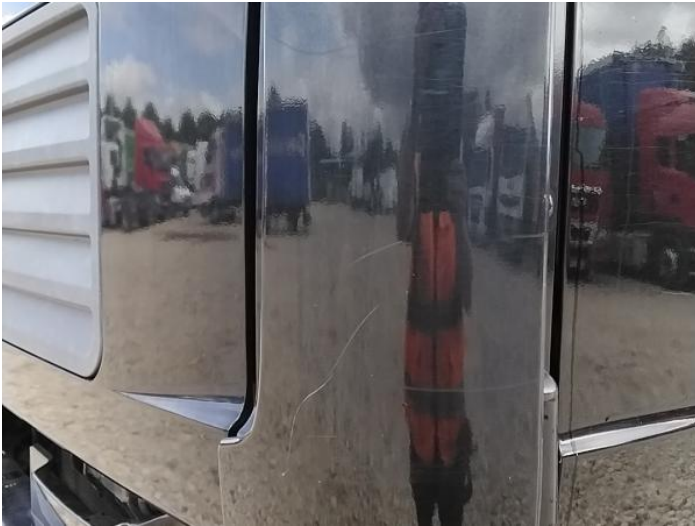
3: Wing nsf
Scratched
UpTo 25mm Thru Paint

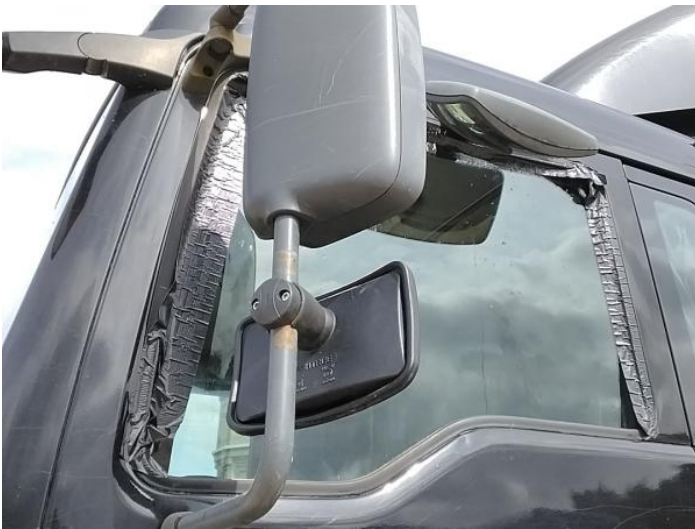
5: Door Mirror Assy nsf
Scuffed (Unpainted)
UpTo 100mm

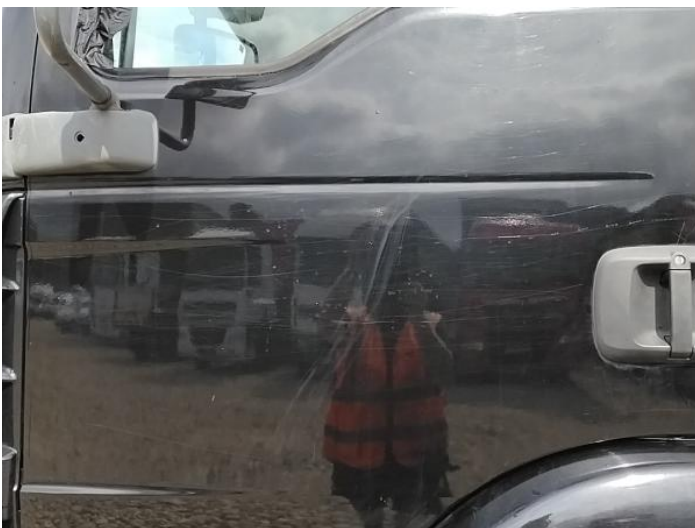
7: Door nsf
Scratched
Over 25mm Not Thru Paint

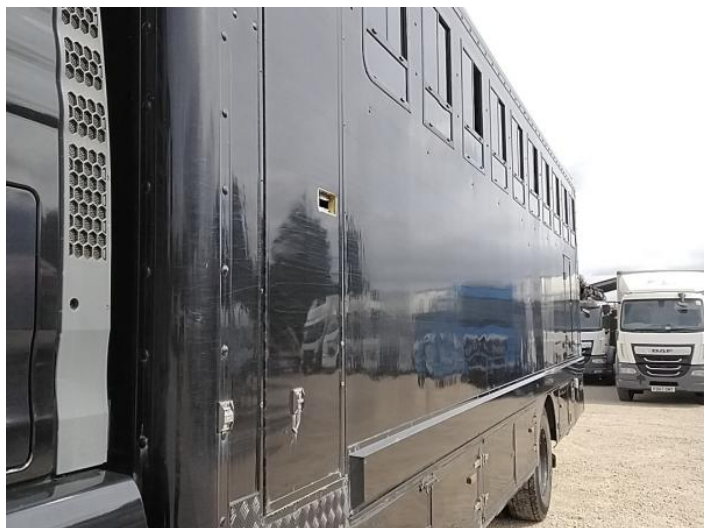
8: Qtr Panel nsr
Scratched
Over 25mm Not Thru Paint

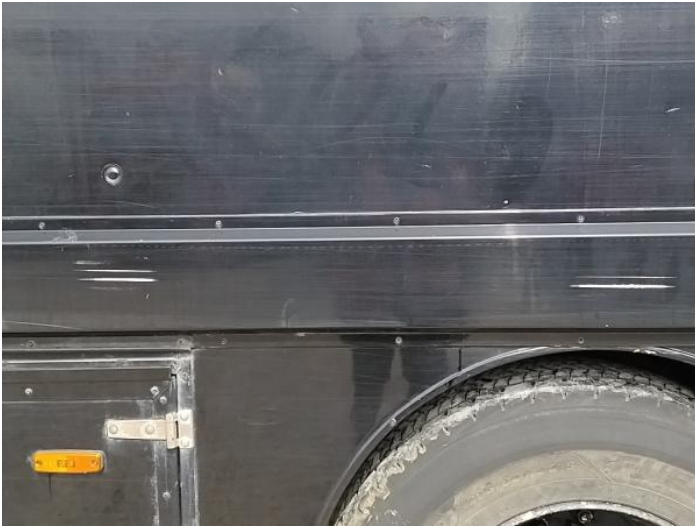
9: Qtr Panel nsr
Scratched
Over 25mm Thru Paint

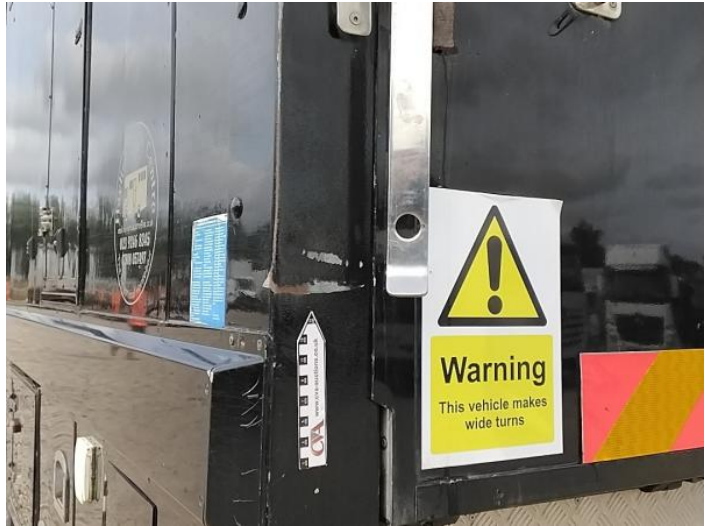
10: Panel Rear
Scratched
UpTo 25mm Thru Paint

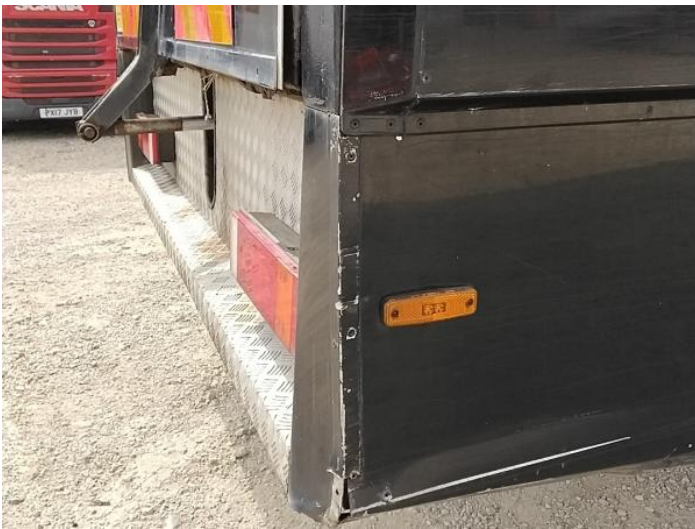
11: Qtr Panel osr
Hole
Over 10mm

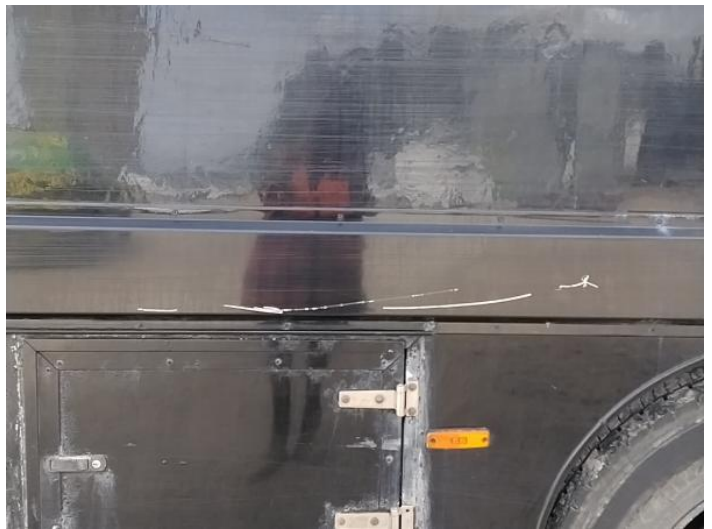
12: Qtr Panel osr
Scratched
Over 25mm Thru Paint

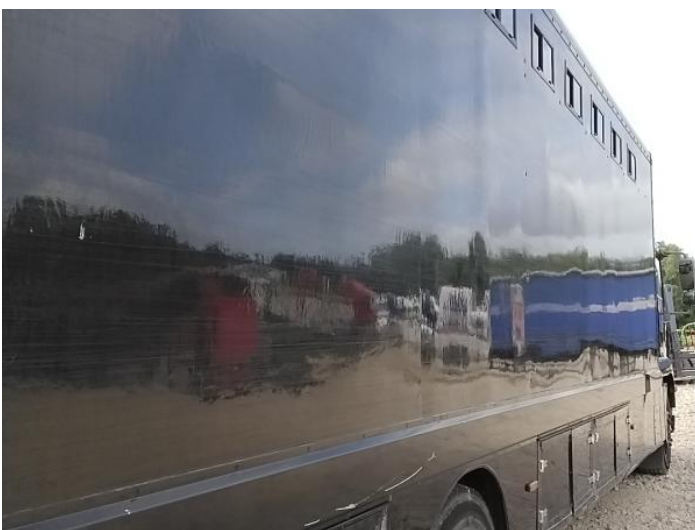
13: Qtr Panel osr
Scratched
Over 25mm Not Thru Paint

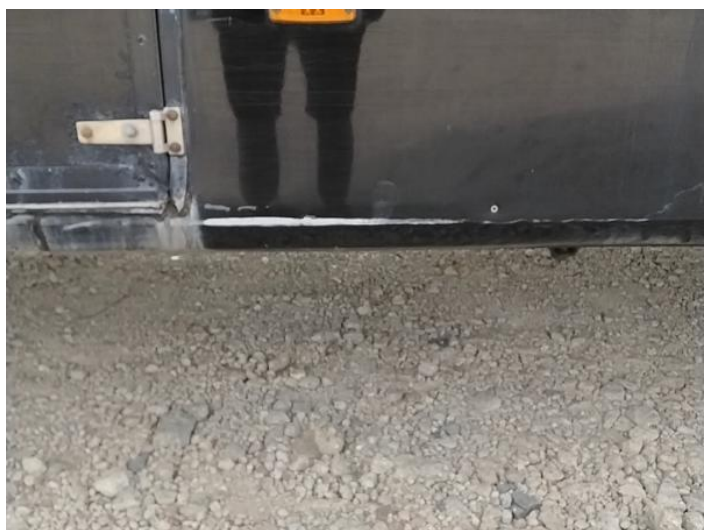
14: Qtr Panel osr
Scratched
Over 25mm Thru Paint

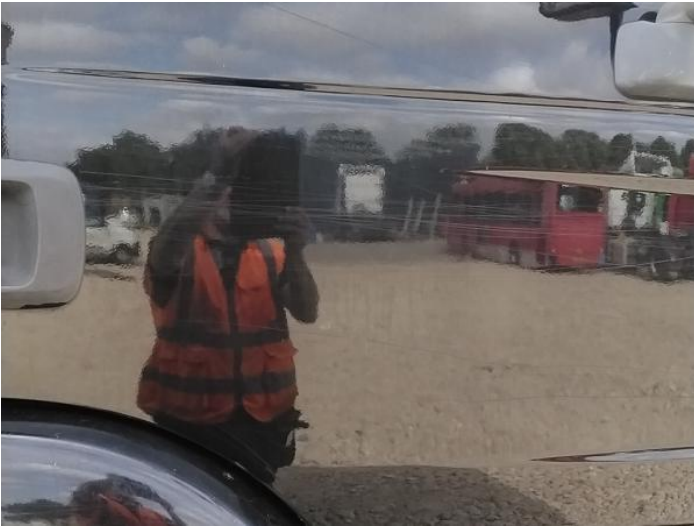
15: Door osf
Scratched
Over 25mm Not Thru Paint

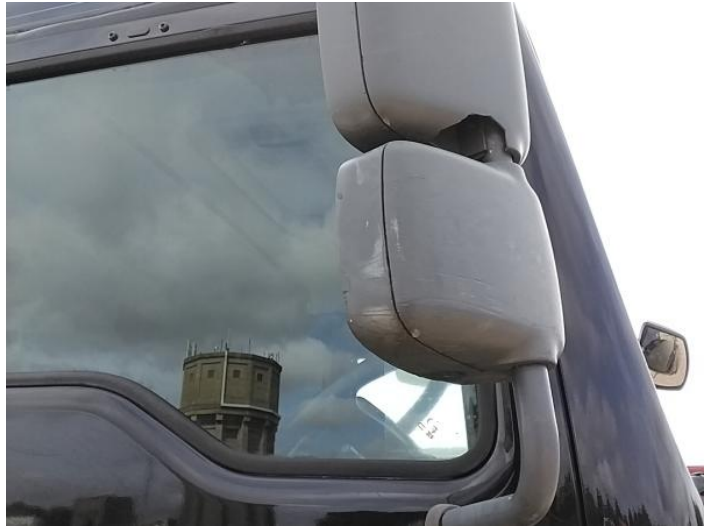
16: Door Mirror Assy osf
Broken
Replace

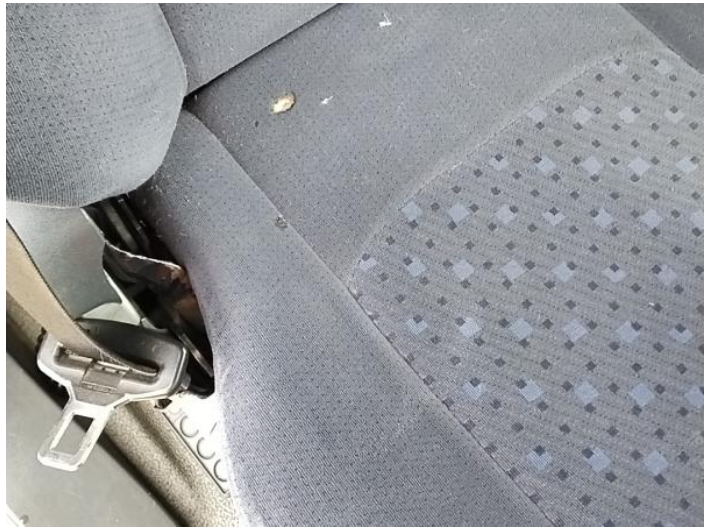
18: Seat Base Cover osf
Burn
Over 3mm

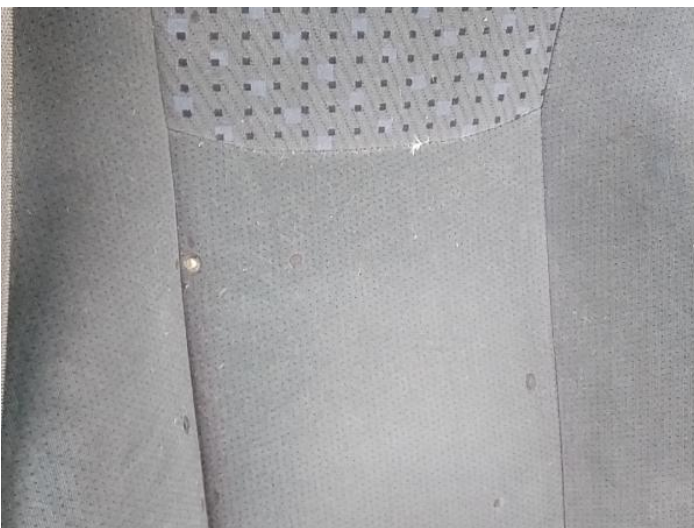
19: Seat Back Cover osf
Burn
Over 3mm
