VEHICLE INSPECTION REPORT

PN17HZE

Daf LF 260

NON RUNNER - NO GEARBOX

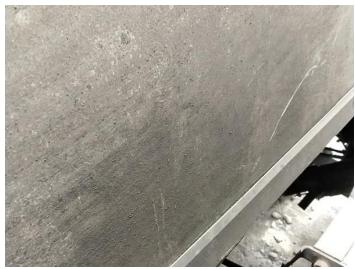
1: Unclassified Major Parts Missing Report Only

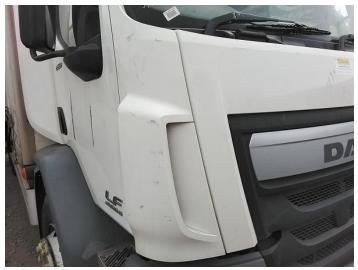
2: Panel Front Scratched Over 25mm Thru Paint

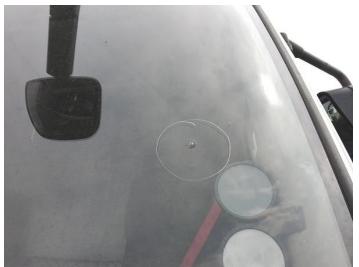
3: Screen Front Cracked Replace

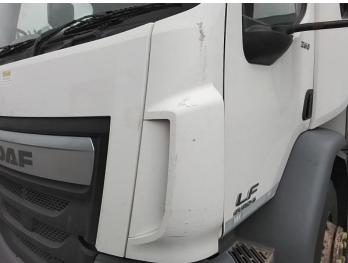
4: Panel Front Scratched Over 25mm Thru Paint

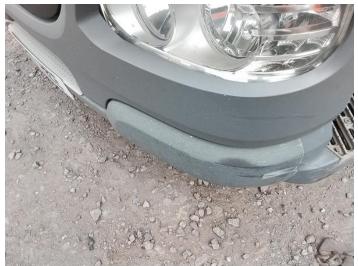
5: Bumper Front Dented With Paint Damage

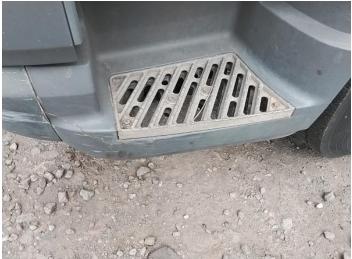
6: Bumper Front Moulding Broken Replace

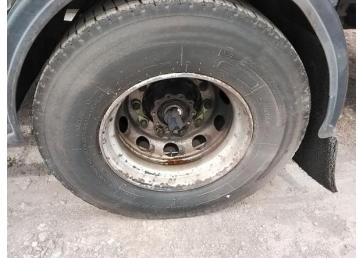
7: Unclassified Major Parts Missing Report Only

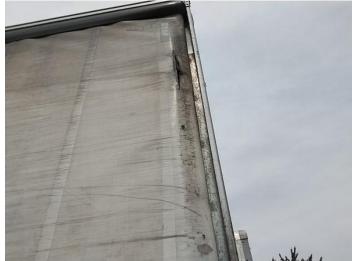
8: Qtr Panel nsr Hole Over 10mm

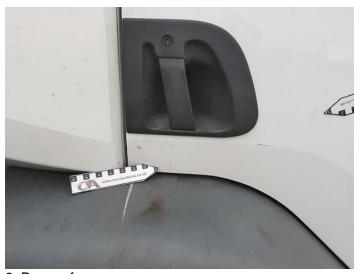
9: Door osf Scratched Over 25mm Thru Paint

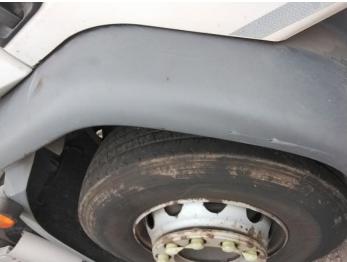
10: Wing osf Scratched Over 25mm Thru Paint

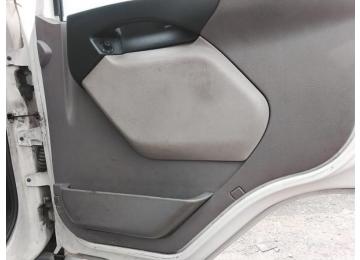
11: Door Pad osf Soiled Heavy

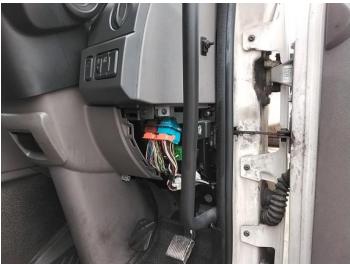
12: Fascia Panel Missing Replace
