# VEHICLE INSPECTION REPORT

**FG65JWO**

## Mercedes-Benz Antos 1842

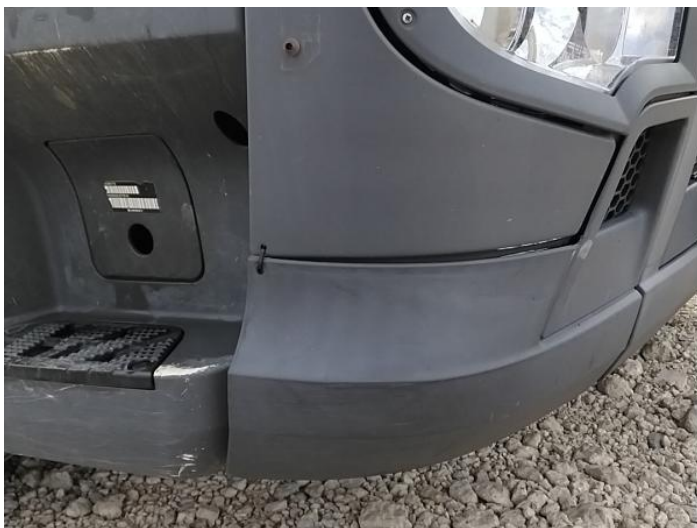
1: Bumper Front Moulding  
Broken  
Replace

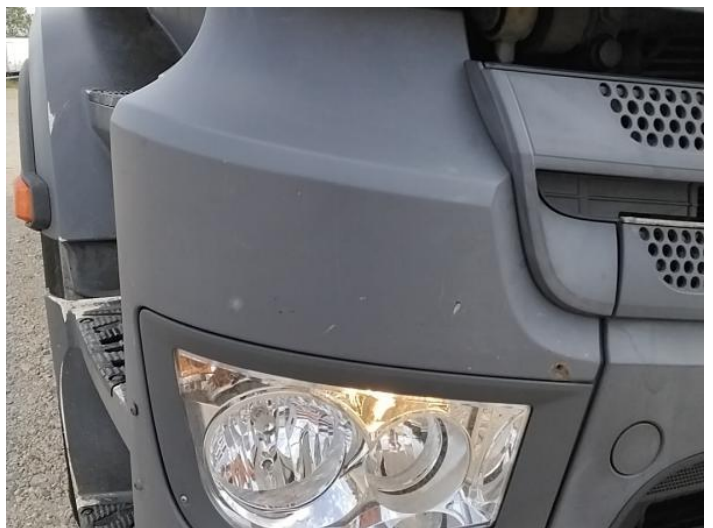
2: Fog Lamp Surround is  
Scuffed (Unpainted)  
Up To 100mm

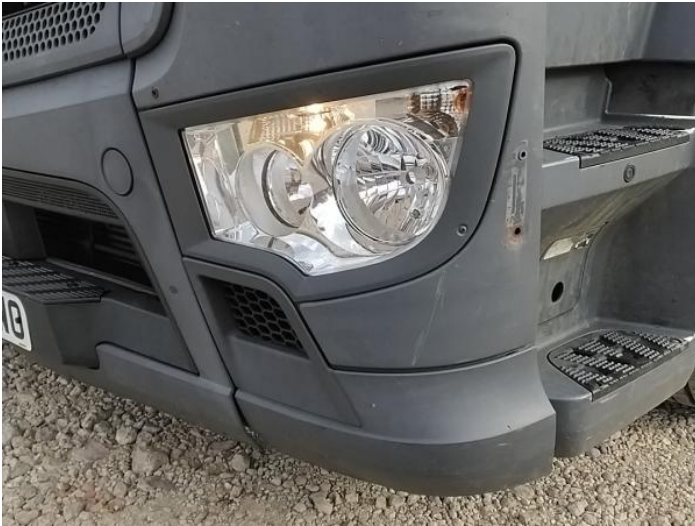
3: Fog Lamp Surround ns  
Scuffed (Unpainted)  
UpTo 100mm

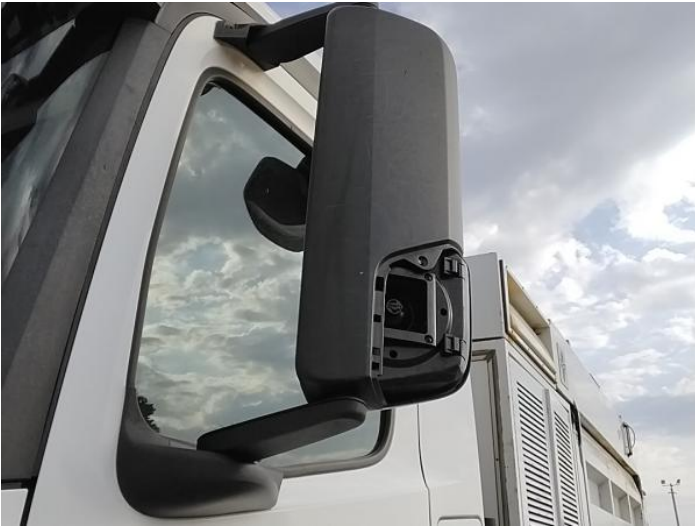
4: Door Mirror Assy nsf  
Missing  
Replace

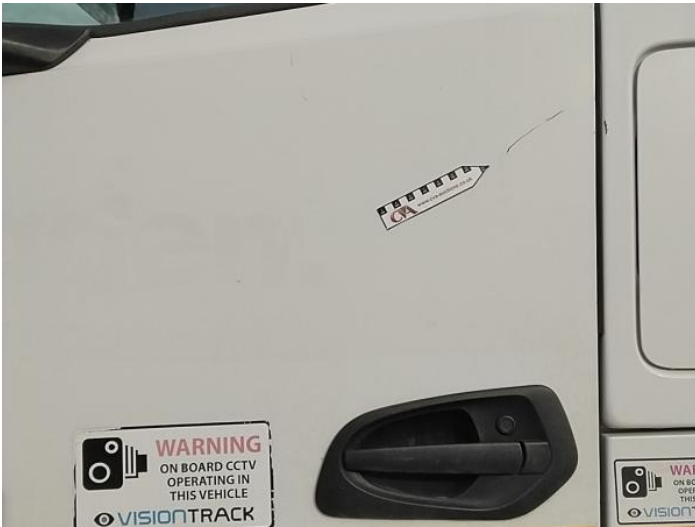
5: Door nsf  
Scratched  
UpTo 25mm Thru Paint

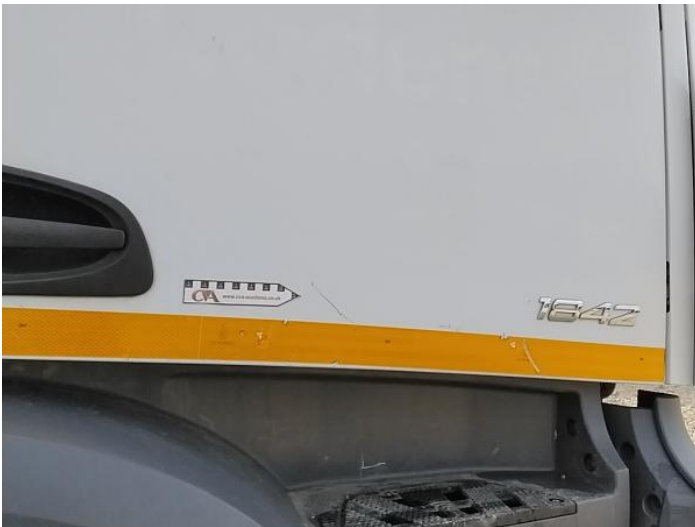
7: Door osf  
Scratched  
UpTo 25mm Thru Paint

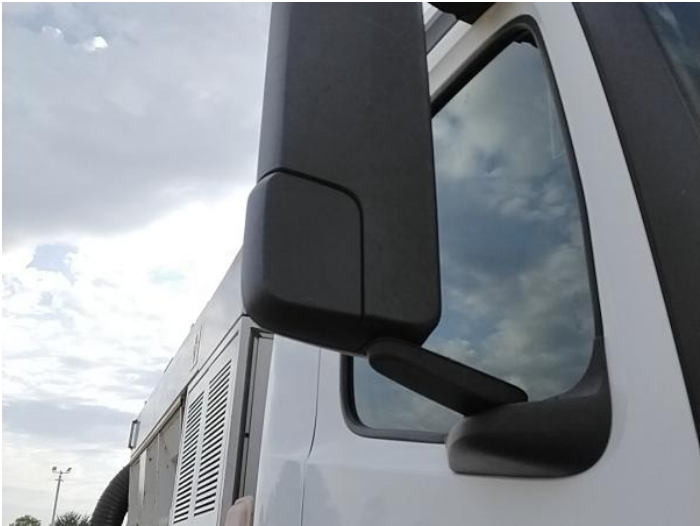
9: Door Mirror Assy osf  
Scuffed (Unpainted)  
UpTo 100mm
