VEHICLE INSPECTION REPORT

GN65NCO

Daf CF 290

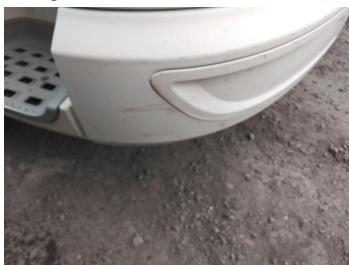
1: Bumper Front Scratched Over 100mm Thru Paint

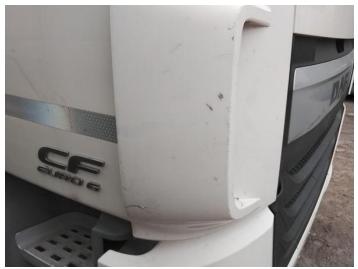
2: Panel Front Cracked Replace

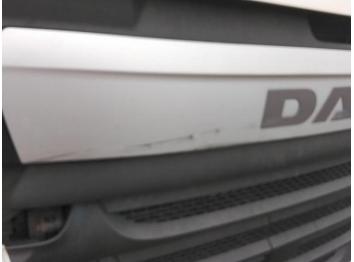
3: Bonnet Scratched Over 25mm Thru Paint

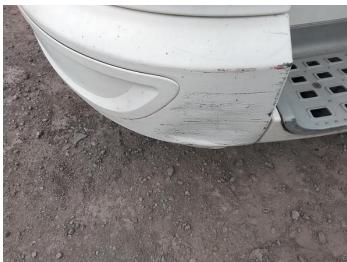
4: Bumper Front Dented With Paint Damage

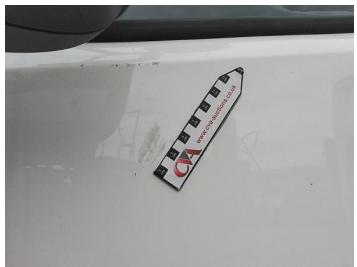
5: Door nsf Scratched Over 25mm Thru Paint

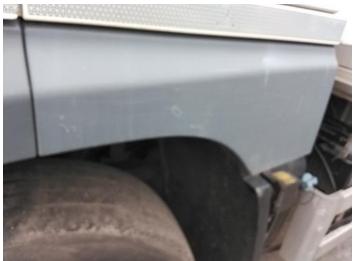
6: Wing nsf Scratched Over 25mm Thru Paint

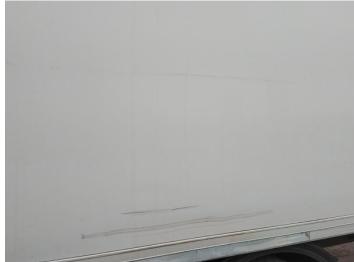
7: Qtr Panel nsr Scratched Over 25mm Thru Paint

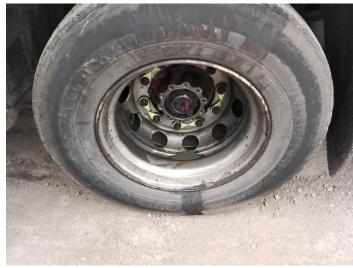
8: Unclassified Major Parts Missing Report Only

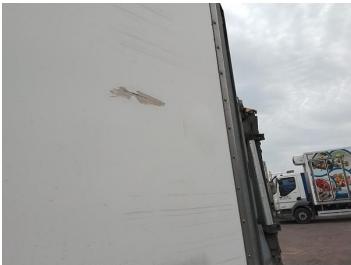
9: Qtr Panel nsr Cracked Replace

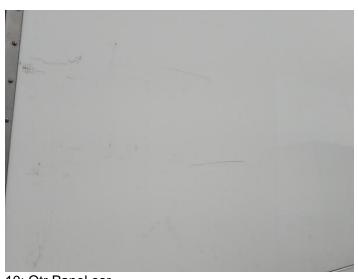
10: Qtr Panel osr Scratched Over 25mm Thru Paint

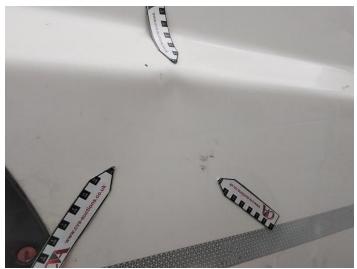
11: Door osf Dented With Paint Damage

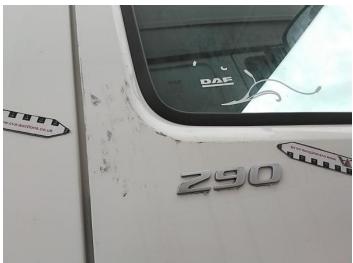
12: Door osf Scratched Over 25mm Thru Paint

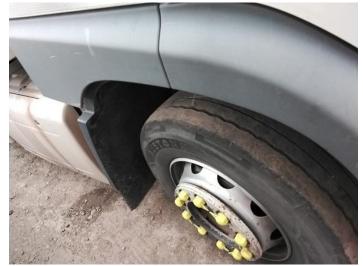
13: Wing osf Scratched Over 25mm Thru Paint

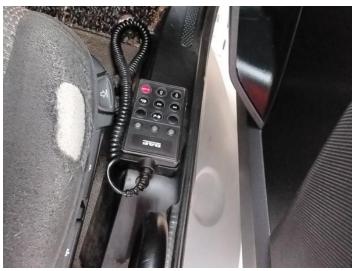
15: Seat Base Cover osf Torn Over 3mm
