VEHICLE INSPECTION REPORT

YB15OHL

Mercedes-Benz Actros 1840

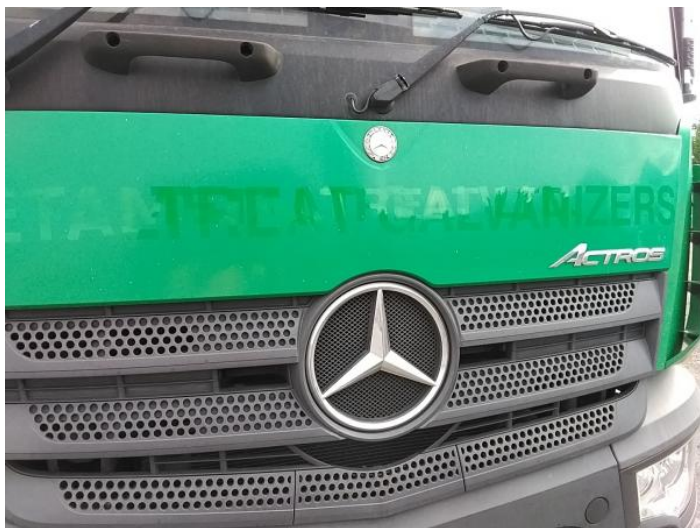
1: Bonnet
Chipped
Multiple Chips

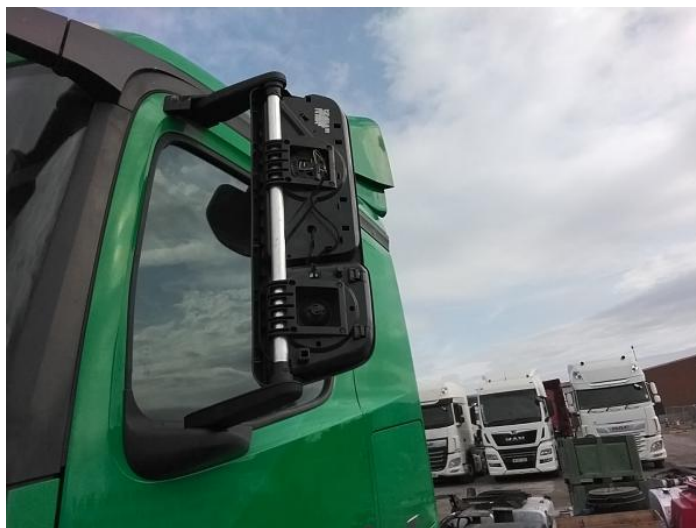
2: Door Mirror Assy nsf
Broken
Replace

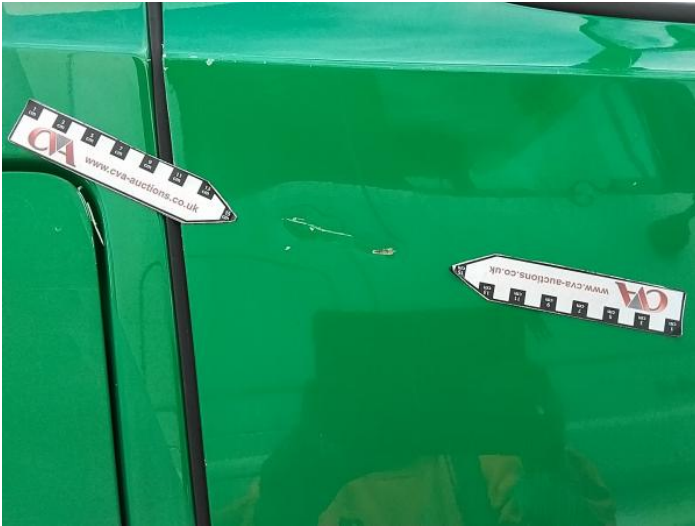
3: Door osf
Dented
With Paint Damage

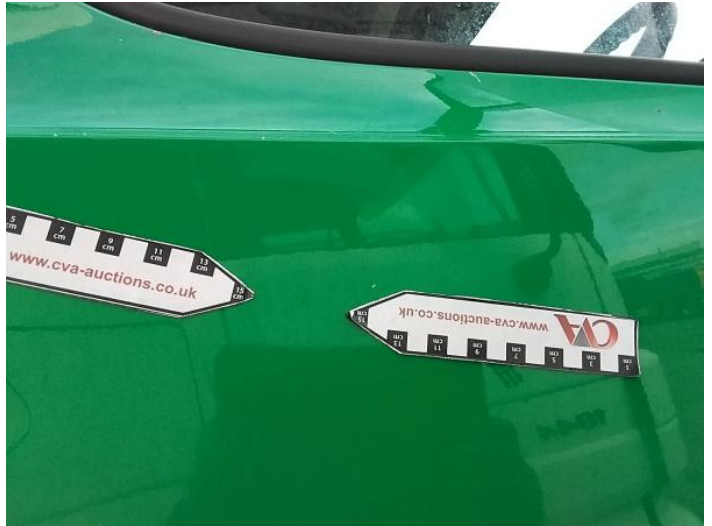
4: Door osf
Dented
Over 30mm

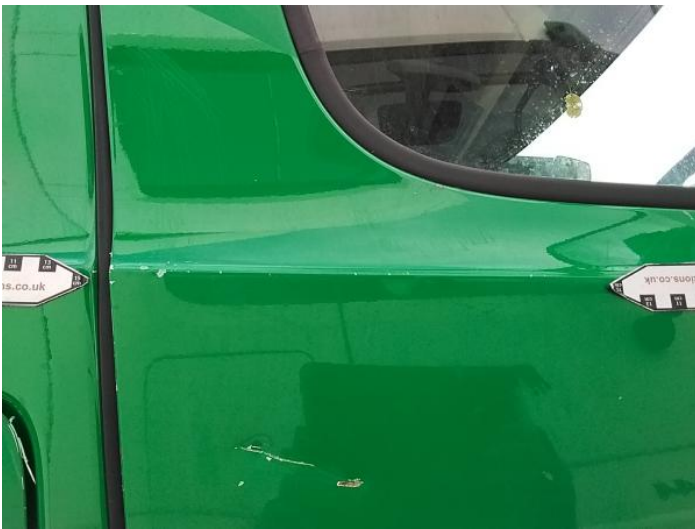
5: Door osf
Scratched
Over 25mm Thru Paint

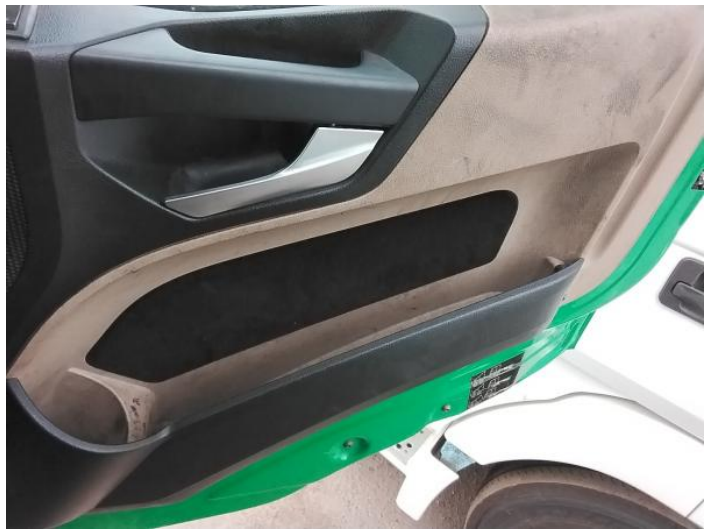
6: Door Pad osf
Soiled
Heavy

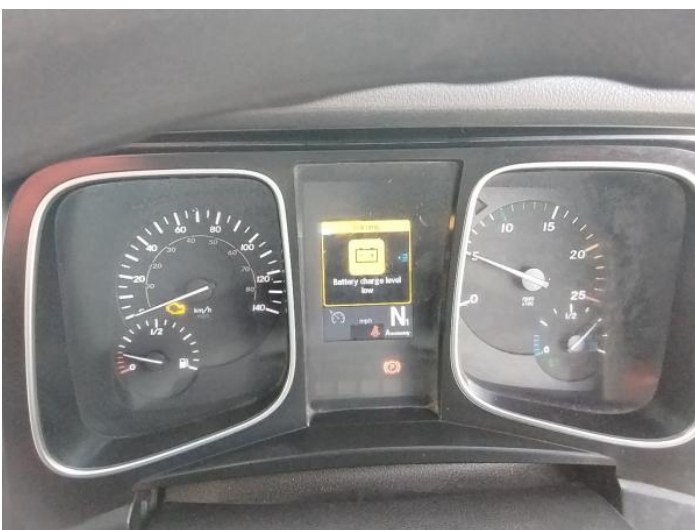
7: Dash Warning Lights
Displayed
No Action

Carpet Condition	OK	Upholstery Condition	Poor
Seat Condition	OK	Odour	-
Engine Runs	OK	No Excessive Smoking	OK
EML light illuminated	OK	DPF light illuminated	Fault
ABS light illuminated	OK
