VEHICLE INSPECTION REPORT

NK15ZVD

Scania P 250

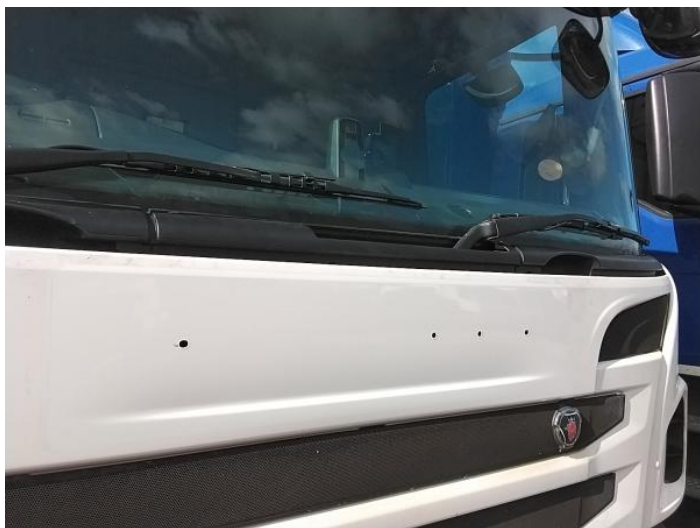
1: Bonnet
Hole
Over 10mm

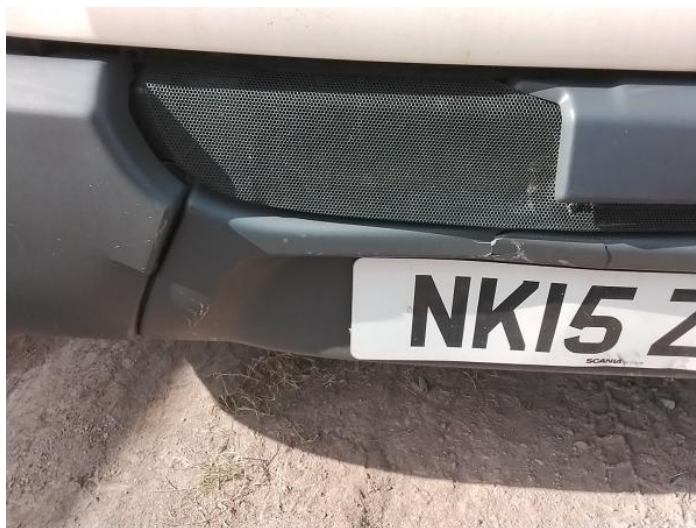
2: Bumper Front
Cracked
Over 25mm

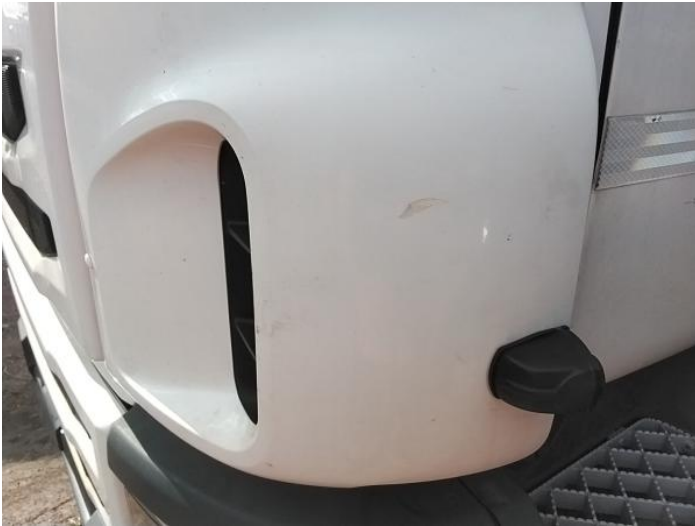
3: Panel Front
Scratched
Over 25mm Thru Paint

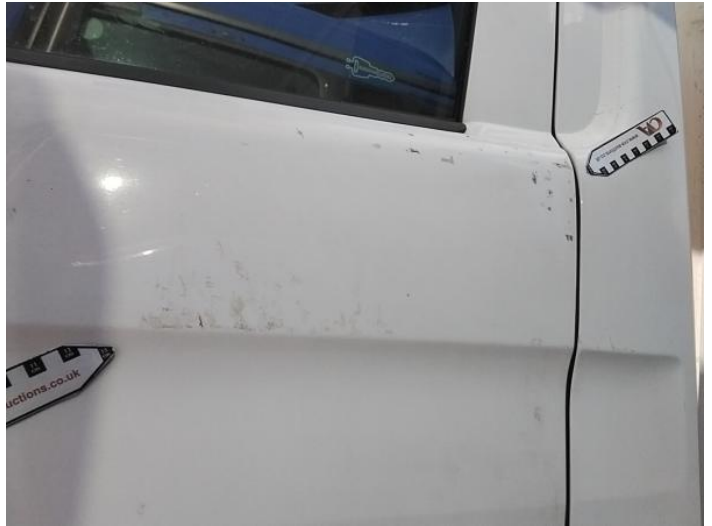
4: Door nsf
Scratched
Over 25mm Thru Paint

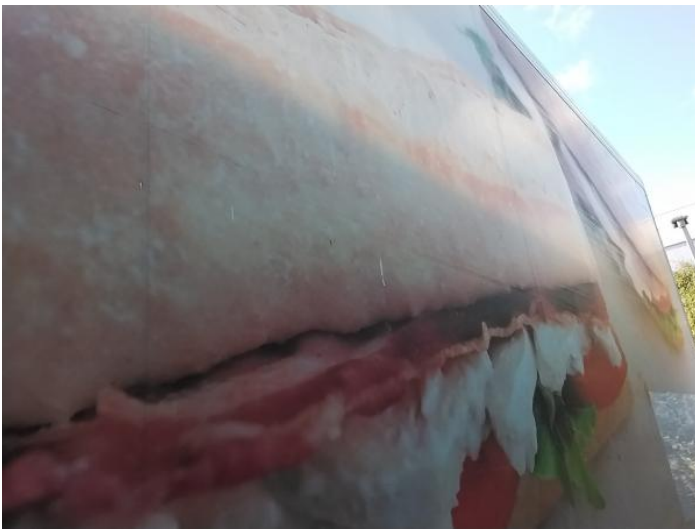
5: Qtr Panel nsr
Scratched
Over 25mm Thru Paint

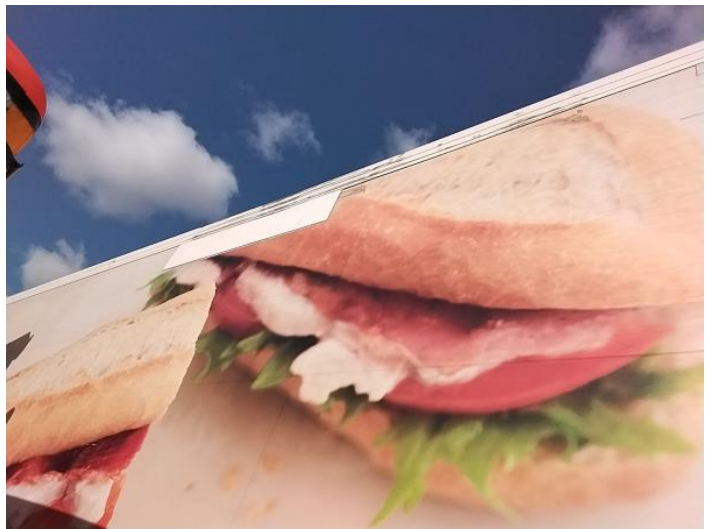
6: Qtr Panel osr
Scratched
Over 25mm Thru Paint

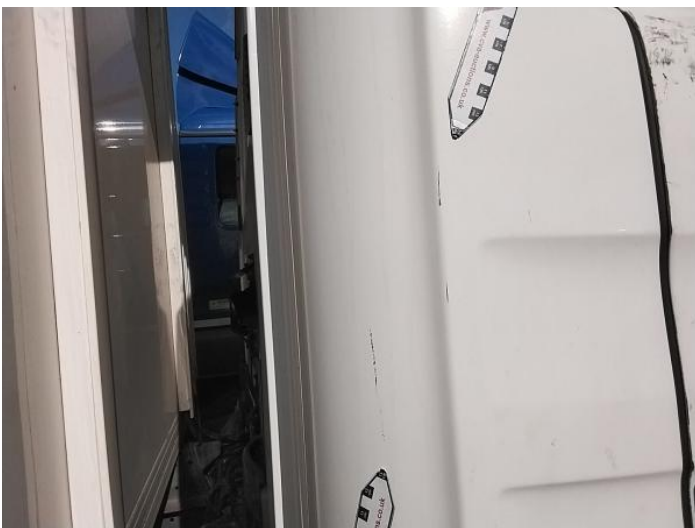
7: B Post os
Scratched
Over 25mm Thru Paint

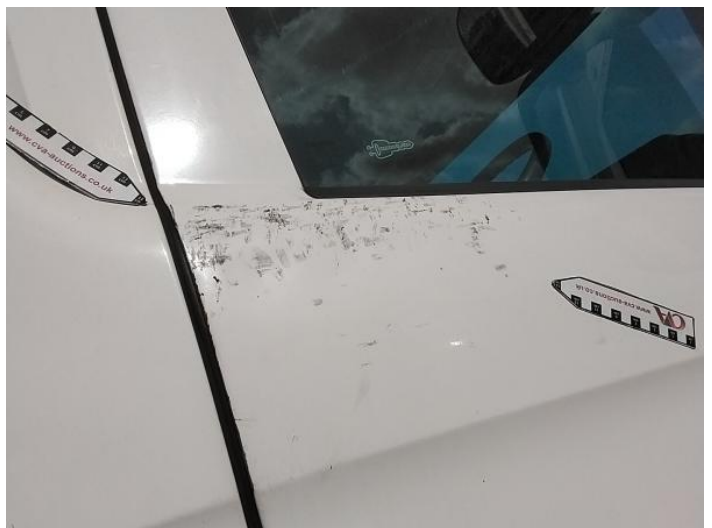
8: Door osf
Scratched
Over 25mm Thru Paint

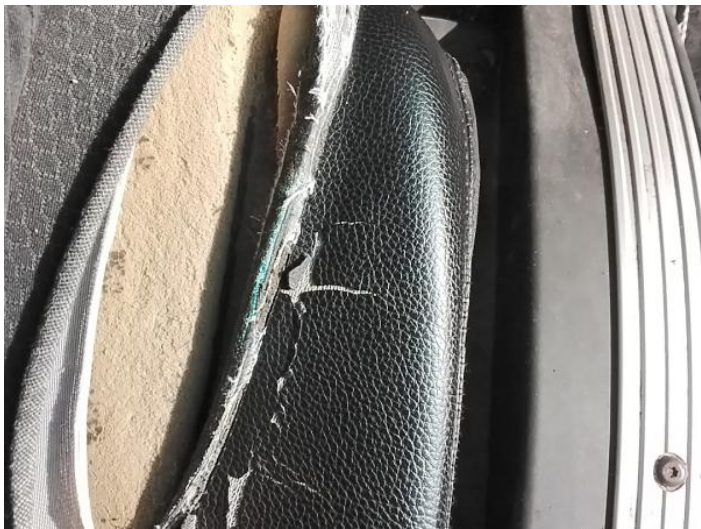
9: Seat Base Cover osf
Torn
Over 3mm
