VEHICLE INSPECTION REPORT

NL69ESV

Scania G 450

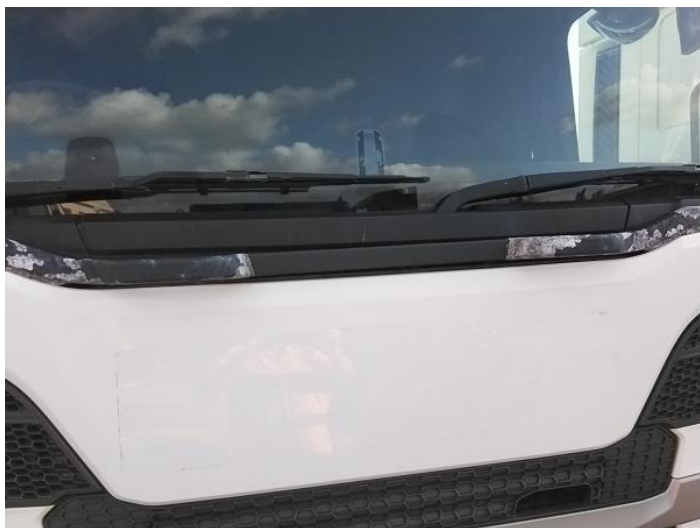
1: Panel Front
Scratched
Over 25mm Thru Paint

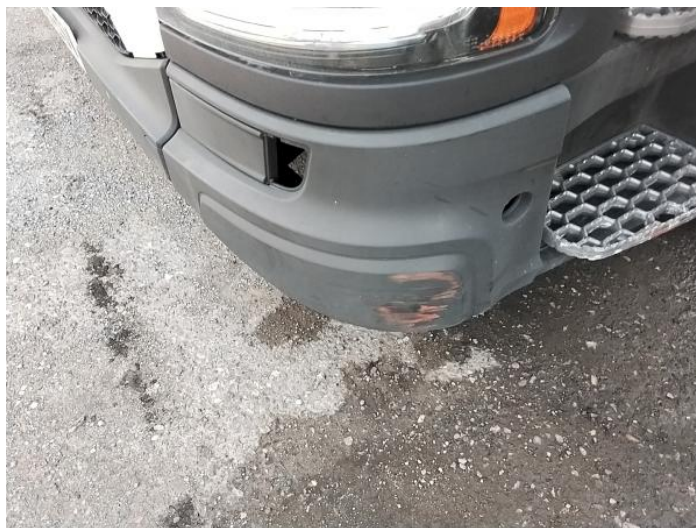
2: Bumper Front
Scratched
Over 100mm Thru Paint

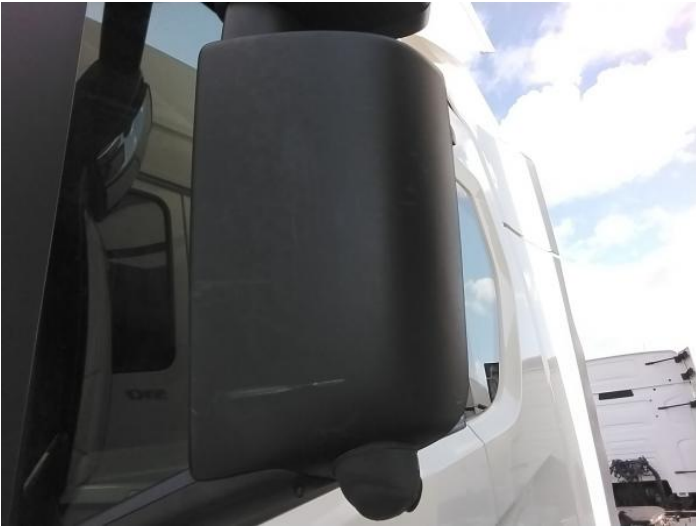
3: Door Mirror Assy nsf
Scuffed (Unpainted)
Over 100mm

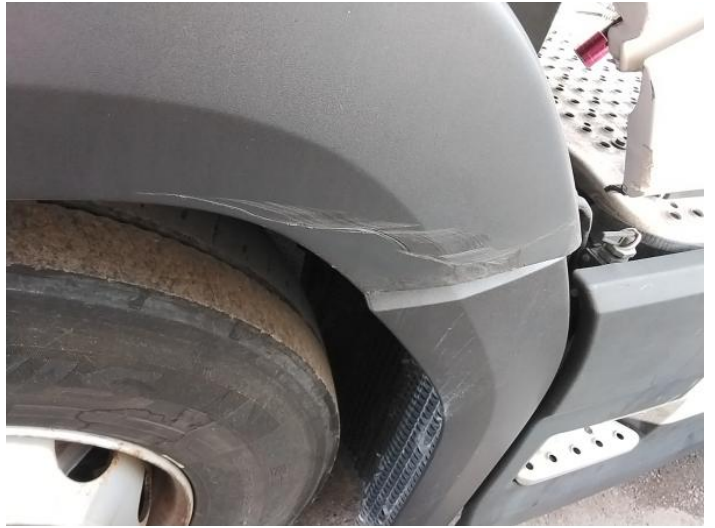
4: Wing nsf
Scratched
Over 25mm Thru Paint

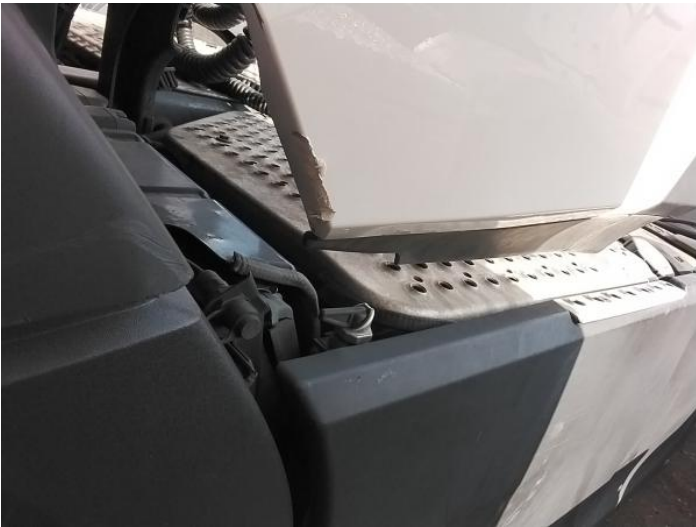
5: Qtr Panel Trim ns
Scuffed
Over 25mm

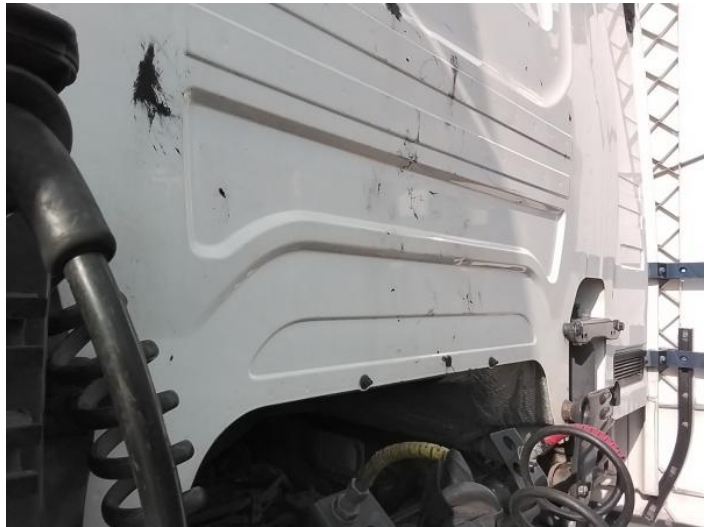
6: Panel Rear
Dented
With Paint Damage

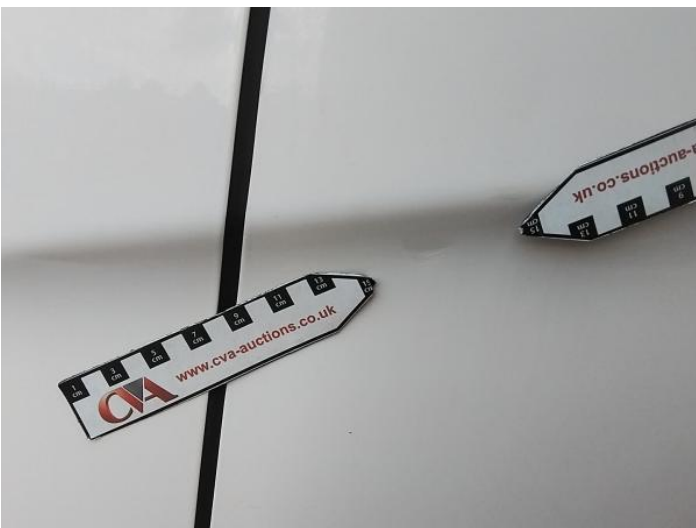
7: Door nsf
Dented
Over 30mm

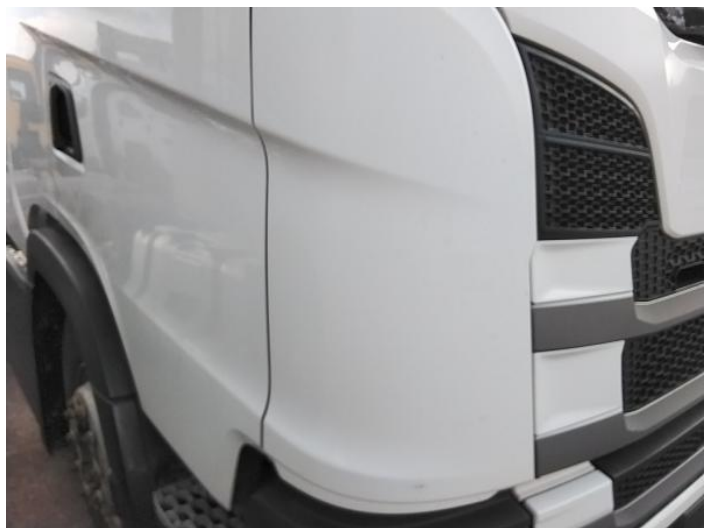
8: Panel Front
Chipped
Multiple Chips

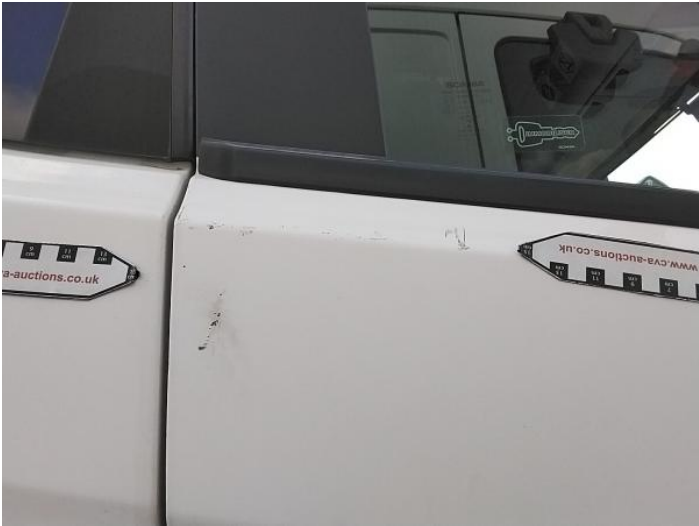
9: Door osf
 Scratched
 Over 25mm Thru Paint

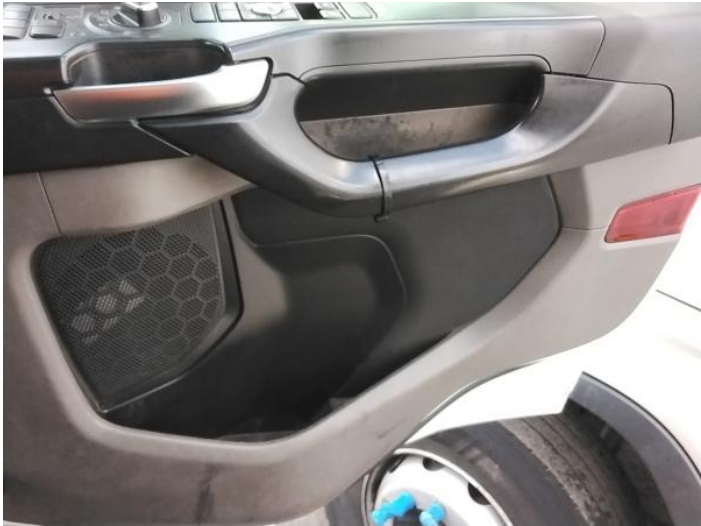
10: Door Pad osf
 Soiled
 Heavy

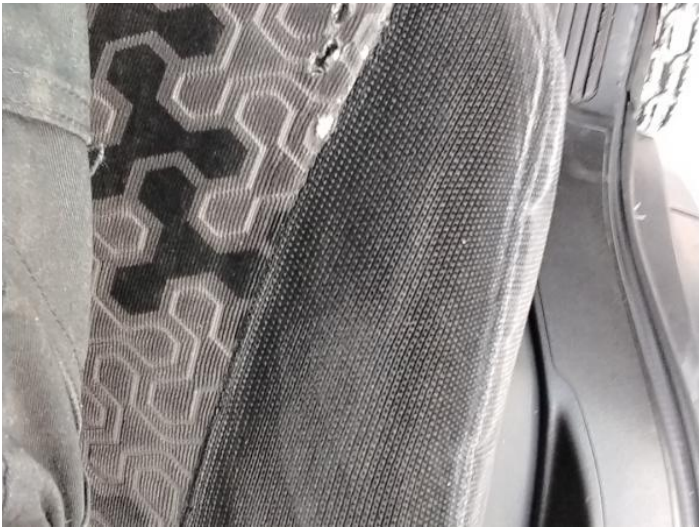
11: Seat Base Cover osf
 Torn
 Over 3mm

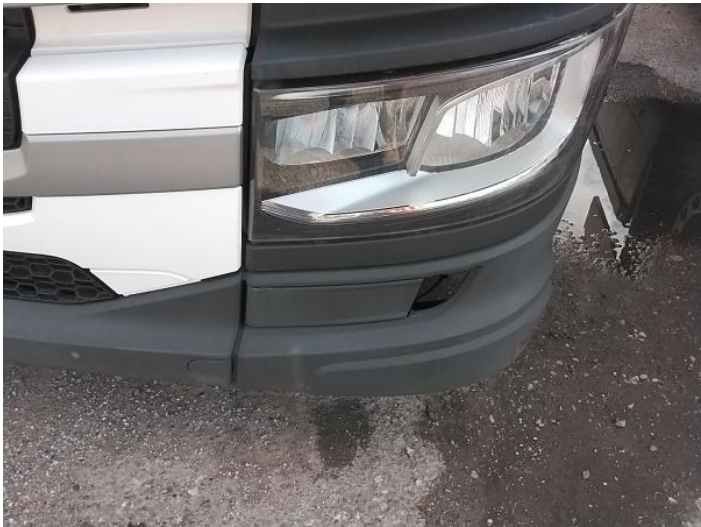
12: Bumper Front Moulding
 Missing
 Replace
