# VEHICLE INSPECTION REPORT

**DE69MRU**

## Isuzu N75 190

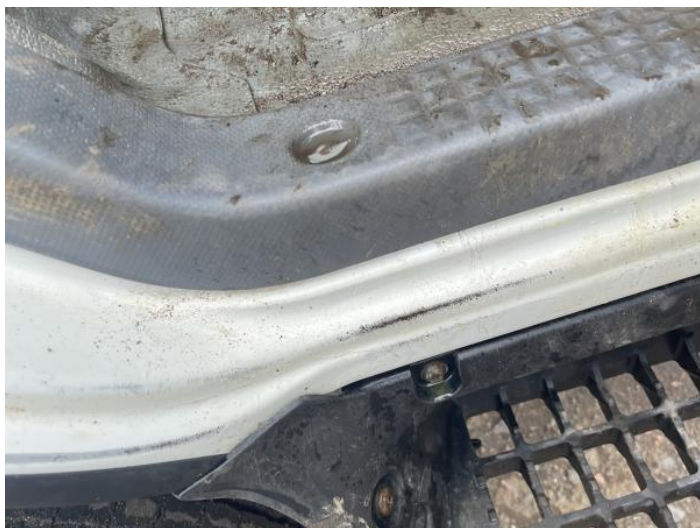
1: Sill os  
Rusted  
Over 5mm

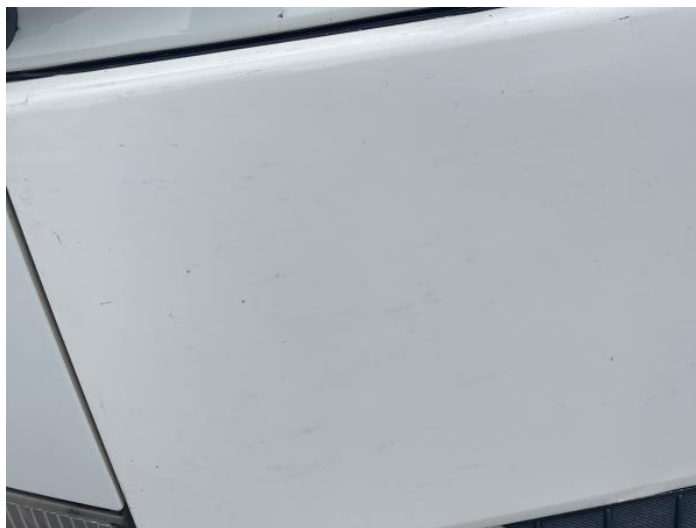
2: Bonnet  
Chipped  
1 To 5

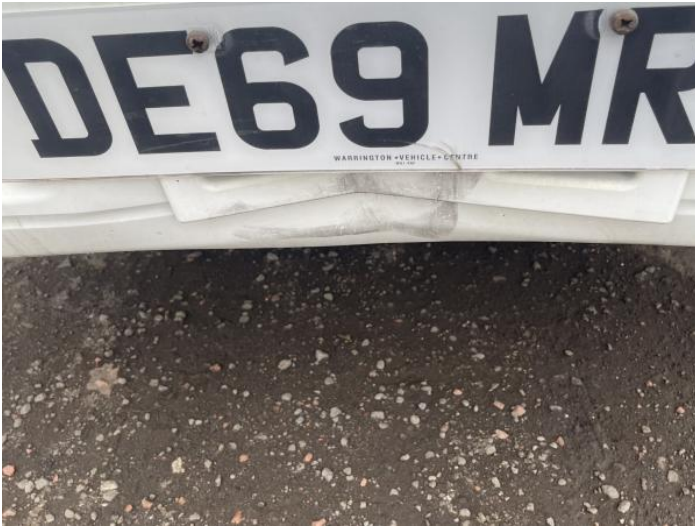
3: Bumper Front  
Dented  
Over 30mm

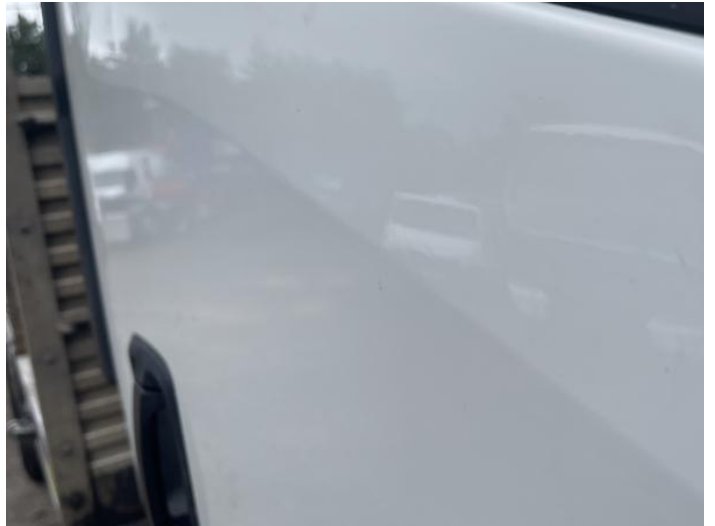
4: Door osf  
Dented  
Over 30mm

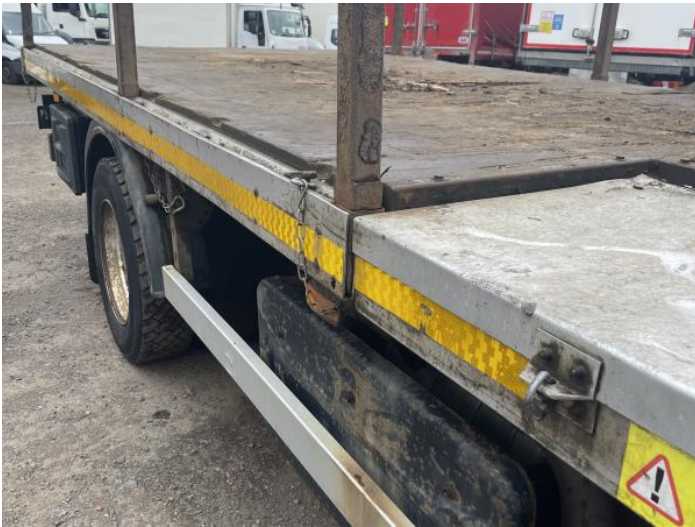
5: Qtr Panel osr  
Dented  
With Paint Damage

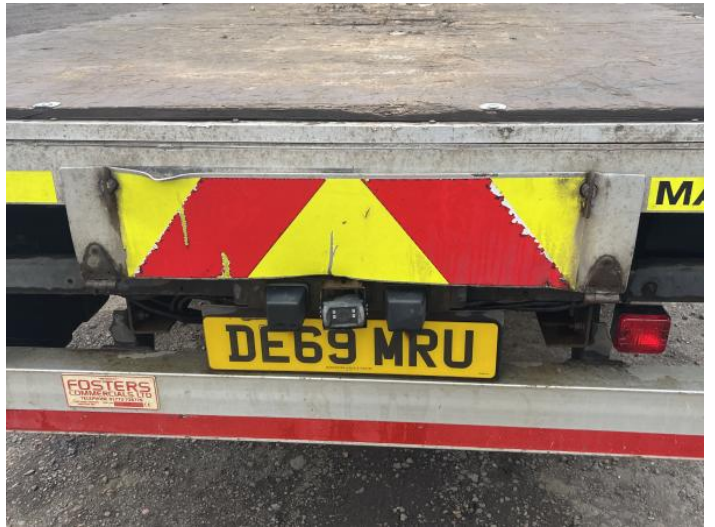
6: Tailgate  
Dented  
With Paint Damage

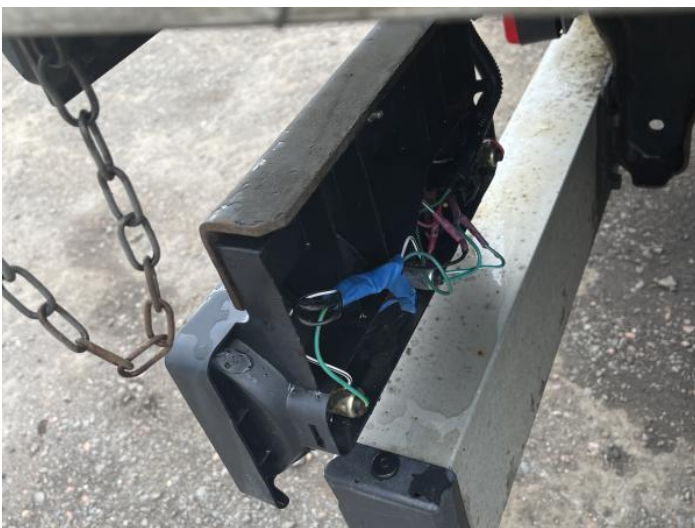
7: Fog Lamp osr  
Broken  
Replace

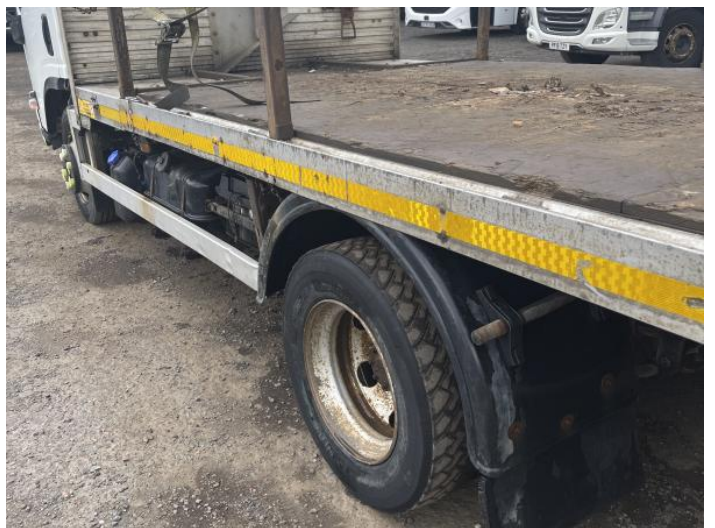
8: Qtr Panel nsr  
Dented  
Over 30mm

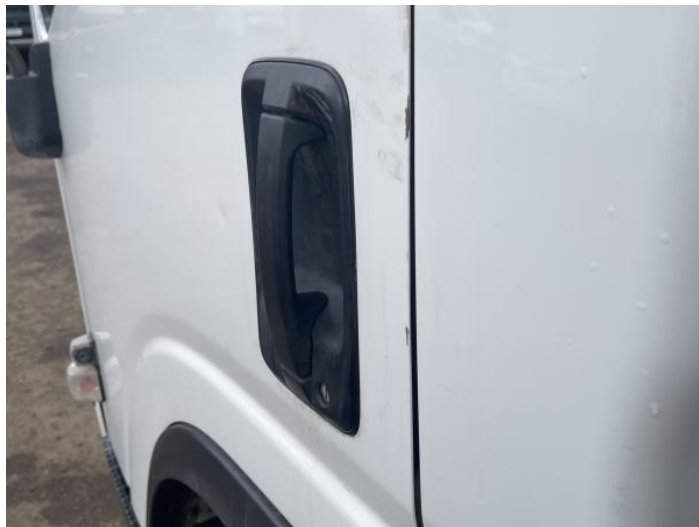
10: Door nsf  
Dented  
With Paint Damage
