VEHICLE INSPECTION REPORT

DG18CVD

Isuzu N75 190

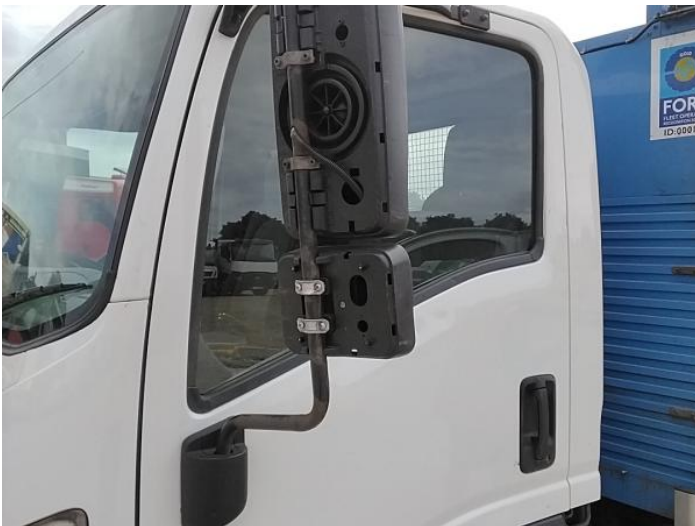
1: Door Mirror Assy nsf
Missing
Replace

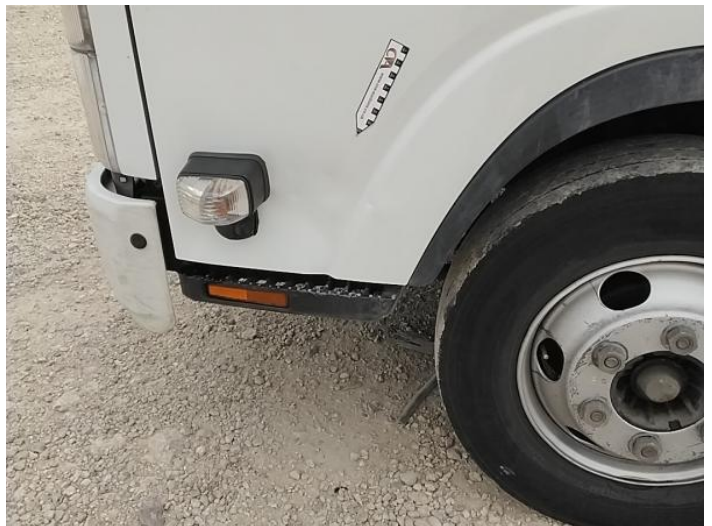
2: Door nsf
Dented
Over 30mm

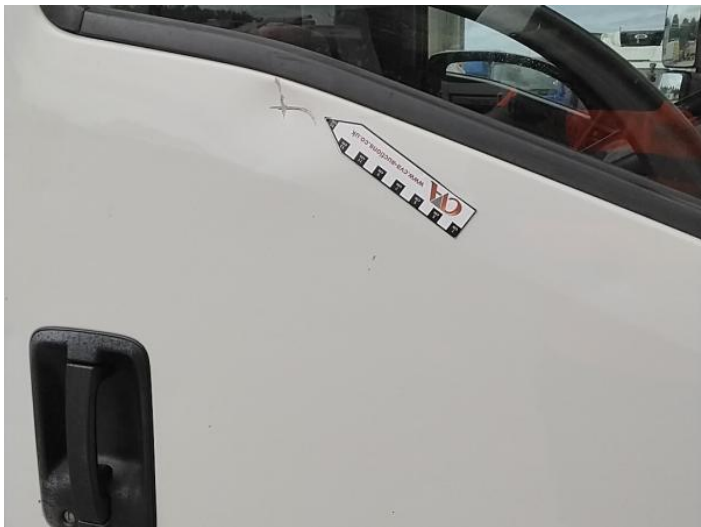
3: Door osf
Dented
With Paint Damage
