VEHICLE INSPECTION REPORT

SJ16NXP

Mercedes-Benz Antos 1827

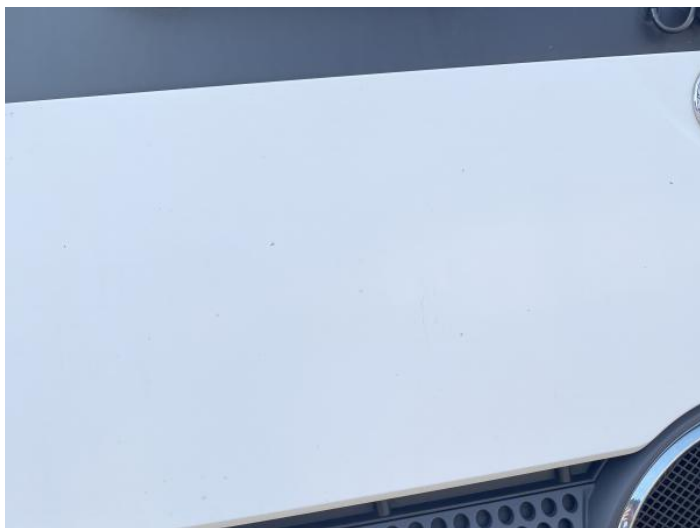
1: Bonnet
Chipped
Multiple Chips

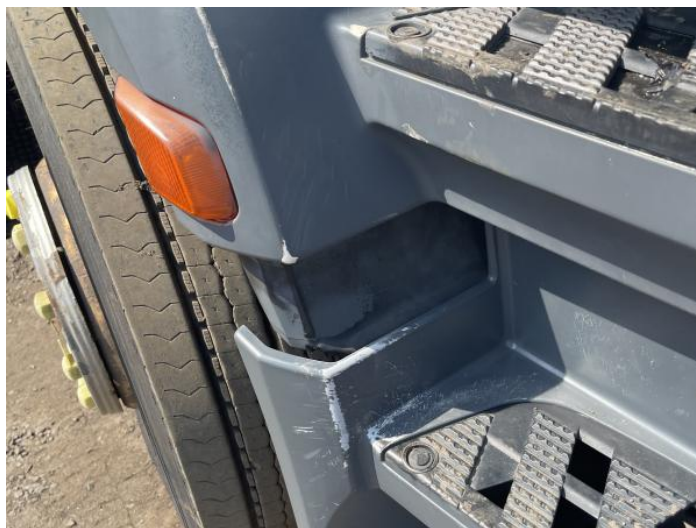
2: Door Moulding osf
Scuffed (Unpainted)
Over 100mm

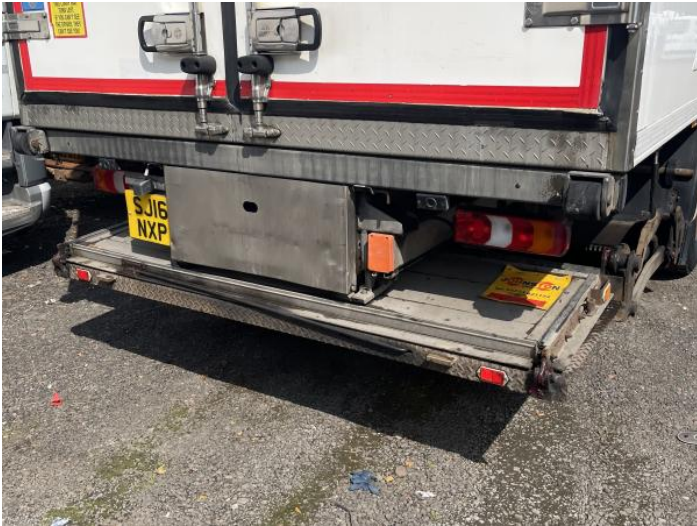
3: Tailgate
Rusted
Over 5mm

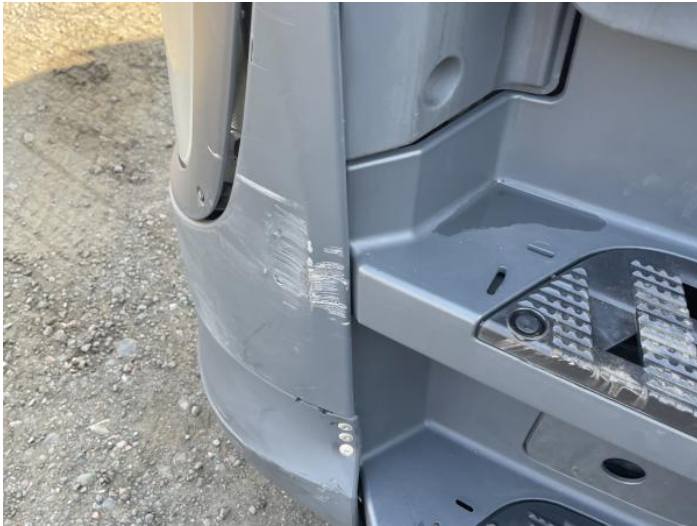
4: Bumper Front Moulding
Scuffed (Unpainted)
Over 100mm
