VEHICLE INSPECTION REPORT

EG66APK

Mercedes-Benz Sprinter 314 CDI

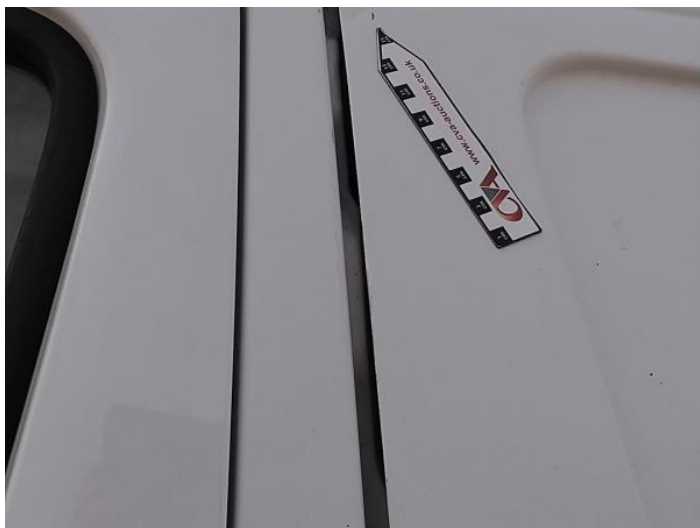
1: Qtr Panel nsr
Dented
Over 2 UpTo 10mm

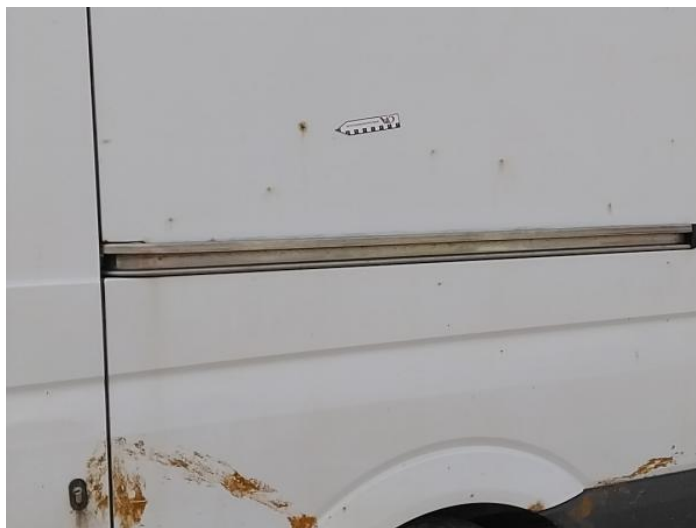
2: Qtr Panel nsr
Rusted
Over 5mm

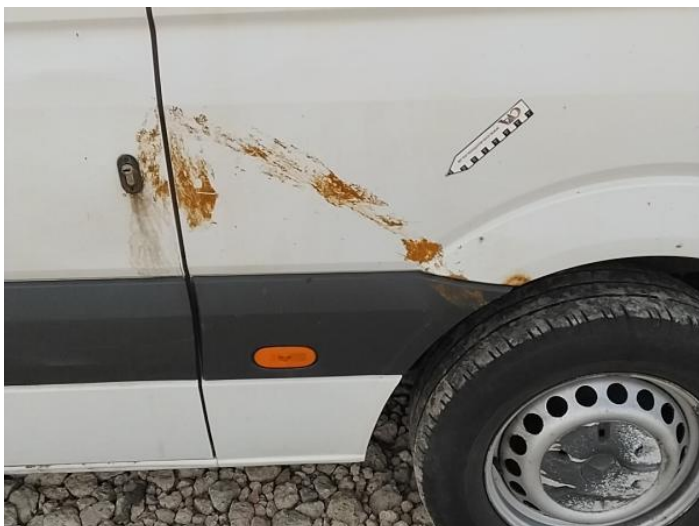
3: Qtr Panel nsr
Rusted
Over 5mm

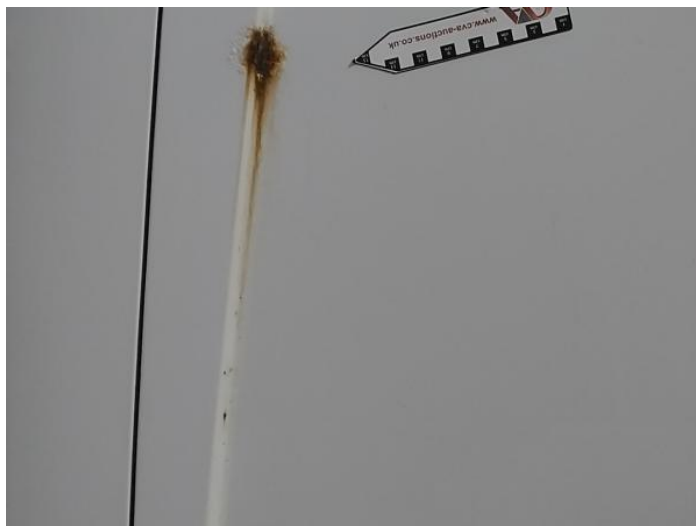
4: Qtr Panel osr
Rusted
Over 5mm

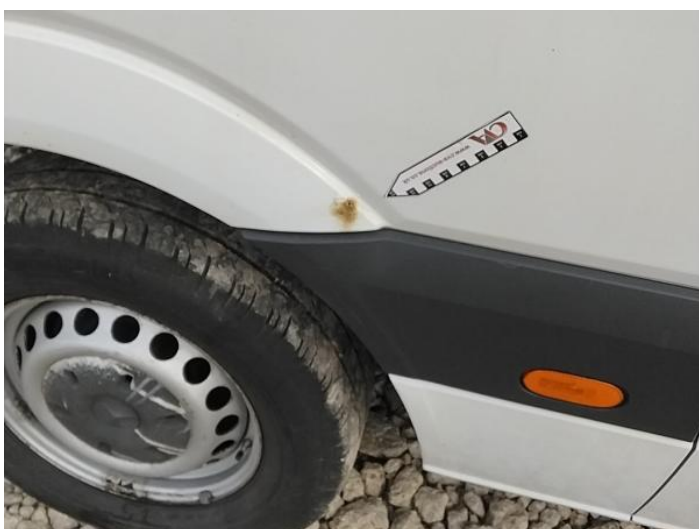
5: Qtr Panel osr
Rusted
Over 5mm

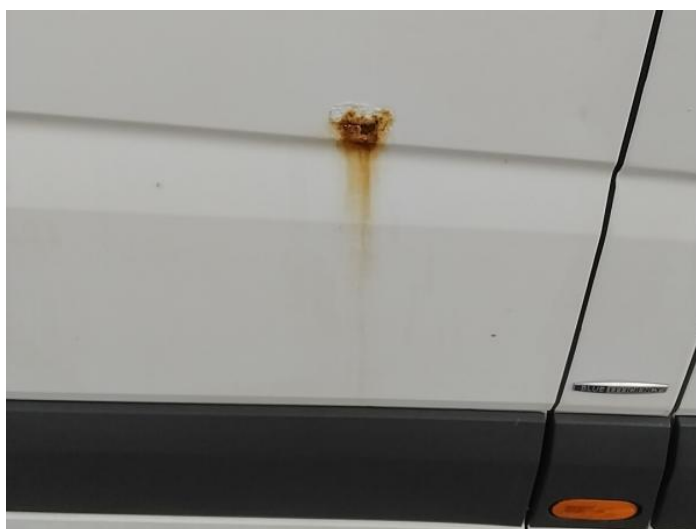
6: D Post os
Rusted
Over 5mm
