VEHICLE INSPECTION REPORT

DA19HAO

Isuzu N75 190

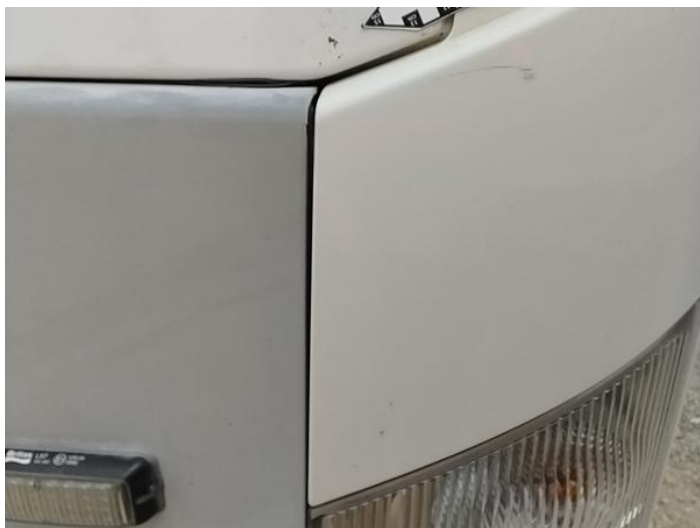
1: Bumper Front
Chipped
1 To 5

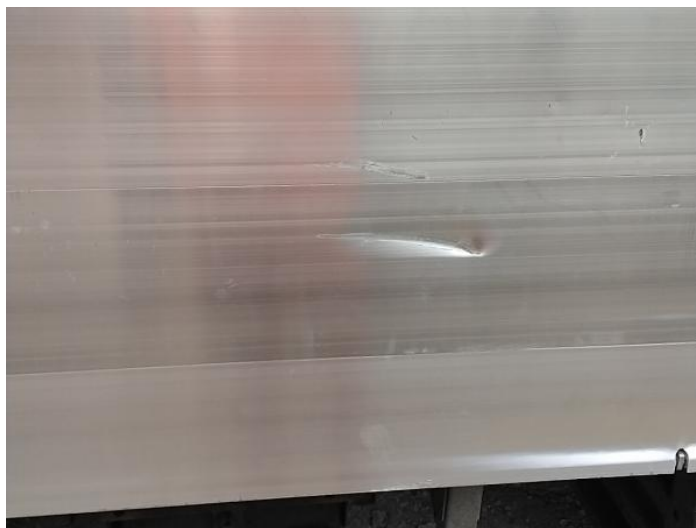
2: Qtr Panel nsr
Dented
Over 30mm

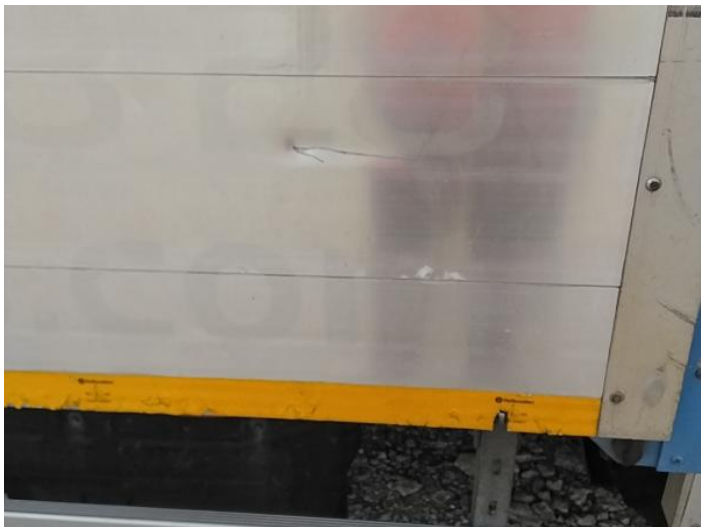
3: Qtr Panel osr
Dented
Over 30mm
