VEHICLE INSPECTION REPORT

ND67CXB

Mercedes-Benz Sprinter 314 Cdi

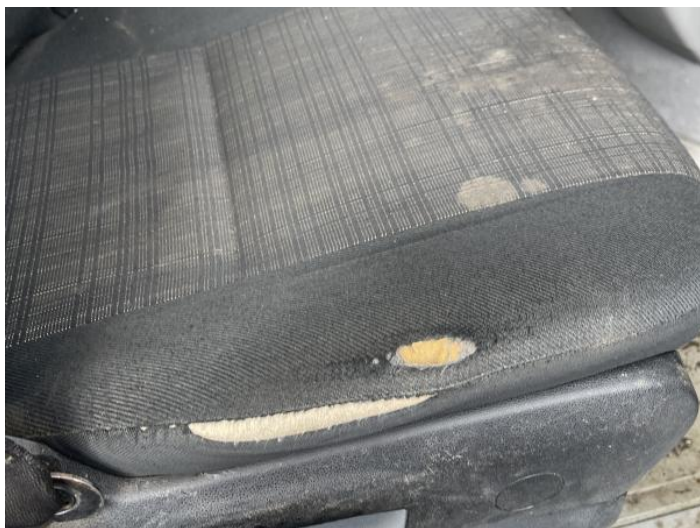
1: Seat Base Cover osf
Torn
Over 3mm

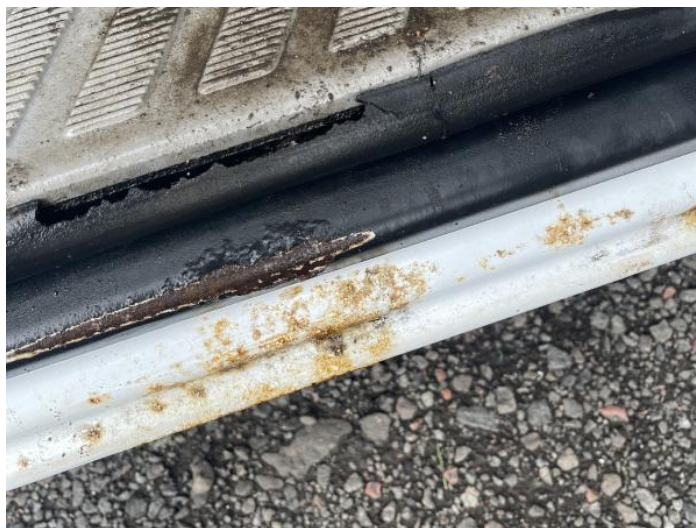
2: Sill os
Rusted
Over 5mm

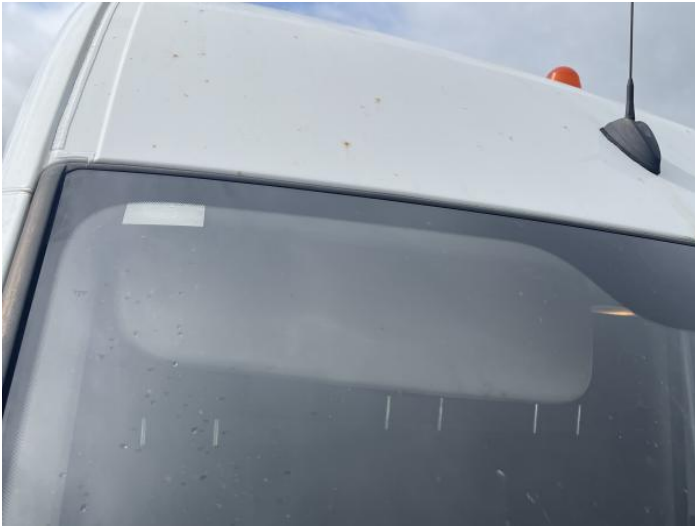
3: Roof
Rusted
Over 5mm

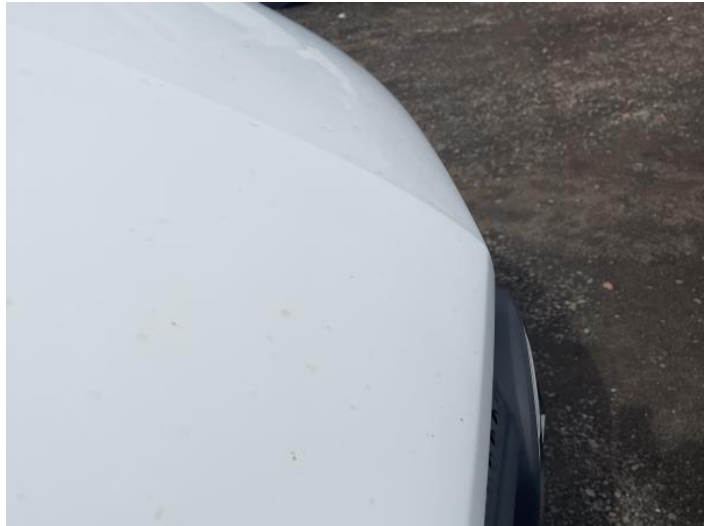
4: Bonnet
Dented
With Paint Damage

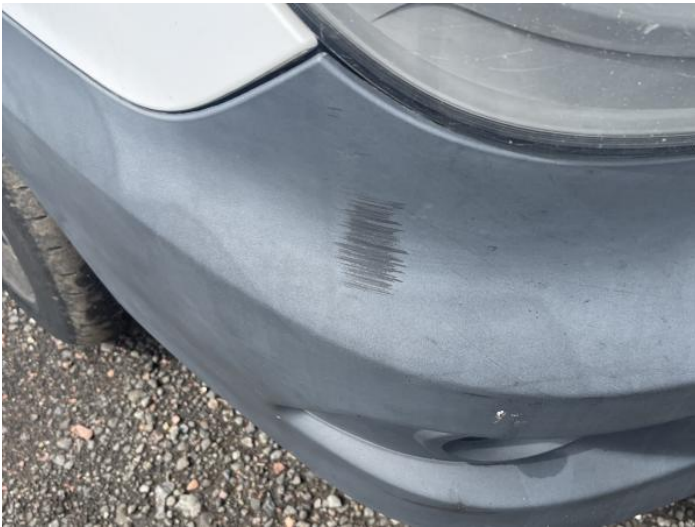
5: Bumper Front Moulding
Scuffed (Unpainted)
Over 100mm

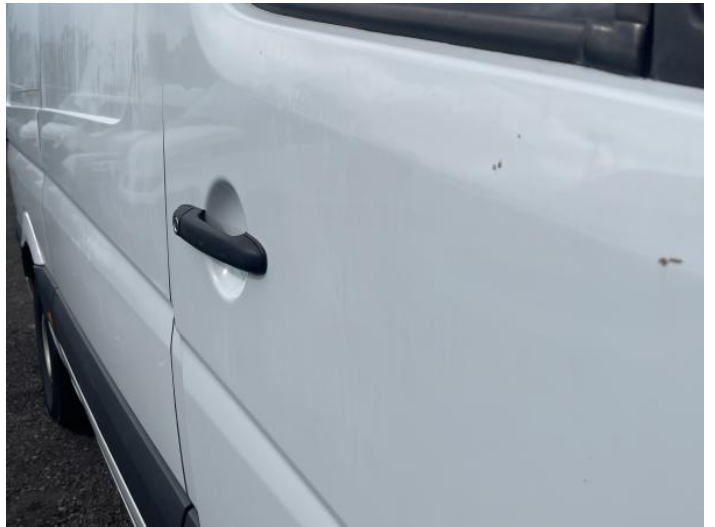
6: Door osf
Dented
Over 30mm

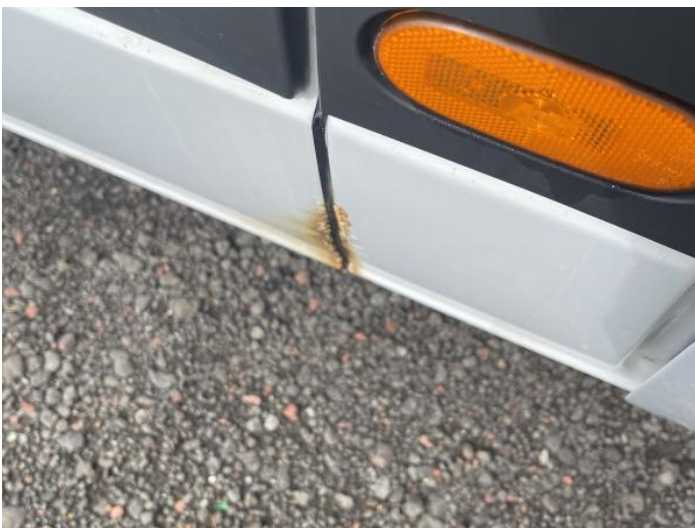
7: B Post os
Rusted
Over 5mm

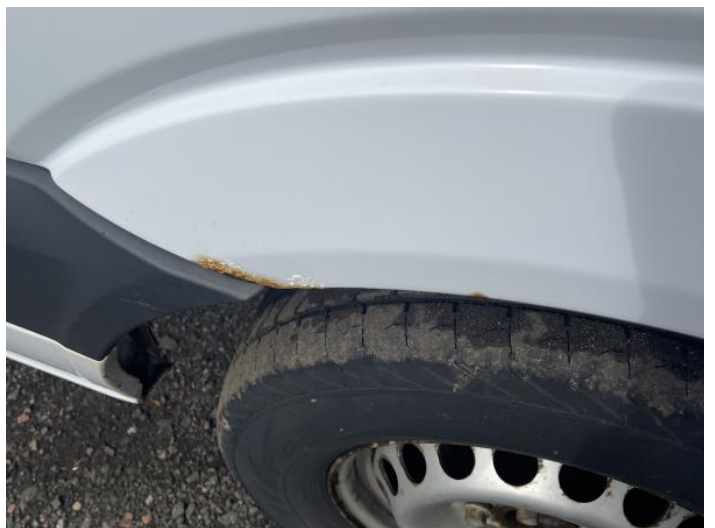
8: Qtr Panel osr
Rusted
Over 5mm

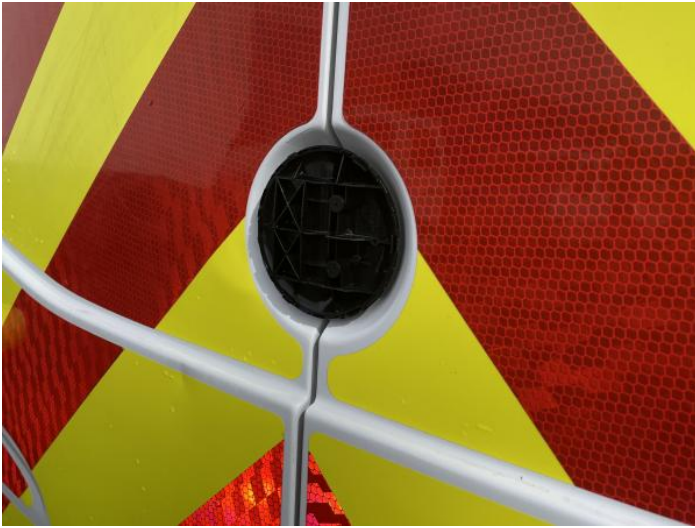
9: Badgedecal Rear
Broken
Replace

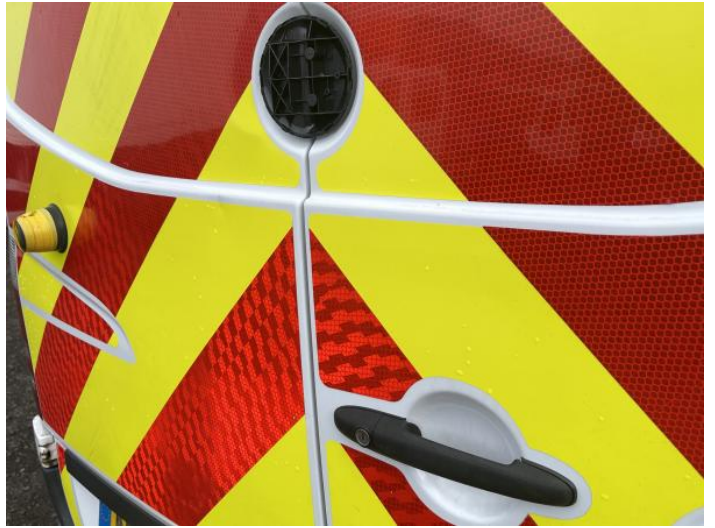
10: Tailgate
Dented
With Paint Damage

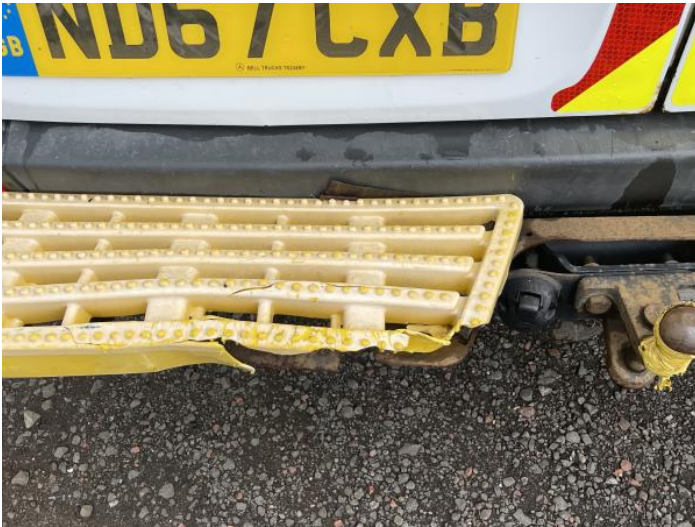
11: Bumper Rear Moulding
Broken
Replace

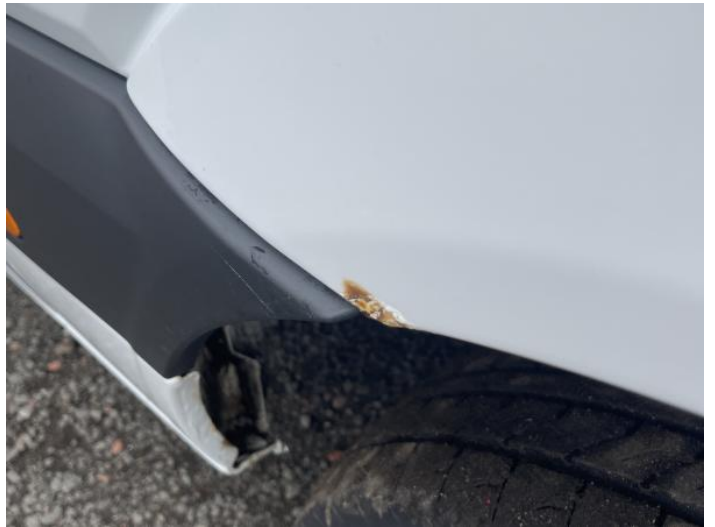
12: Qtr Panel nsr
Rusted
Over 5mm

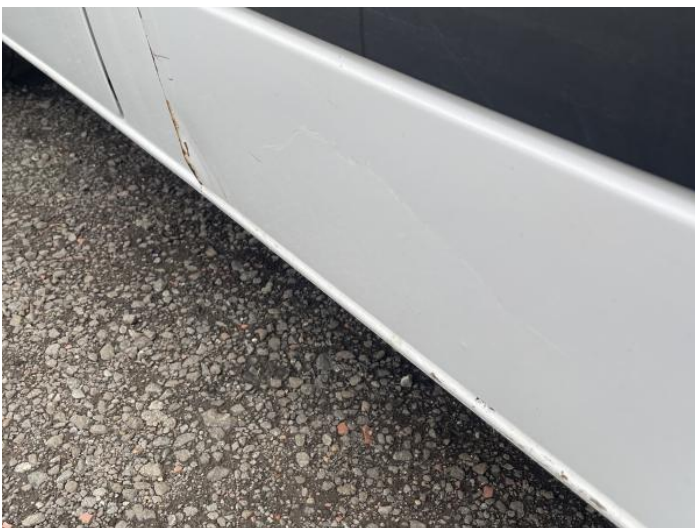
13: Door nsr
Dented
Over 30mm

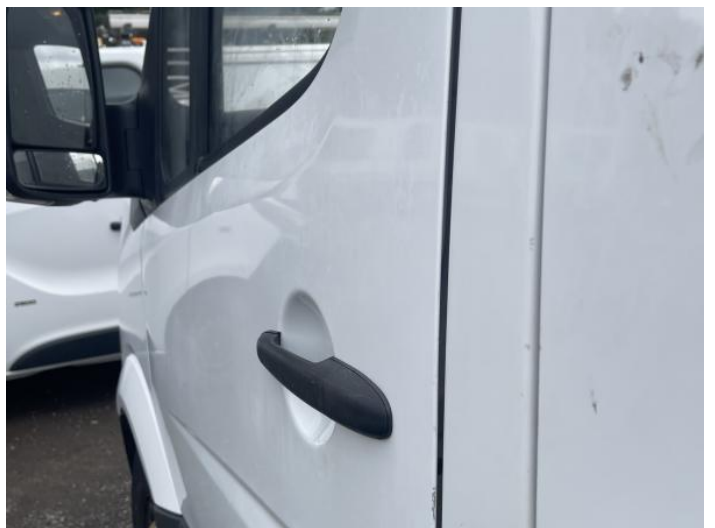
14: Door nsr
Dented
Over 30mm

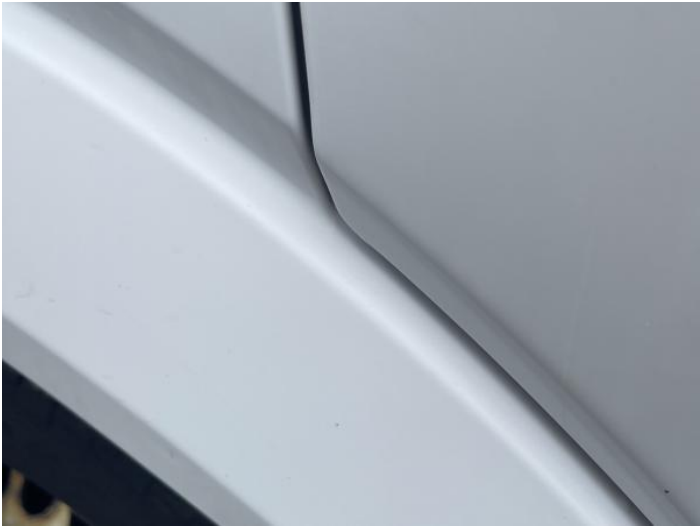
15: Wing nsf
Rusted
Over 5mm
