VEHICLE INSPECTION REPORT

SG16DWJ

Vauxhall Movano 2.3 CDTi BiTurbo ecoFLEX 136ps

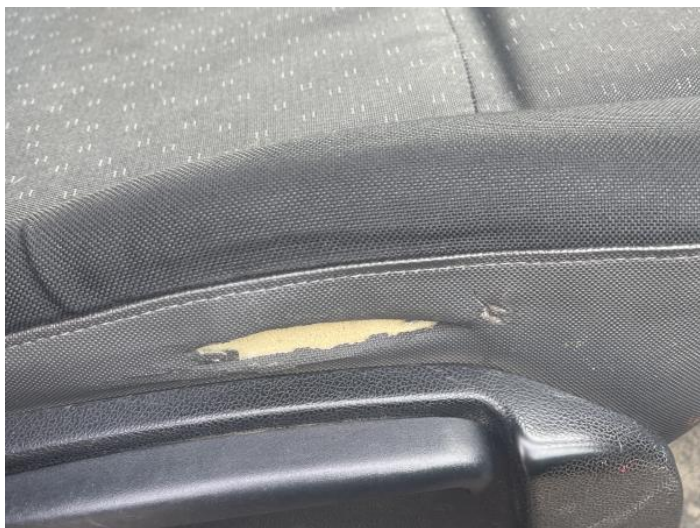
1: Seat Base Cover osf
Torn
Over 3mm

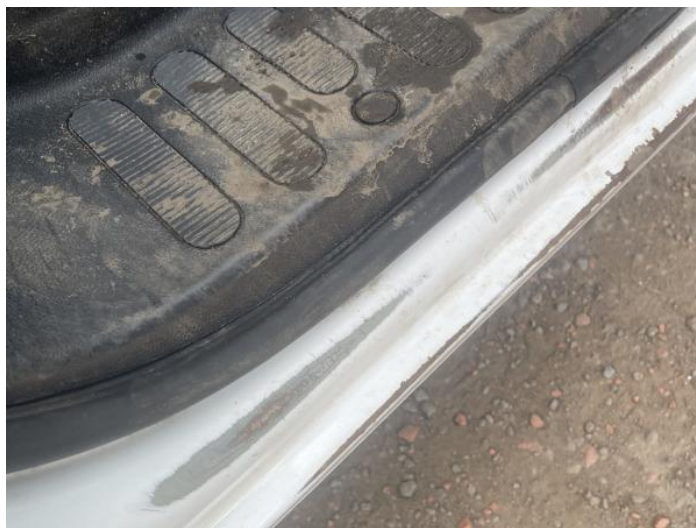
2: Sill os
Rusted
Over 5mm

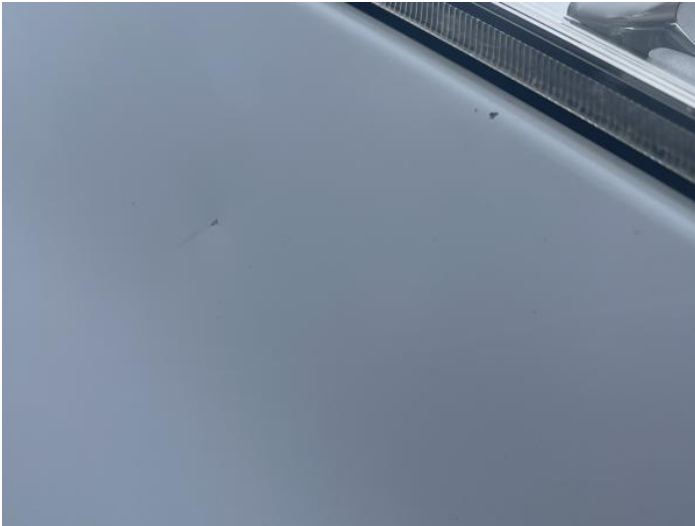
3: Wing osf
Dented
With Paint Damage

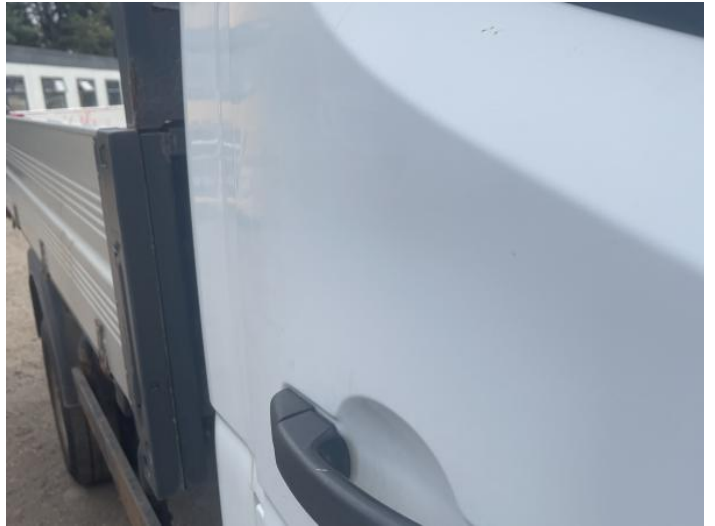
4: Door osf
Dented
Over 2 UpTo 10mm

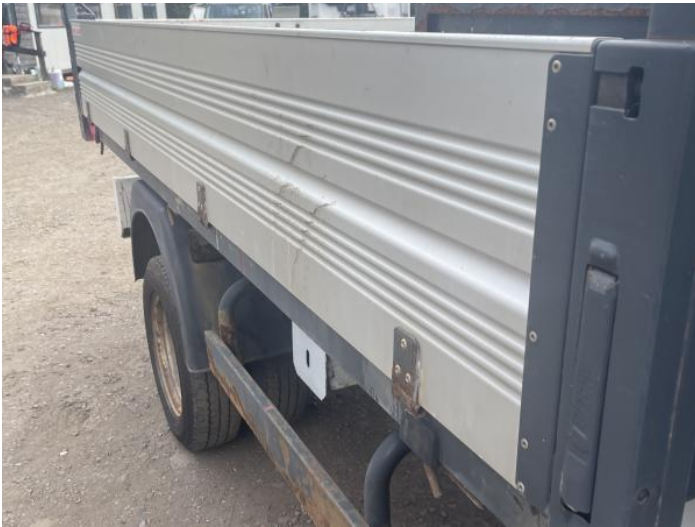
5: Qtr Panel osr
Dented
With Paint Damage

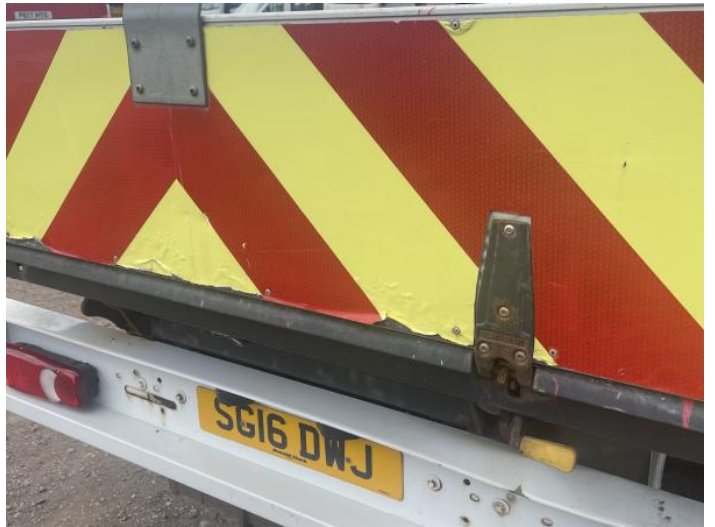
6: Tailgate
Rusted
Over 5mm

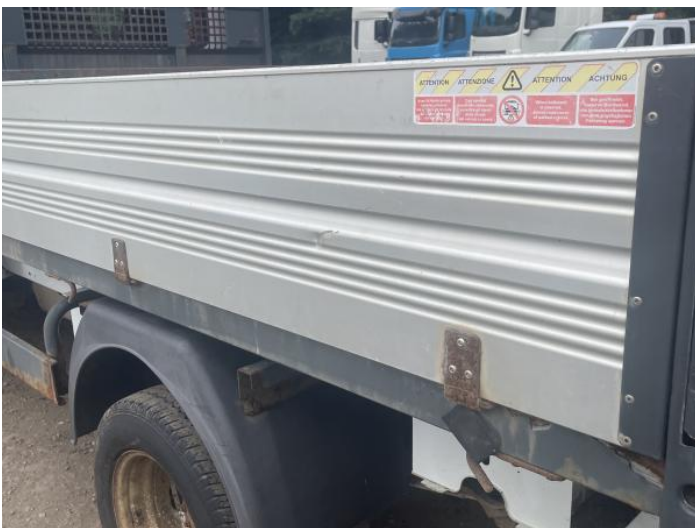
7: Qtr Panel nsr
Dented
With Paint Damage

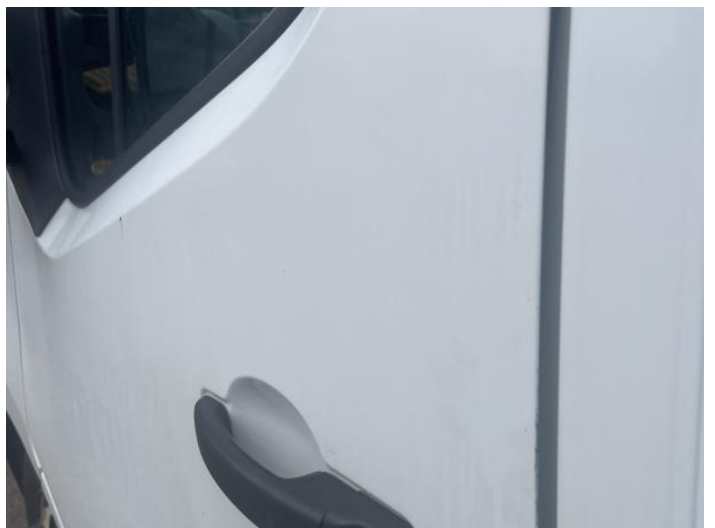
8: Door nsf
Dented
With Paint Damage

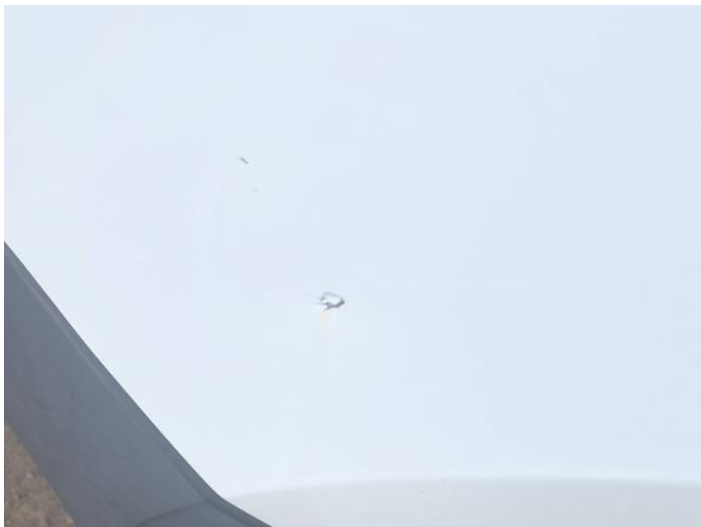
9: Wing nsf
Dented
With Paint Damage
