# VEHICLE INSPECTION REPORT

**DG66JUV**

## Mercedes-Benz Actros 2545

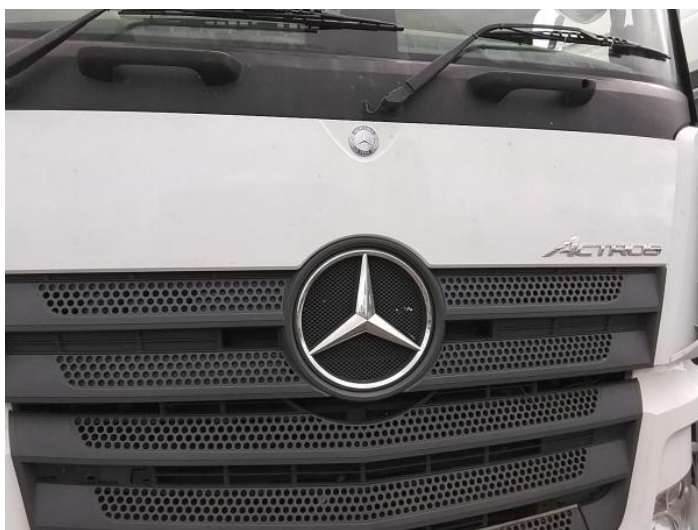
1: Bonnet  
Chipped  
Multiple Chips

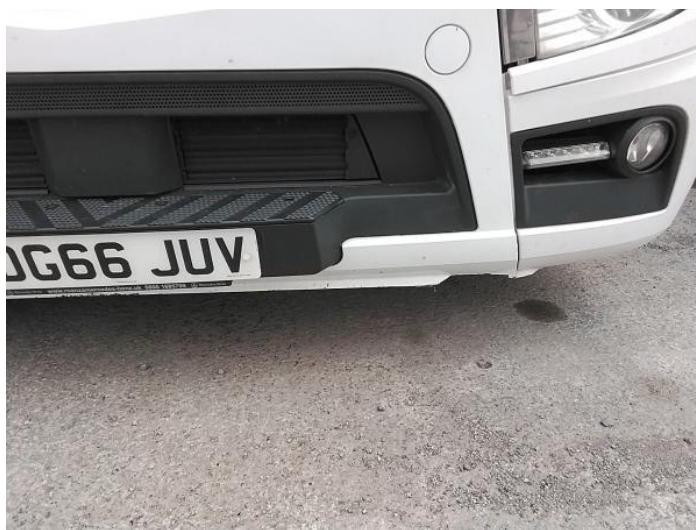
2: Bumper Front  
Cracked  
Over 25mm

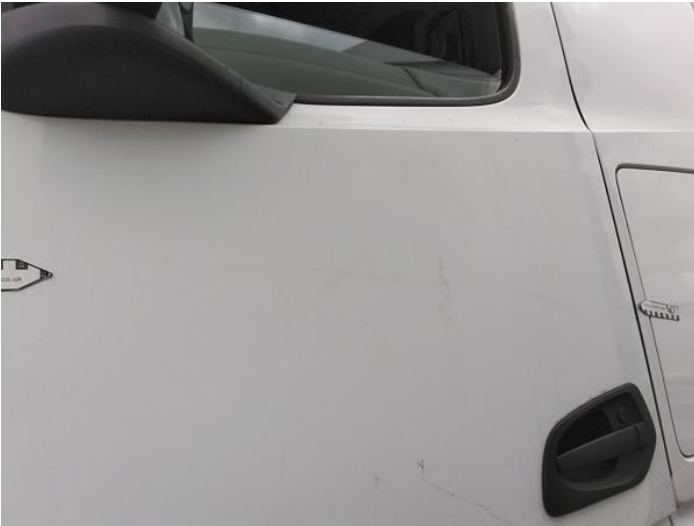
3: Door nsf  
Scratched  
Over 25mm Not Thru Paint

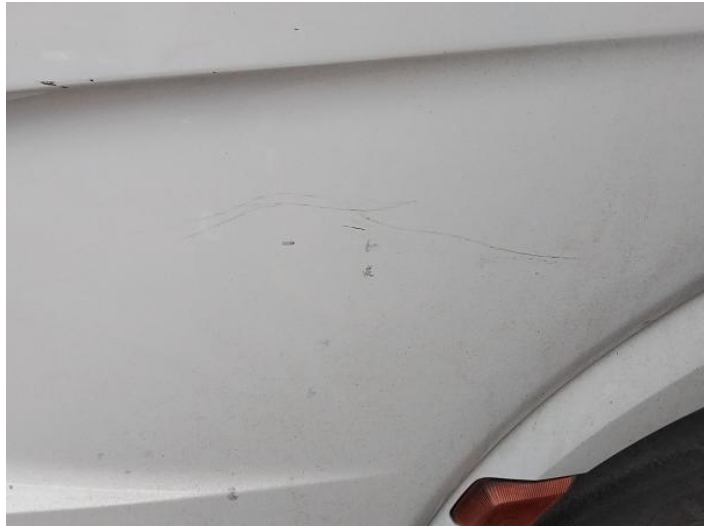
4: Door Moulding nsf  
Scratched (Painted)  
Over 25mm Thru Paint

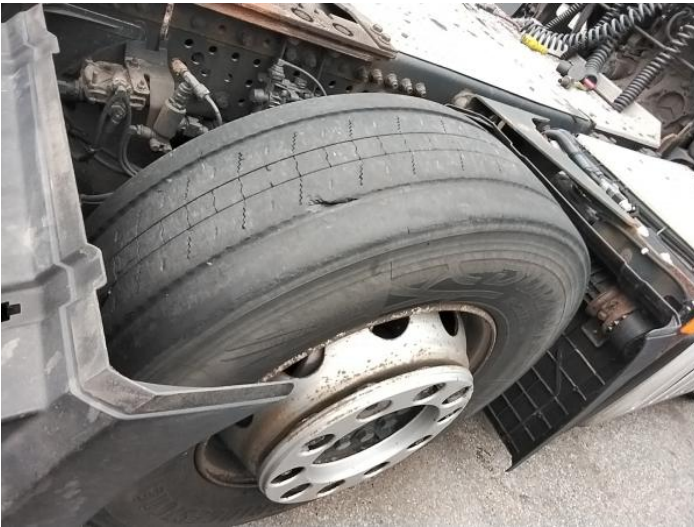
5: Qtr Panel Moulding os  
Missing  
Replace

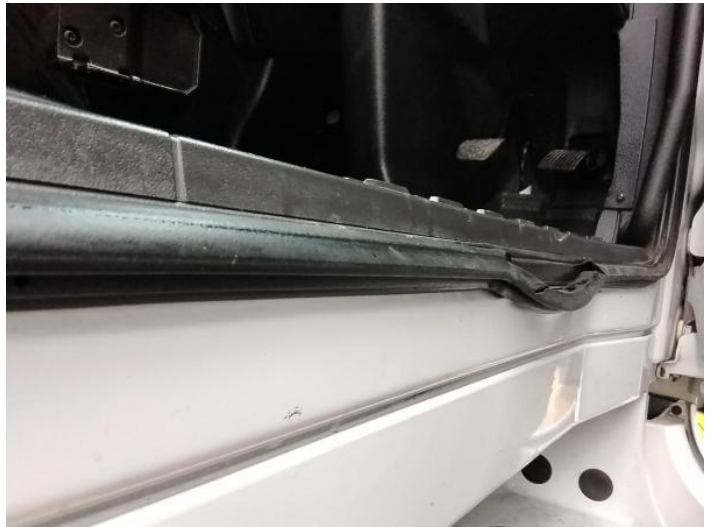
6: Aperture Seal osf  
Broken  
Replace

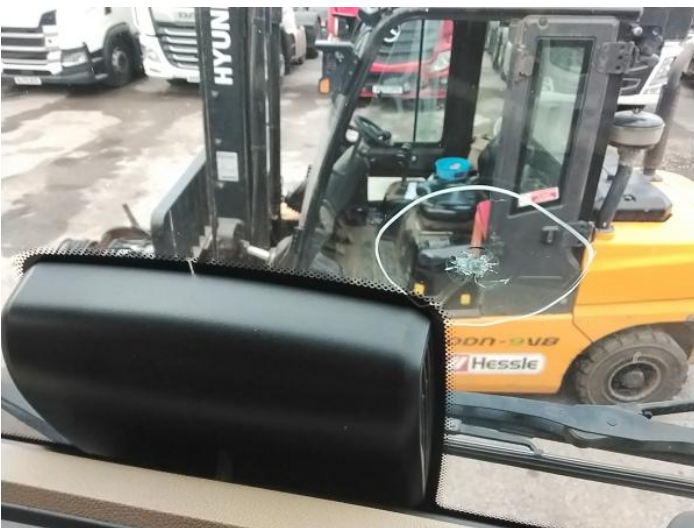
7: Screen Front  
Chipped  
Over 10mm

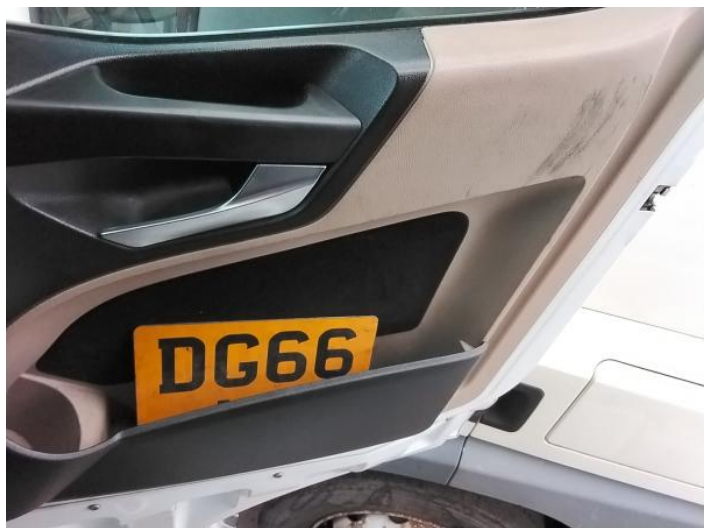
8: Door Pad osf  
Soiled  
Heavy
