VEHICLE INSPECTION REPORT

WN12BFM

Mercedes-Benz Sprinter 513

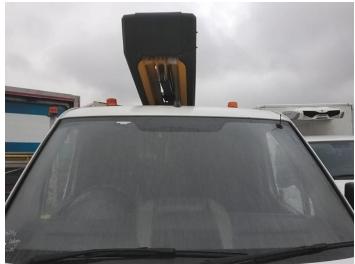
1: Roof Chipped Multiple Chips

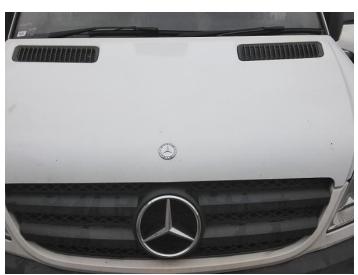
2: Bonnet Chipped Multiple Chips

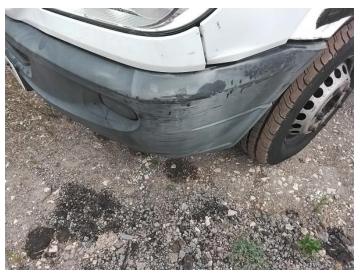
3: Bumper Front Dented With Paint Damage

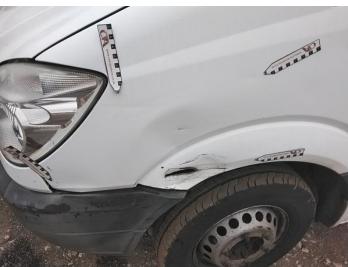
4: Wing nsf Dented Over 30% Of Panel

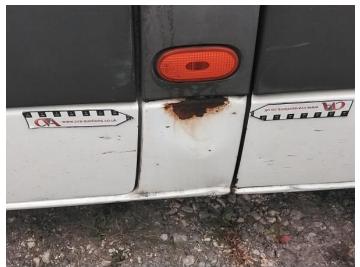
5: B Post ns Dented With Paint Damage

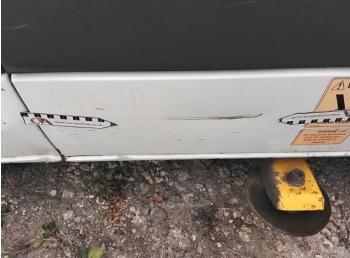
6: Qtr Panel nsr Dented With Paint Damage

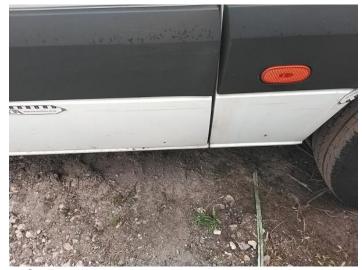
7: Qtr Panel nsr Scratched Over 25mm Thru Paint

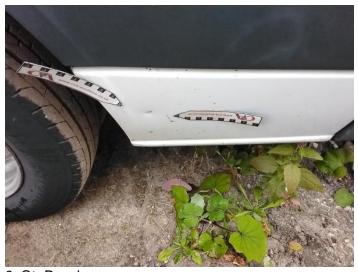
9: Qtr Panel nsr Dented With Paint Damage

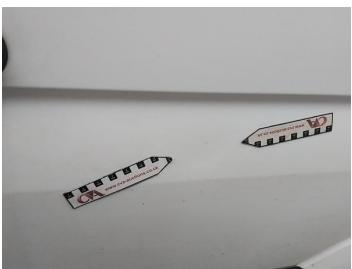
10: Qtr Panel osr Dented Over 30mm

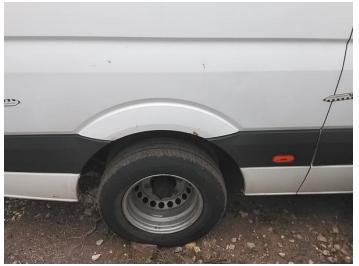
11: Qtr Panel osr Scratched Over 25mm Thru Paint

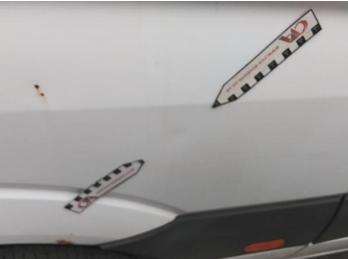
12: Qtr Panel osr Dented Over 30mm

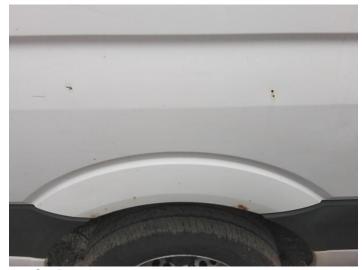
13: Qtr Panel osr Rusted Over 5mm

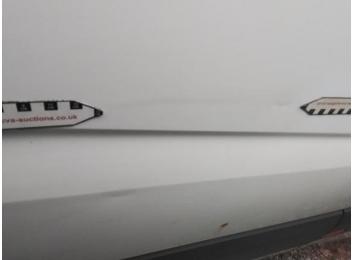
14: Qtr Panel osr Dented With Paint Damage

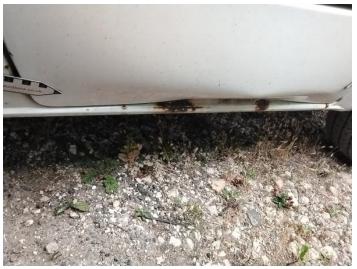
15: Door osf Dented With Paint Damage

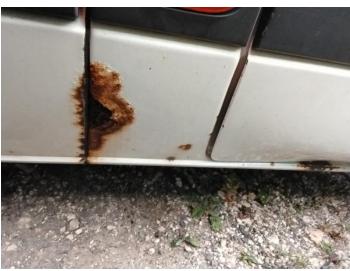
16: B Post os Rusted Over 5mm

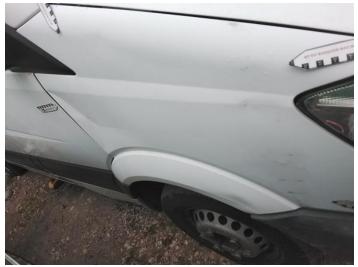
17: Wing osf Dented Over 30% Of Panel

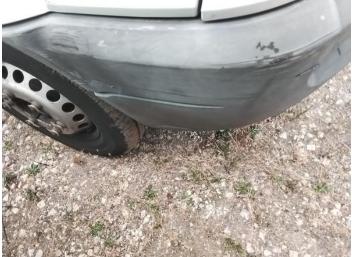
18: Bumper Front Scratched Over 100mm Thru Paint

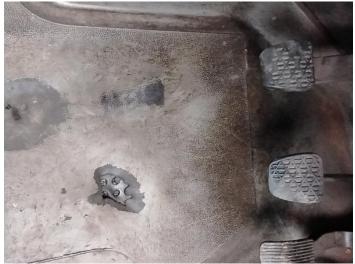
19: Carpets Front Holed Over 3mm

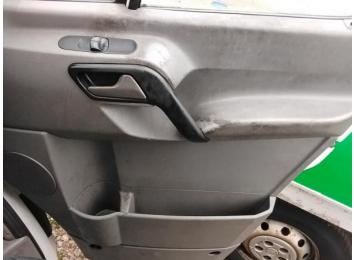
20: Door Pad osf Soiled Heavy

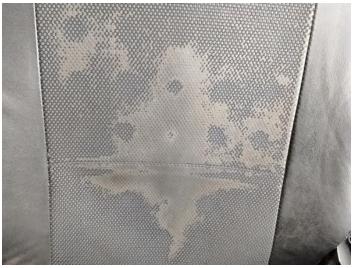
21: Seat Base Cover osf Scuffed Over 25mm

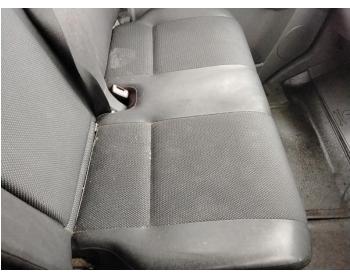
22: Seat Base Cover nsf Soiled Heavy

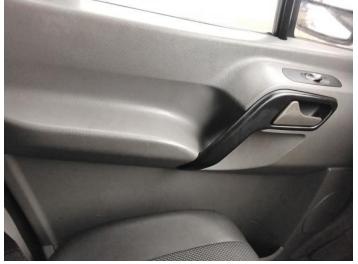
23: Door Pad nsf Soiled Heavy
