VEHICLE INSPECTION REPORT

DA19HBB

Isuzu N75 190

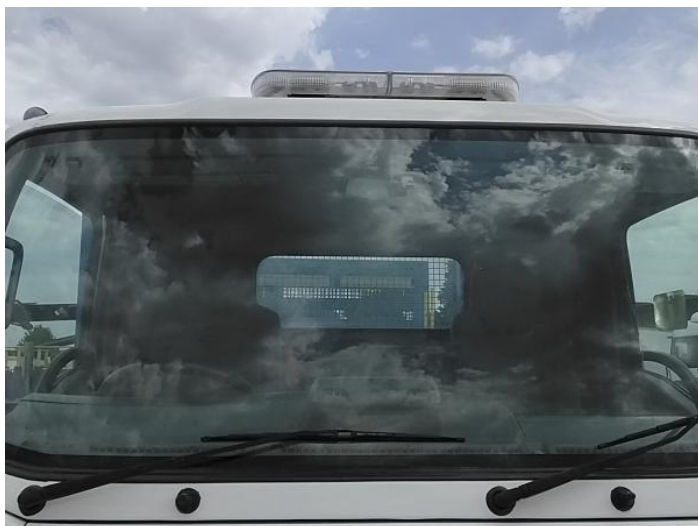
1: Screen Front
Chipped
Over 10mm

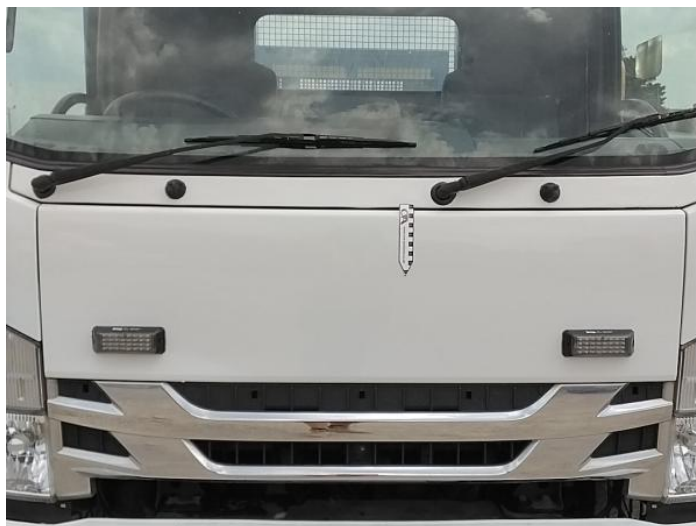
2: Bonnet
Chipped
Multiple Chips

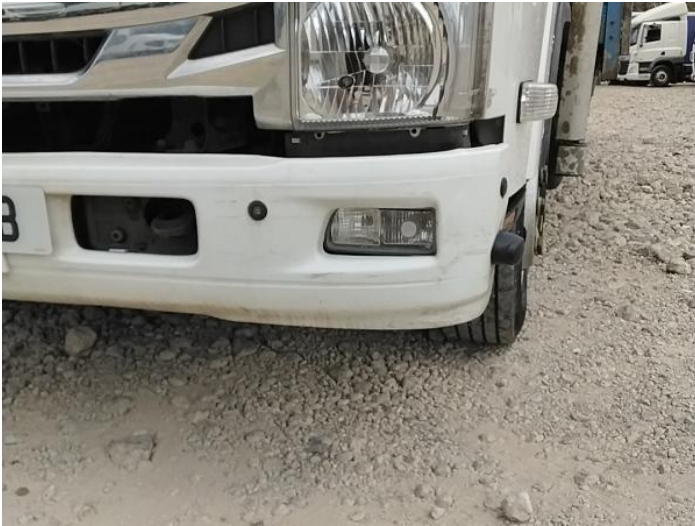
3: Bumper Front
Scratched
Over 25mm Not Thru Paint

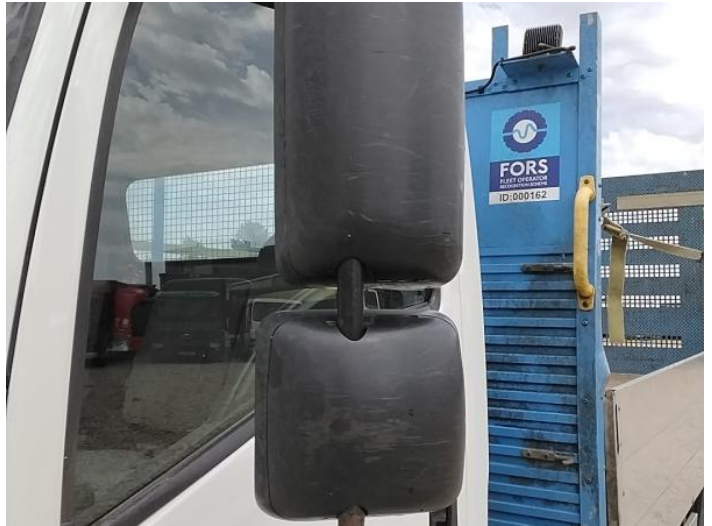
4: Door Mirror Assy nsf
Scuffed (Unpainted)
UpTo 100mm

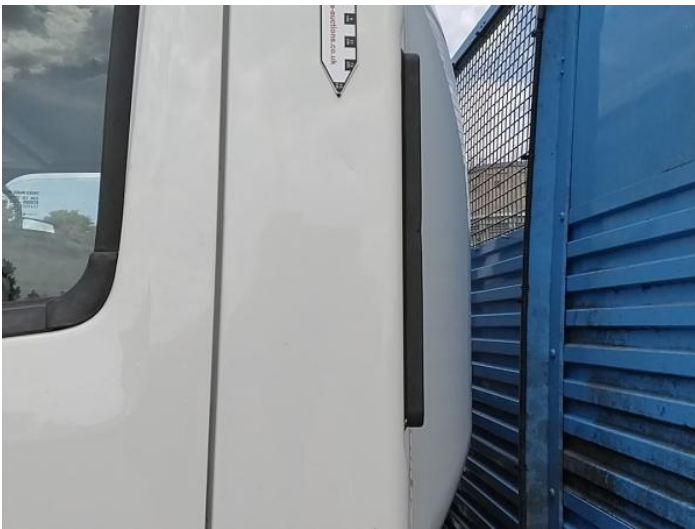
5: B Post ns
Dented
Over 2 UpTo 10mm

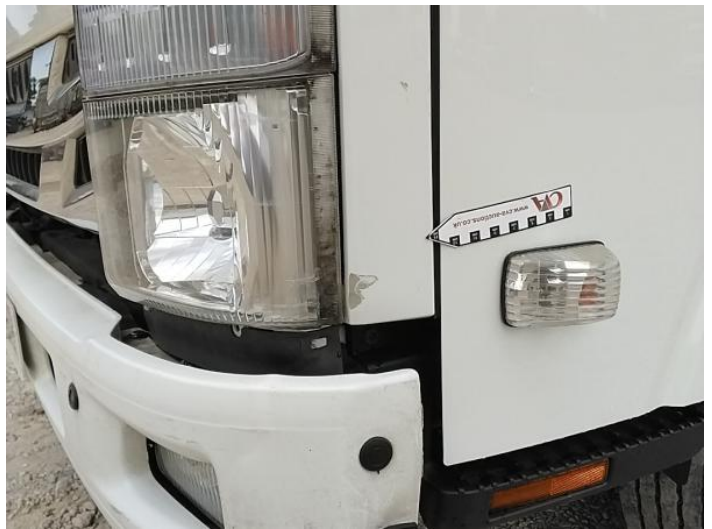
6: Wing nsf
Scratched
UpTo 25mm Thru Paint

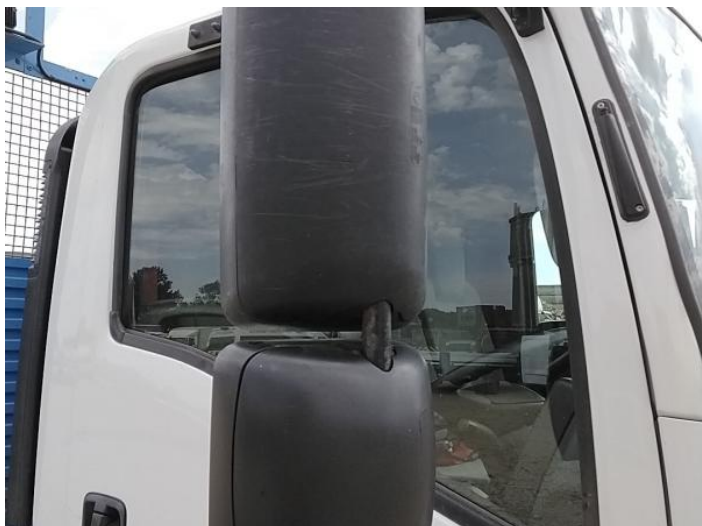
9: Door Mirror Assy osf
Scuffed (Unpainted)
UpTo 100mm

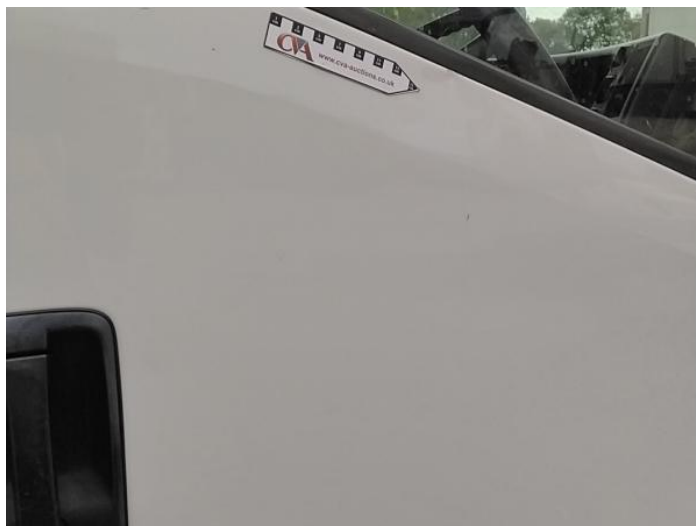
10: Door osf
Dented
With Paint Damage

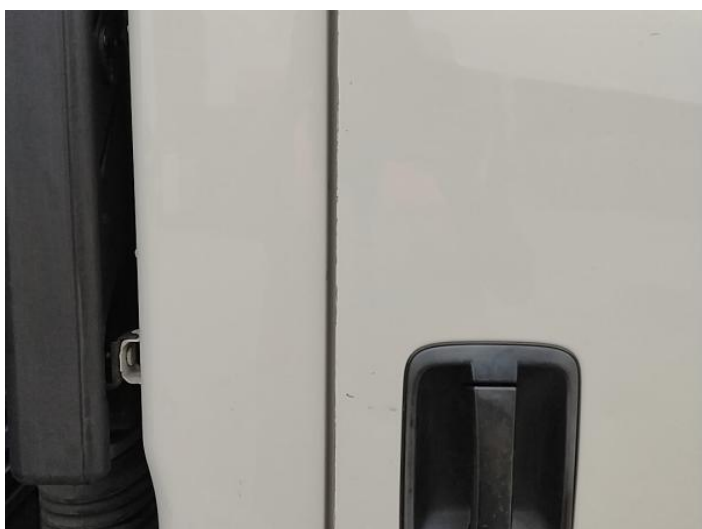
11: Door osf
Chipped
Edge Chip

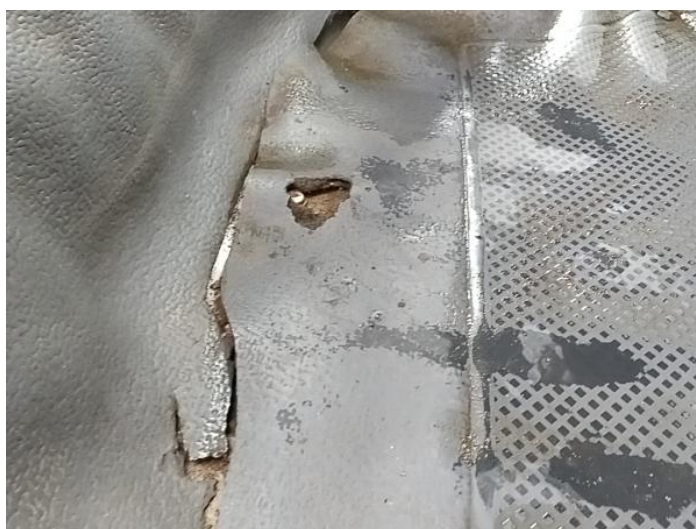
12: Carpets Front
Holed
Over 3mm
