VEHICLE INSPECTION REPORT

OU15ZVF

MAN NEOPLAN TOURLINER COACH

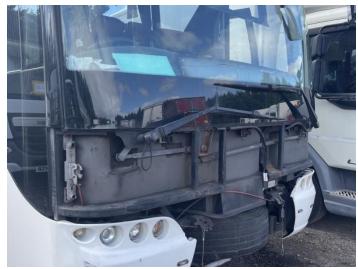
1: Bonnet Missing Replace

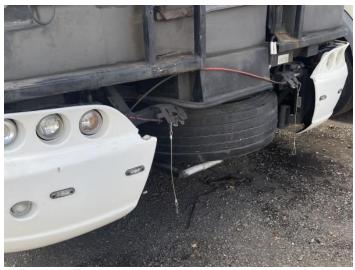
2: Bumper Front Missing Replace

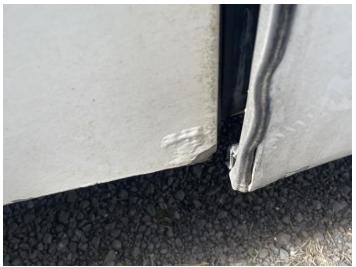
3: Qtr Panel osr Rusted Over 5mm

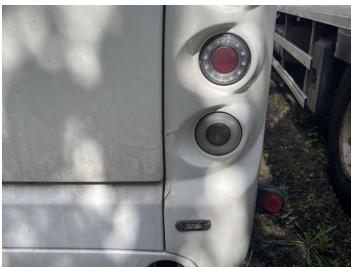
4: Bumper Rear Cracked Over 25mm

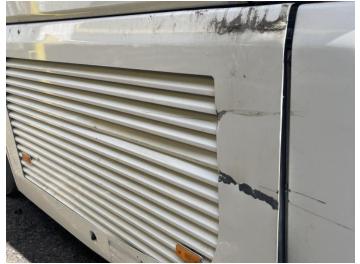
5: Qtr Panel nsr Dented With Paint Damage

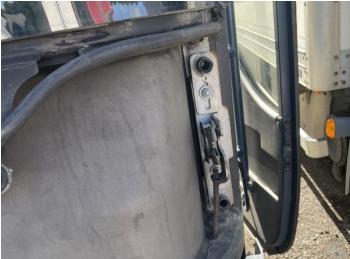
6: Headlamp ns Missing Replace

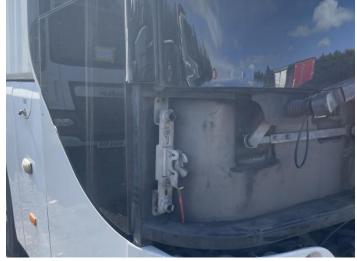
7: Headlamp os Missing Replace
