# VEHICLE INSPECTION REPORT

**R30KTL**

## Scania R 580 V8

**Non Runner**  
Inspection

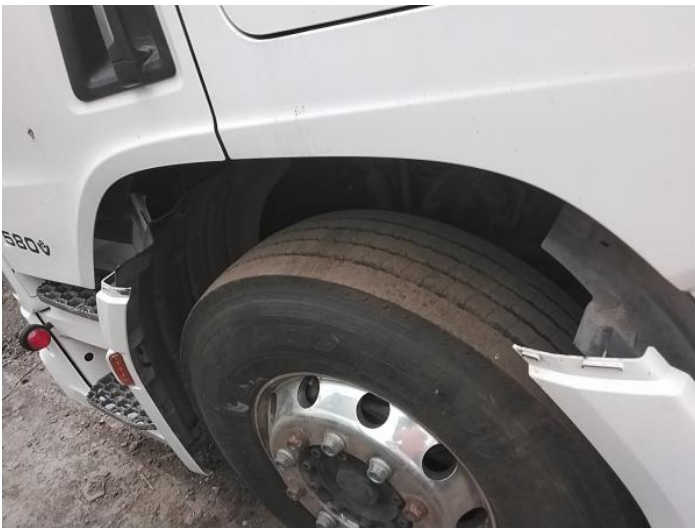
1: Wing nsf  
Missing  
Replace

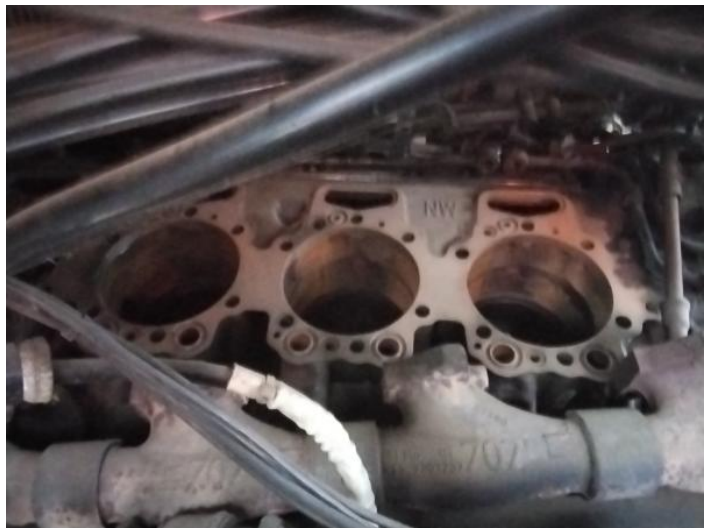
2: Unclassified  
Major Parts Missing  
Report Only

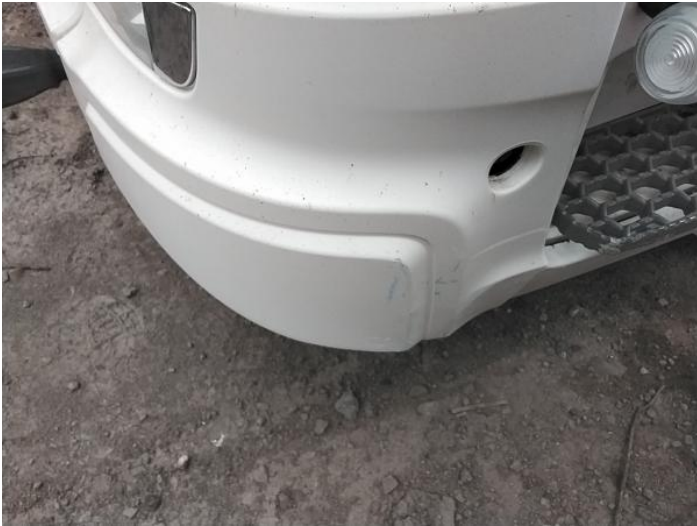
3: Bumper Front  
Scratched  
Over 25mm Not Thru Paint

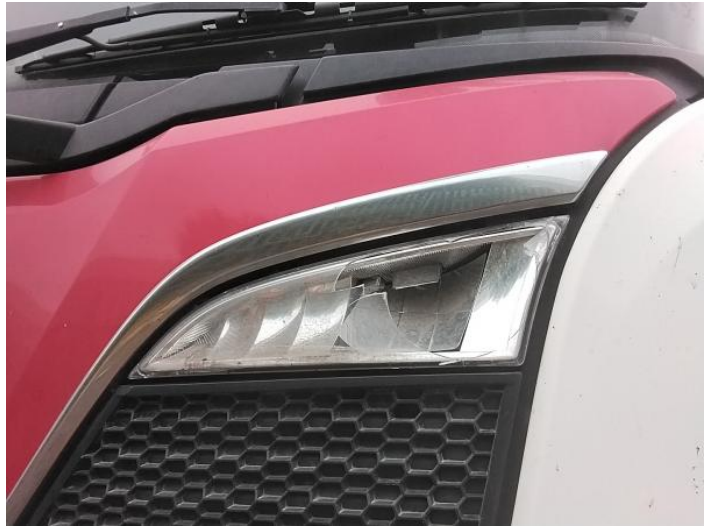
4: Fogdriving Lamp nsf  
Broken  
Replace

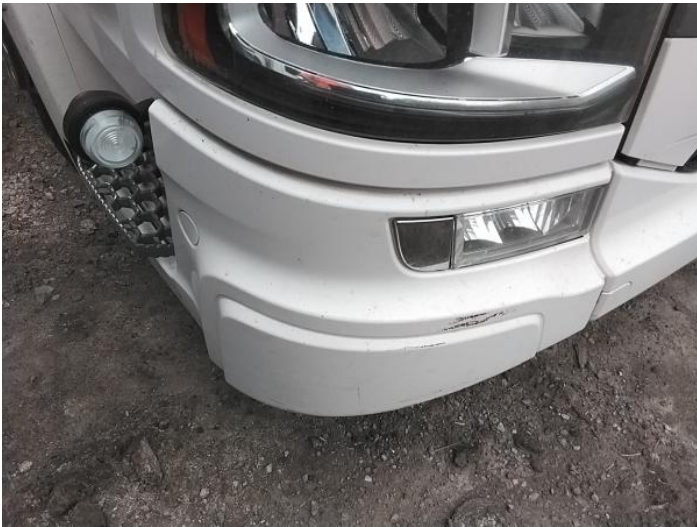
5: Bumper Front  
Scratched  
Over 100mm Thru Paint

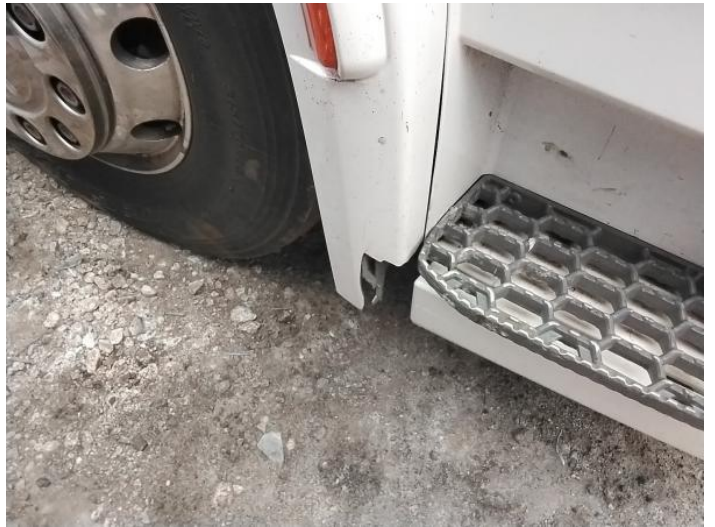
6: Bumper Front Moulding  
Broken  
Replace

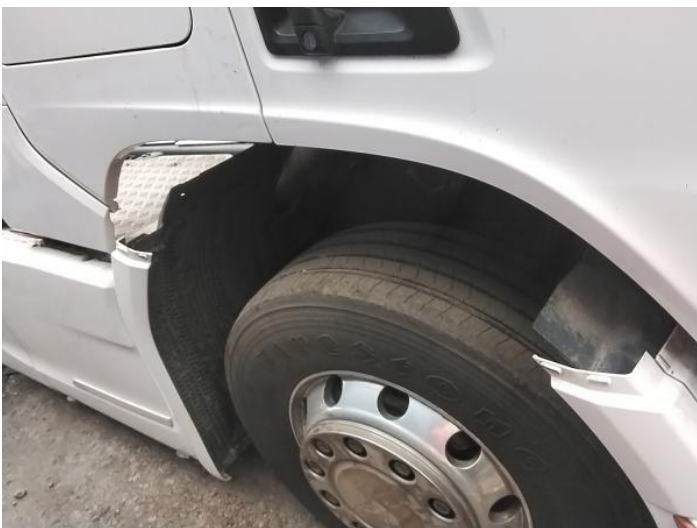
7: Wing nsf  
Missing  
Replace

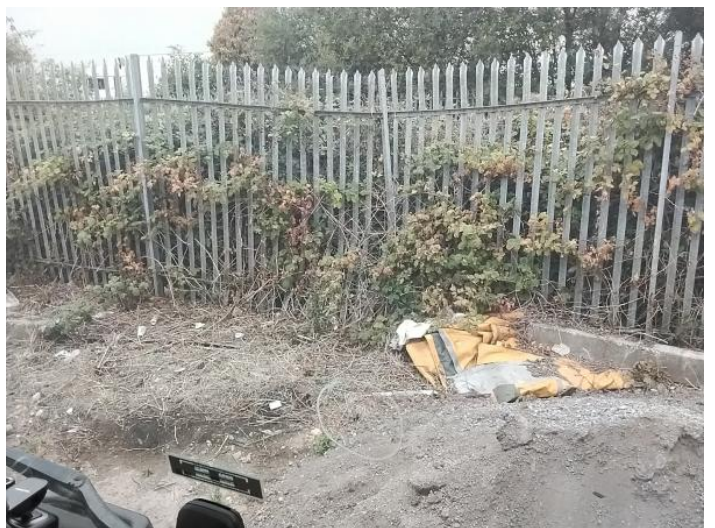
8: Screen Front  
Chipped  
Over 10mm

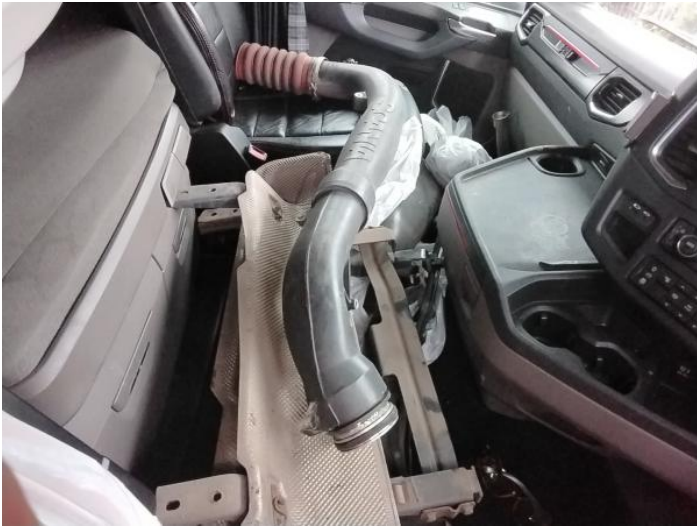
9: General Interior  
Soiled  
Light
