# VEHICLE INSPECTION REPORT

**DE69MRX**

## ISUZU N 75.190

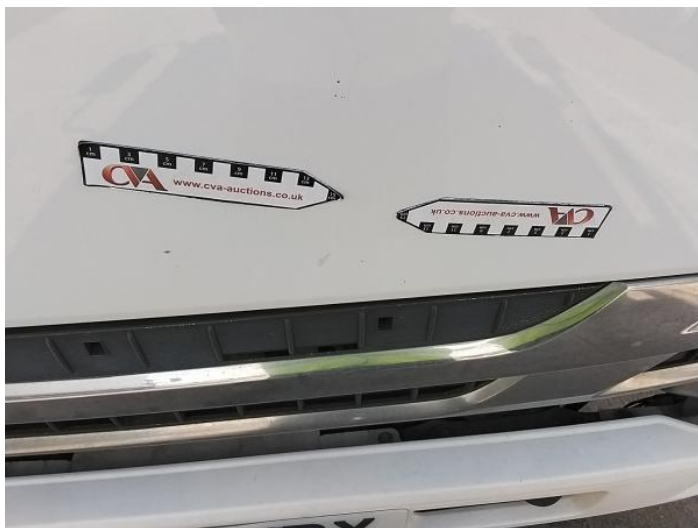
1: Bonnet  
Dented  
Over 30mm

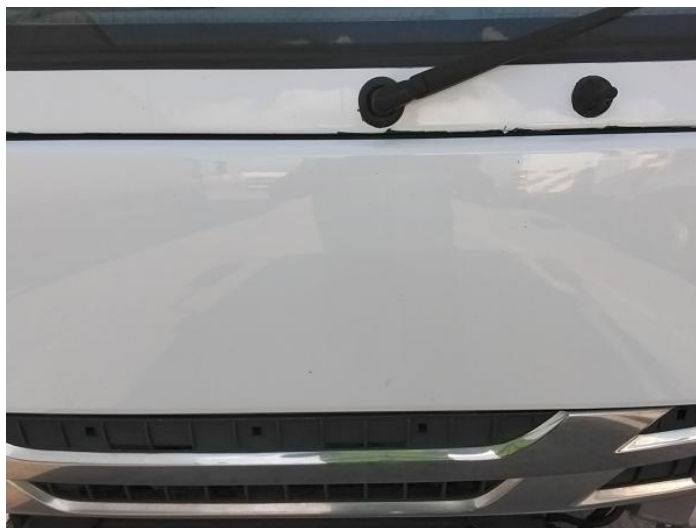
2: Bonnet  
Chipped  
Multiple Chips

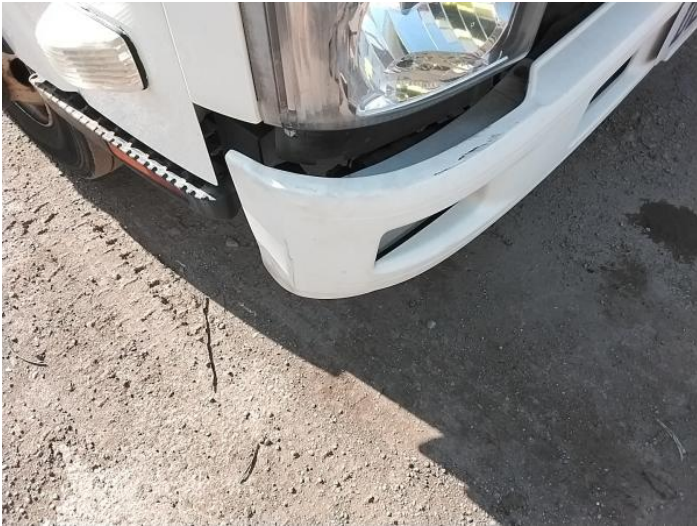
3: Bumper Front  
Dented  
With Paint Damage

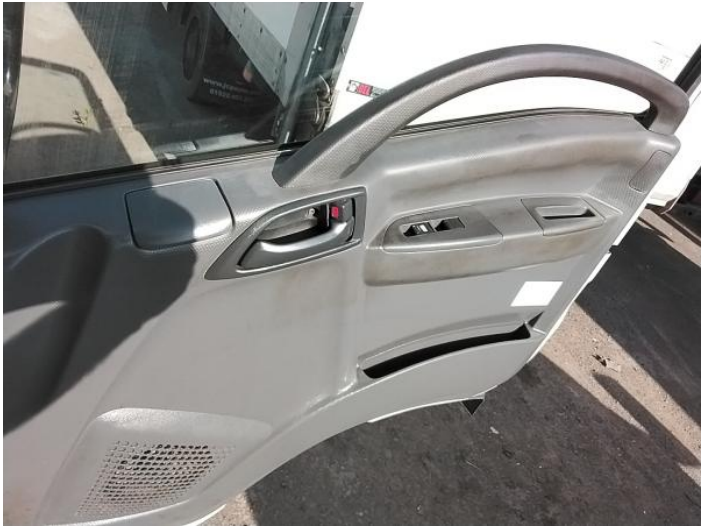
4: Door Pad osf  
Soiled  
Heavy

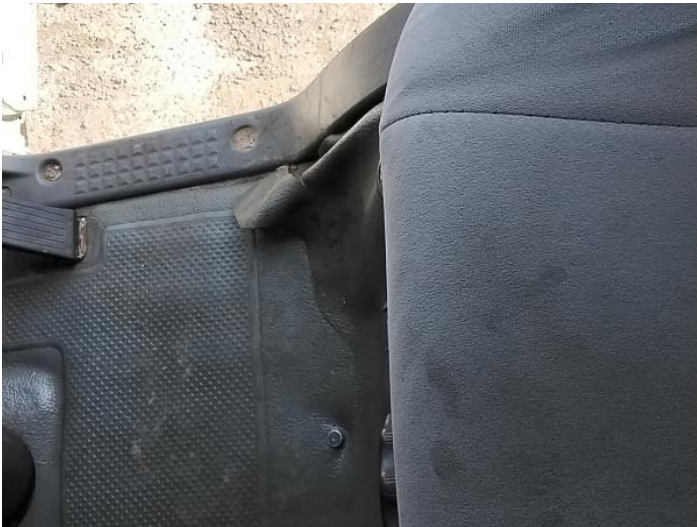
5: Seat Base Cover osf  
Soiled  
Heavy

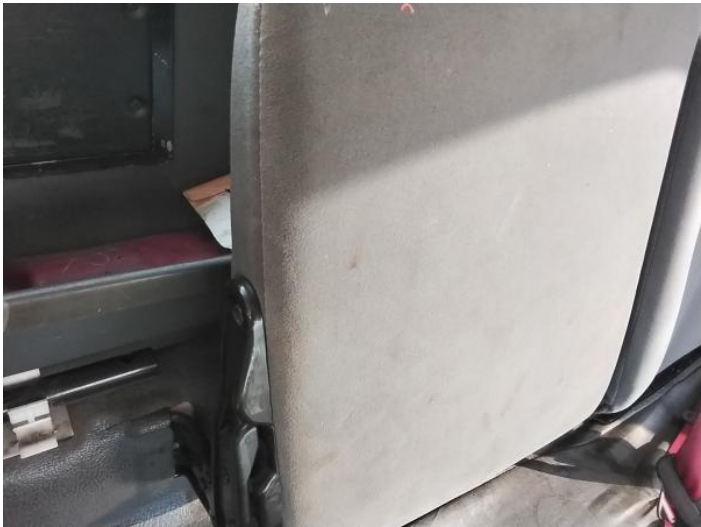
6: Seat Back Cover nsf  
Soiled  
Heavy
